## TOWN OF HUNTSVILLE BRIDGE INSPECTIONS

Inspection Report

Project # 17-4022-07

November 2018

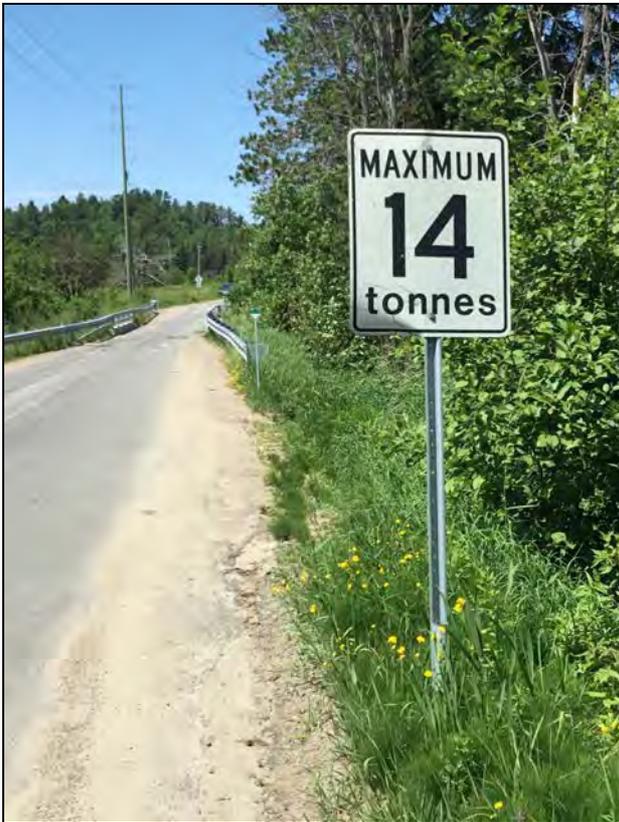
**Accessories / Signs**

**Description: Surface cracking maximum load sign at south end of bridge**

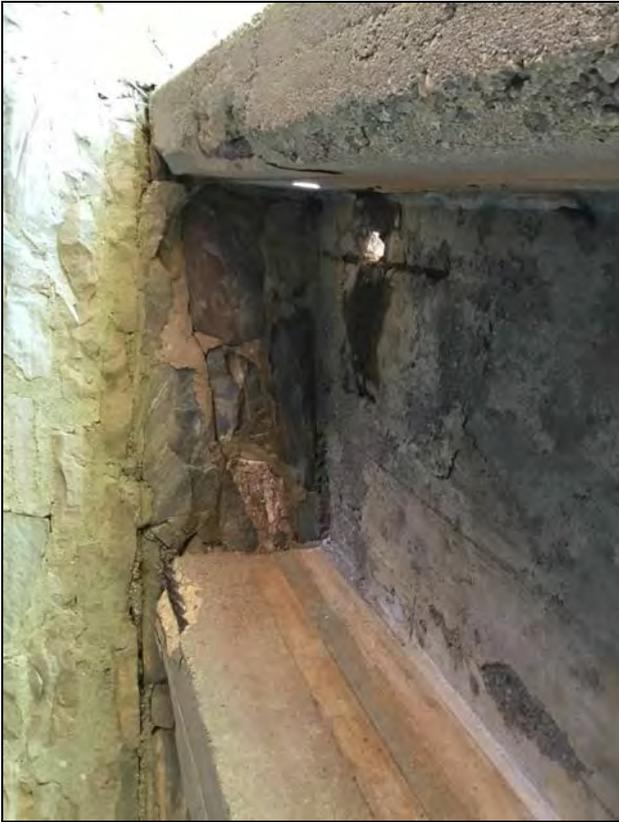
**Description: Spalling and scaling exposing rebar on west girder and west old soffit**  
**Decks / Soffit - Thin Slab**

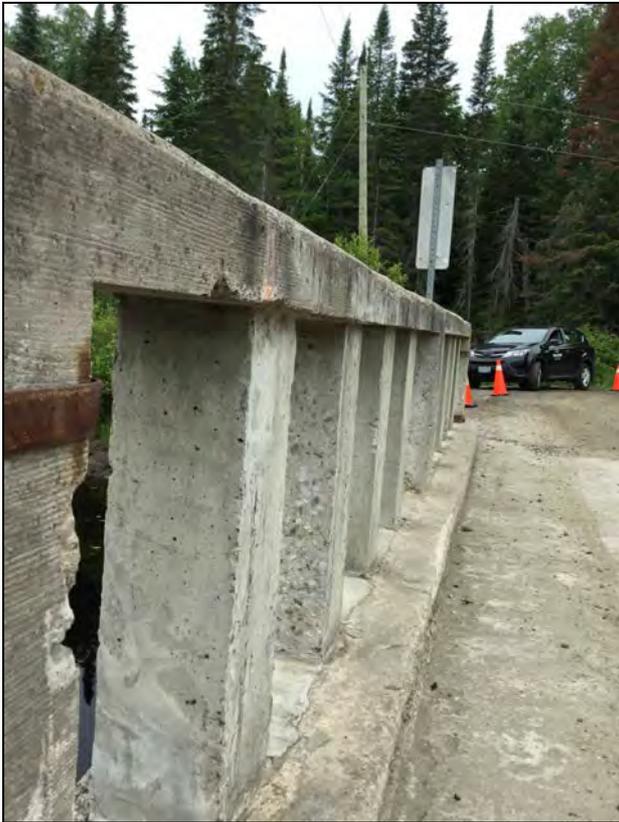
**Description: S spalling on bottom edge**  
**Barriers / Railing Systems (North and South)**

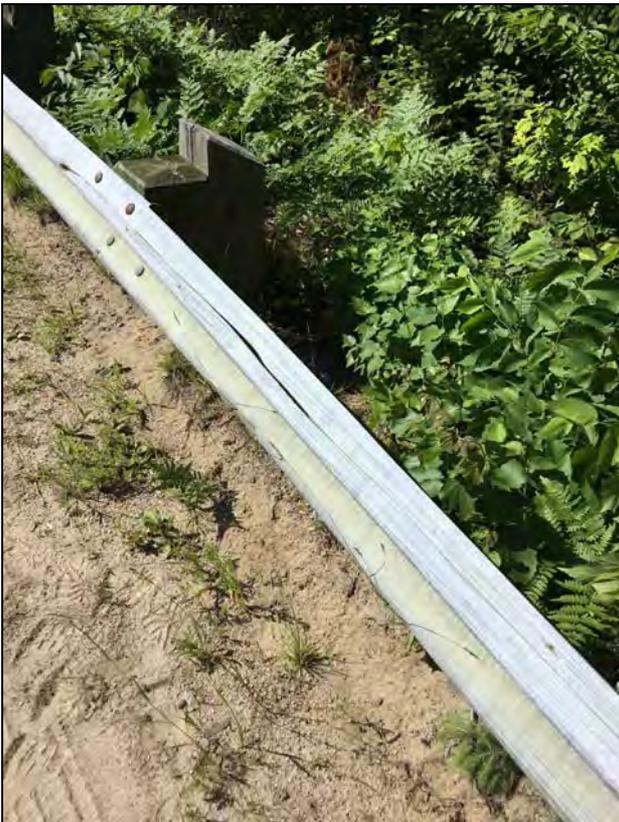
**Description: Damaged beam (gash)**  
**Approaches / Barriers (All Quadrants)**

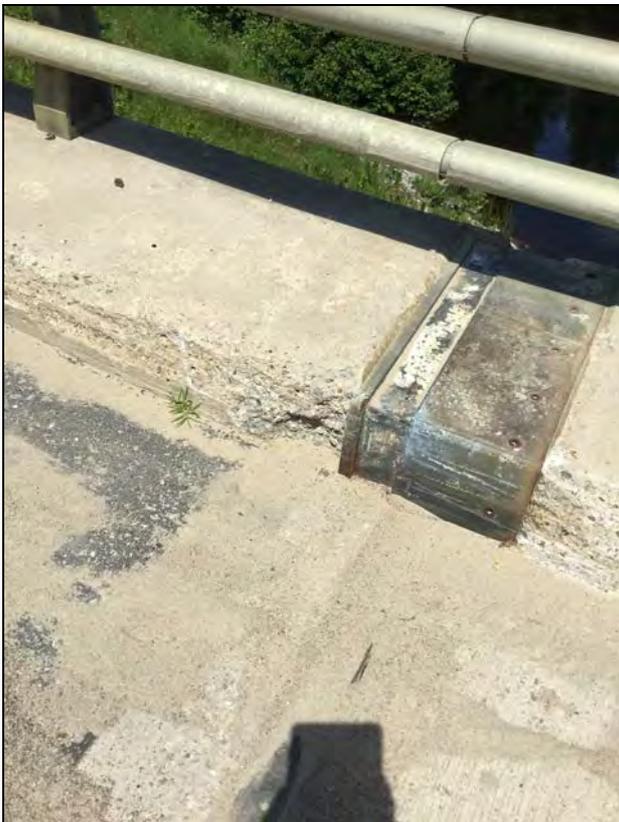
**Description: Spall at north joint**  
**Approaches / Curb and Gutters (Northwest Southeast)**

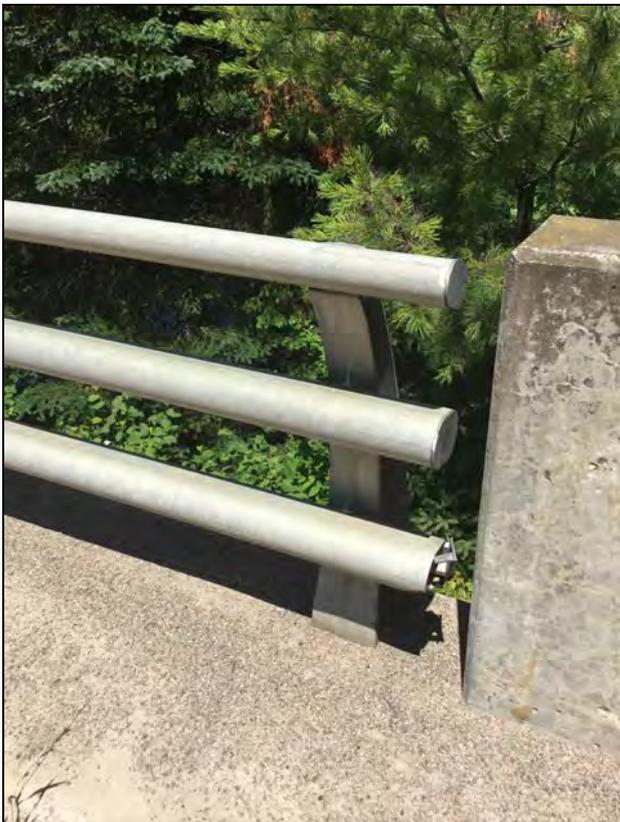
**Description: North railing se side missing cap**  
**Barriers / Railing Systems (North and south)**

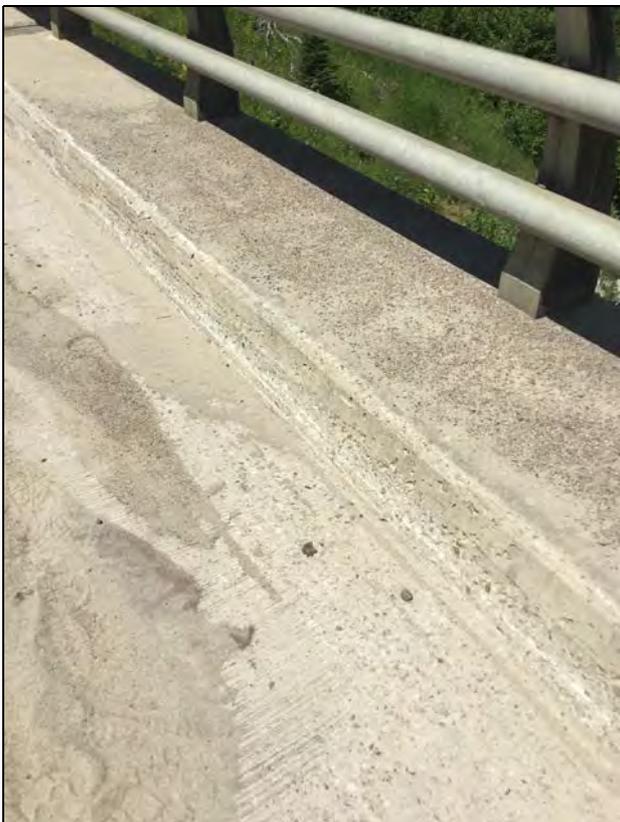
**Description: Scraping damage and sand build up north side**  
**Sidewalks/curbs / Curbs (North and south sides.)**

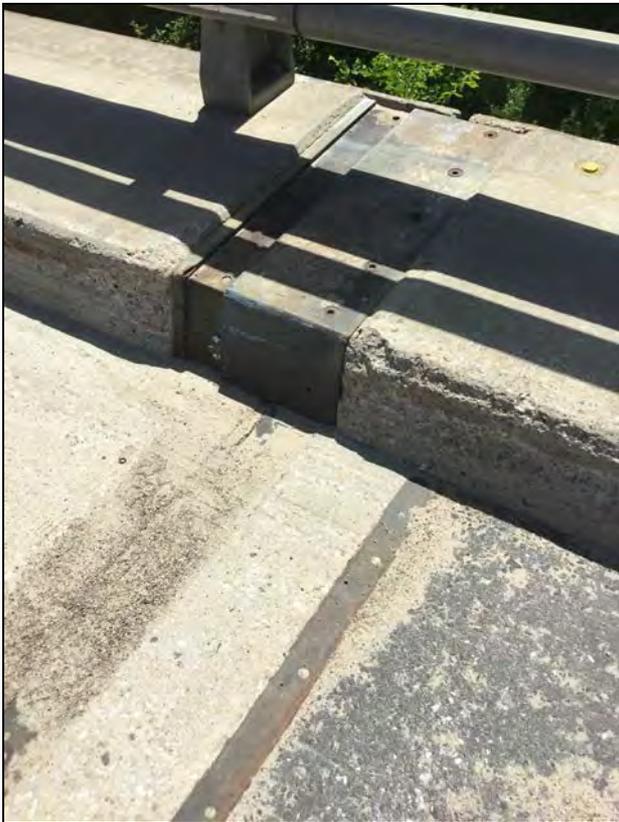
**Description: Scraping damage south side  
Sidewalks/curbs / Curbs (North and south sides.)**

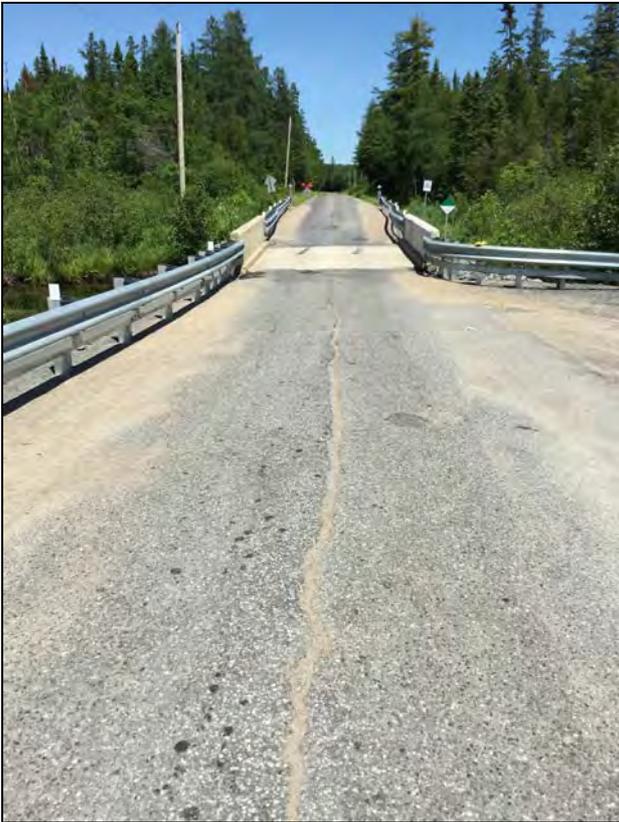
**Description: Severe longitudinal crack down centre line of W approach Approaches / Wearing surface (East and west)**

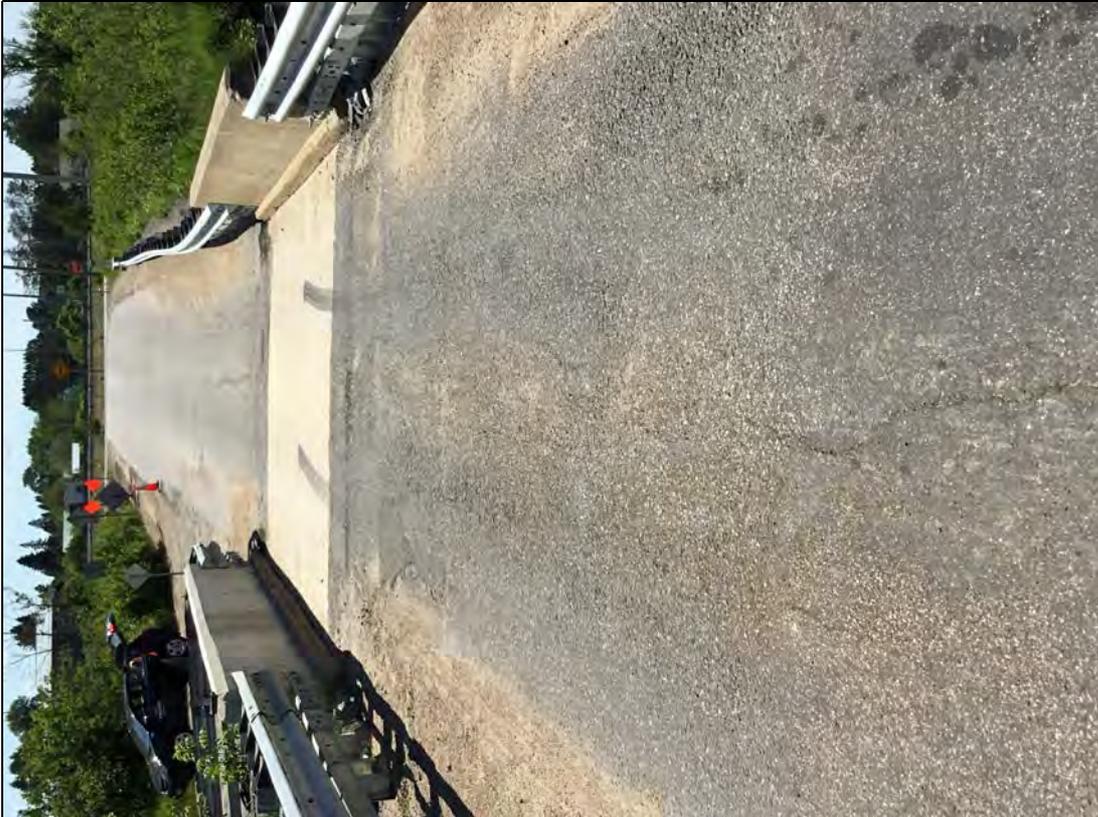
**Description: Settling at approach to deck interface, behind abutment Approaches / Wearing surface (East and west)**

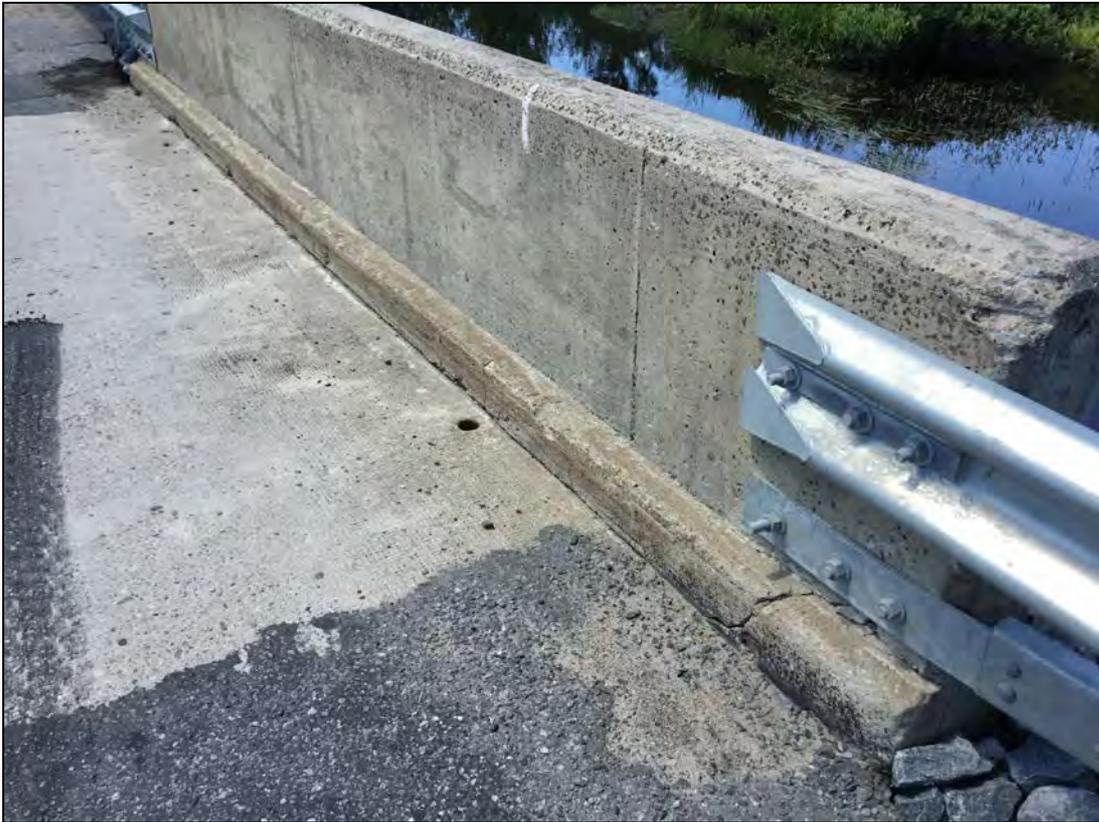
**Description: Severe crack NE**  
**Sidewalks/curbs / Curbs (North and South)**

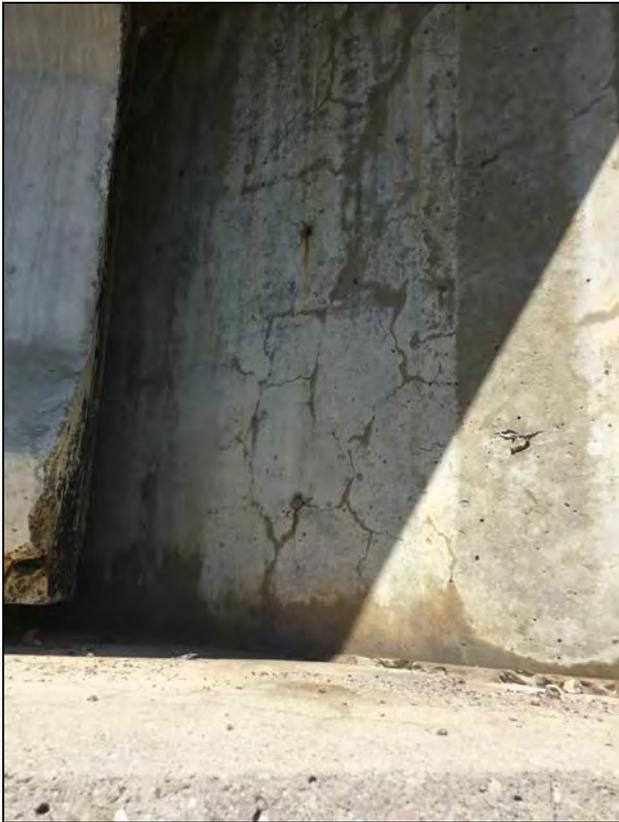
**Description: Narrow pattern cracking ne quadrant  
Abutments / Ballast Walls (North and South)**

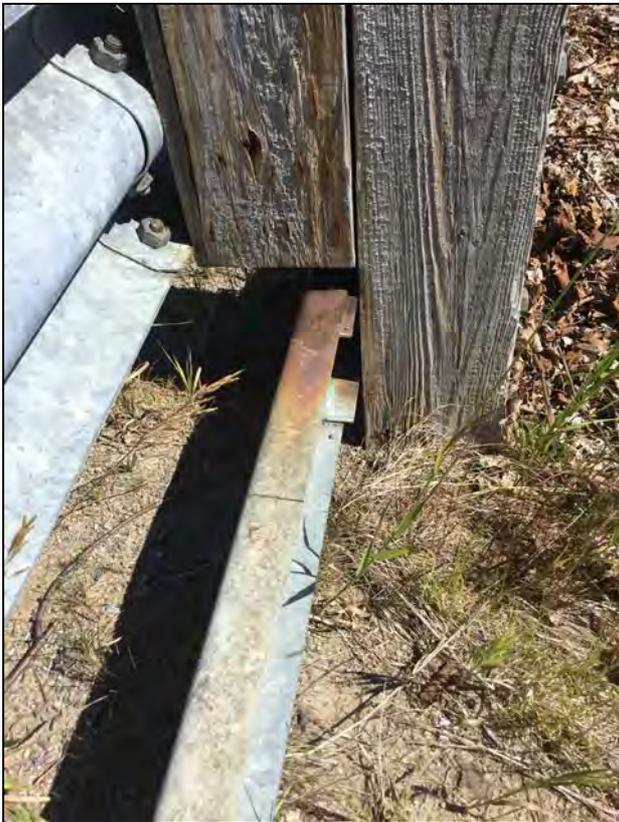
**Description: Corrosion at wood blocks (typ.)**  
**Approaches / Barriers (East)**

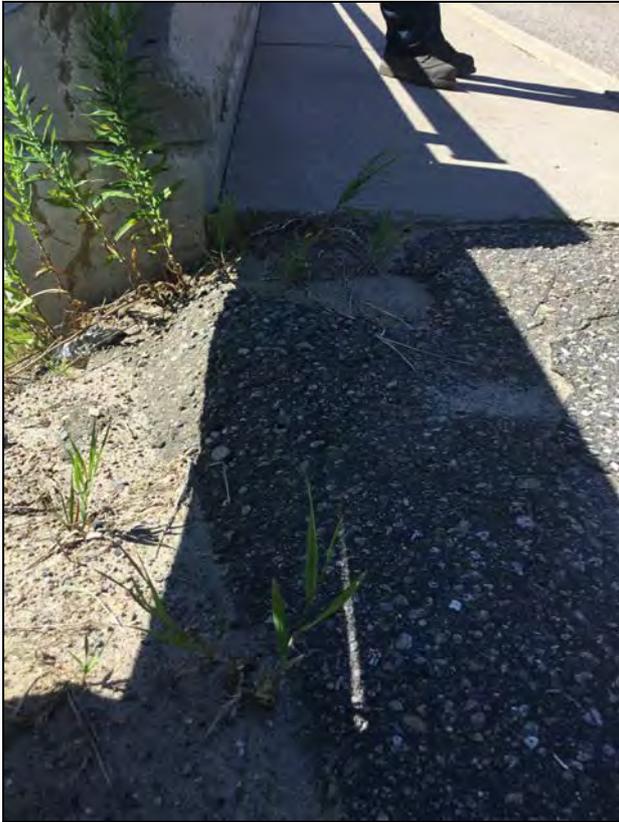
**Description: Minor erosion**

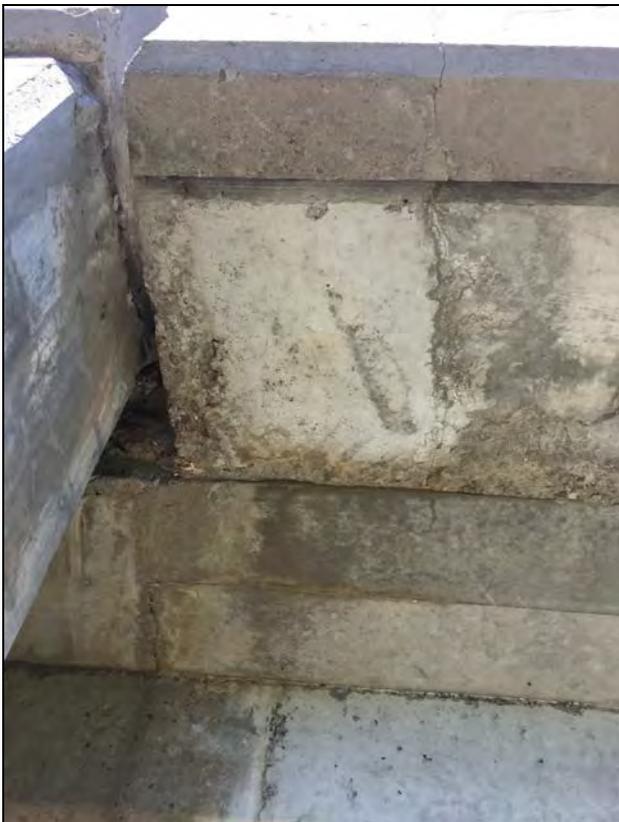
**Description: Past cracking and leaking. Minor spall SE side**  
**Decks / Soffit - Thin Slab (Ends)**

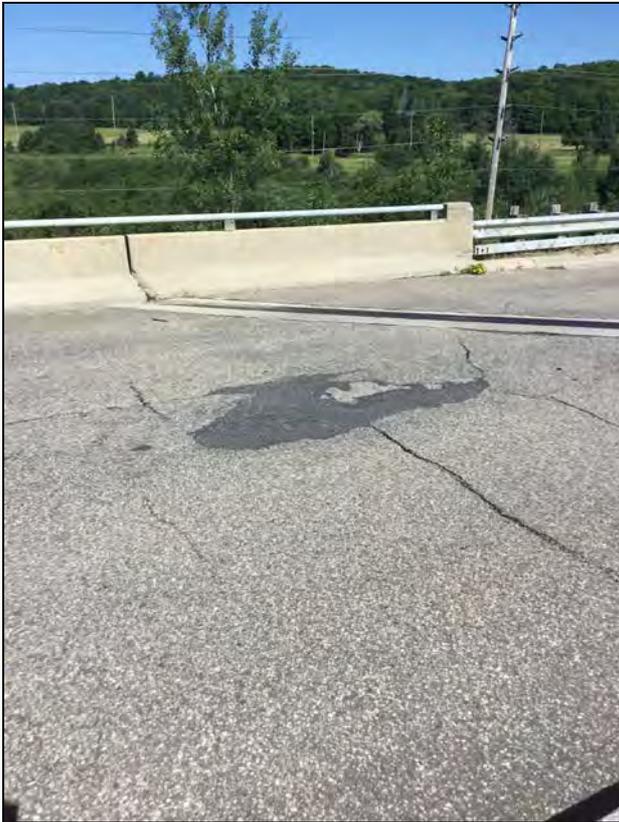
**Description: Patched pothole N end  
Decks / Wearing Surface**

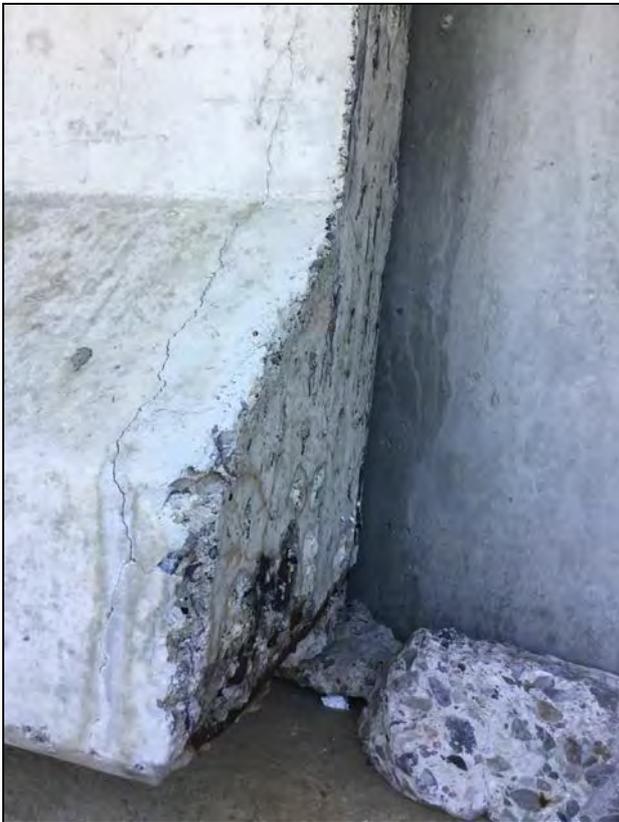
**Description: Southwest crack and evident spall.  
Beams/Main Longitudinal Elements / Girders (Ends)**

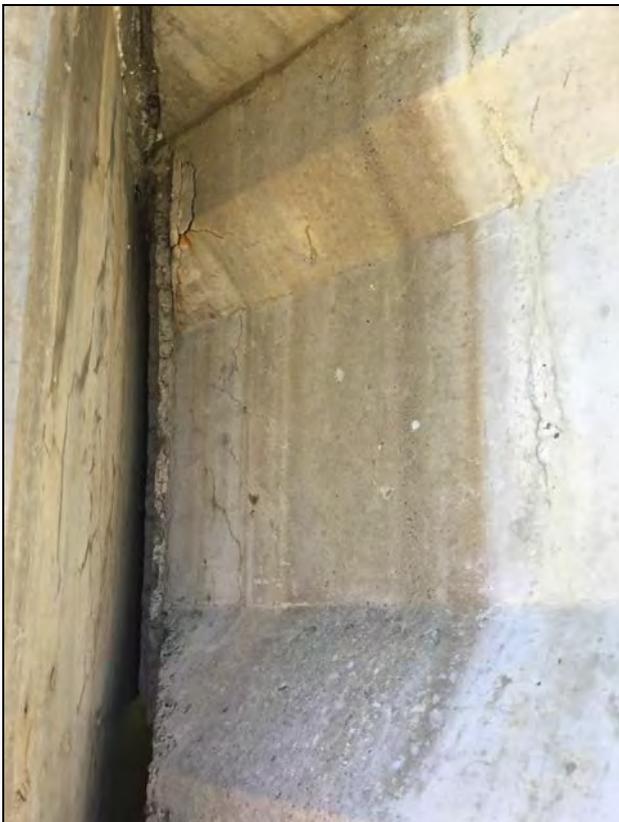
**Description: Narrow cracks and efflorescence.  
Beams/Main Longitudinal Elements / Girders (Ends)**

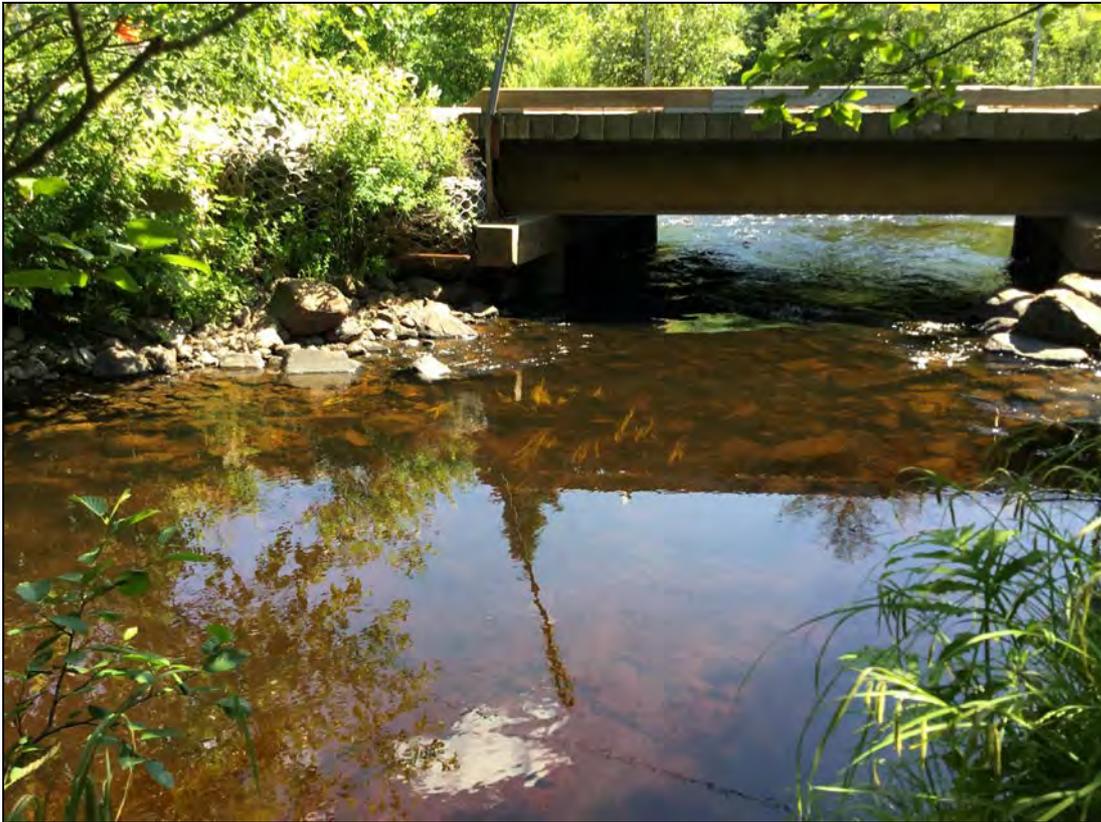
**Description: Increased velocity due to shallow depth under bridge (Looking S)  
Embankments & Streams / Streams and Waterways (North and South)**

- Blend to road on west side to provide sufficient drainage. Regrade east approach.
- Replace all four edge boards.
- Clear concrete debris from under bridge, currently shallow water due to debris is causing increased velocity and therefore increased erosion.

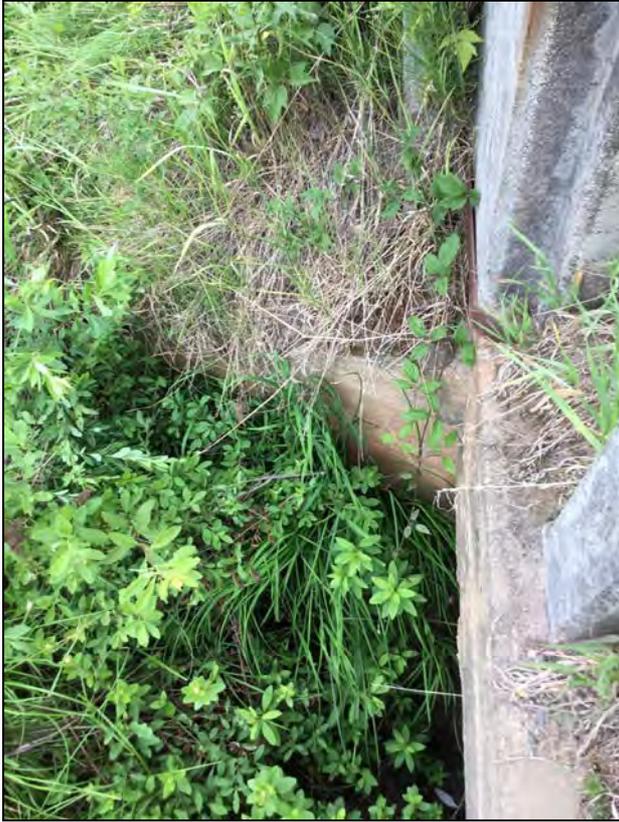
**Description: NW - overgrown vegetation.**  
**Abutments / Wingwalls (4 Corners of Structure)**

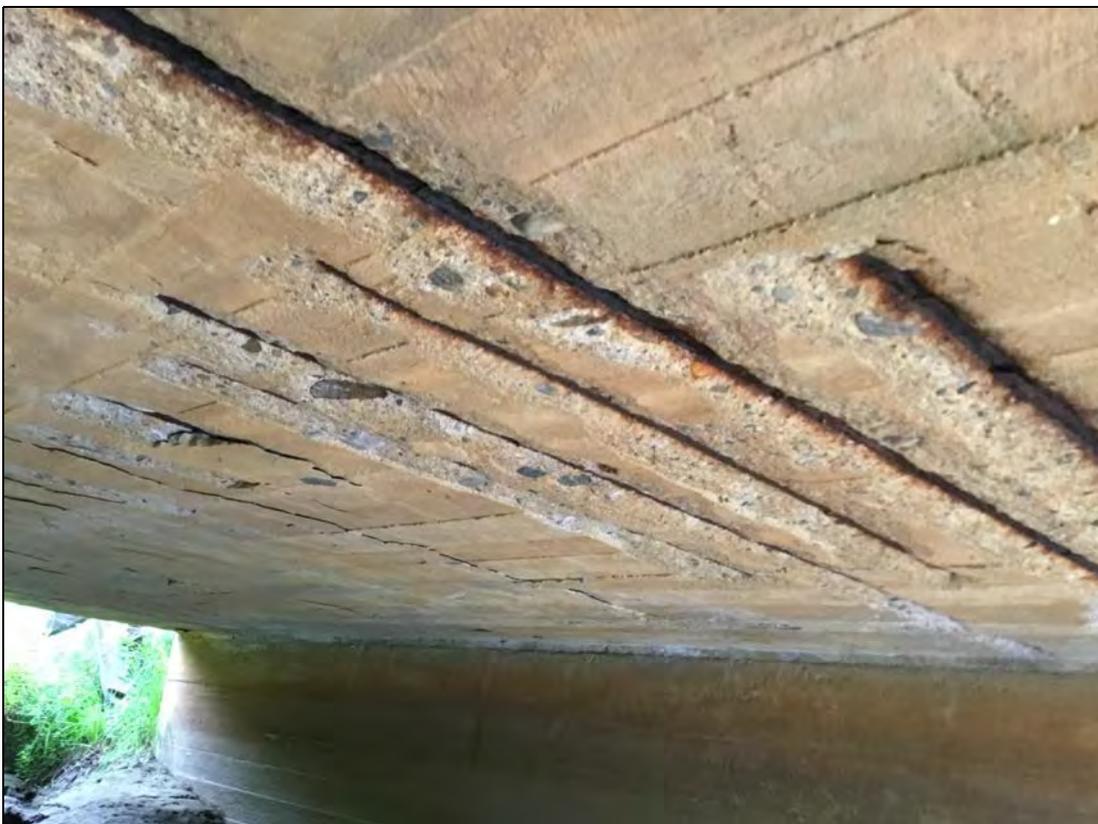
**Decks / Soffit - Thick slab (Interior)**

**Description: Interior soffit with exposed rebar**

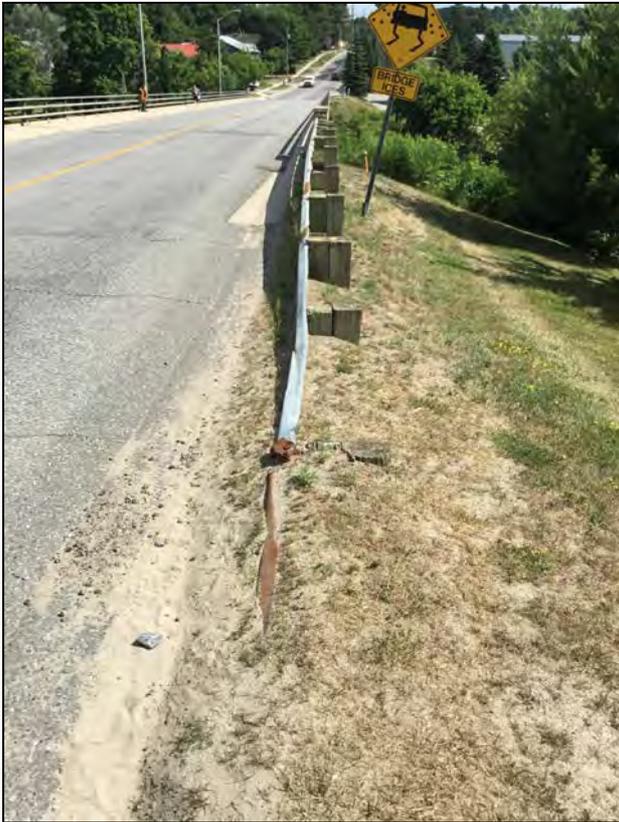
**Approaches / Barriers (NE, NW)**

**Description: Damaged NW steelbeam guide rail**

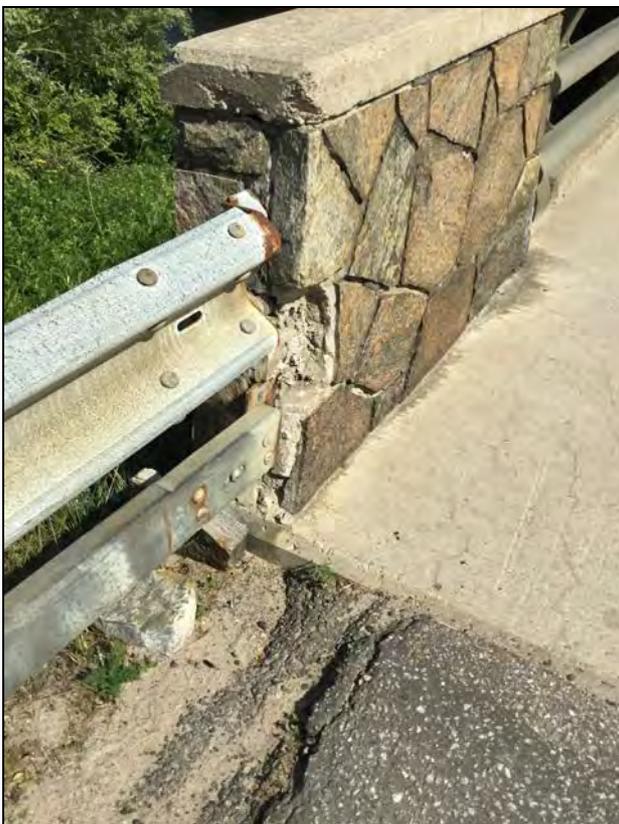
**Barriers / Barrier/Parapet Walls**

**Description: NE spall**

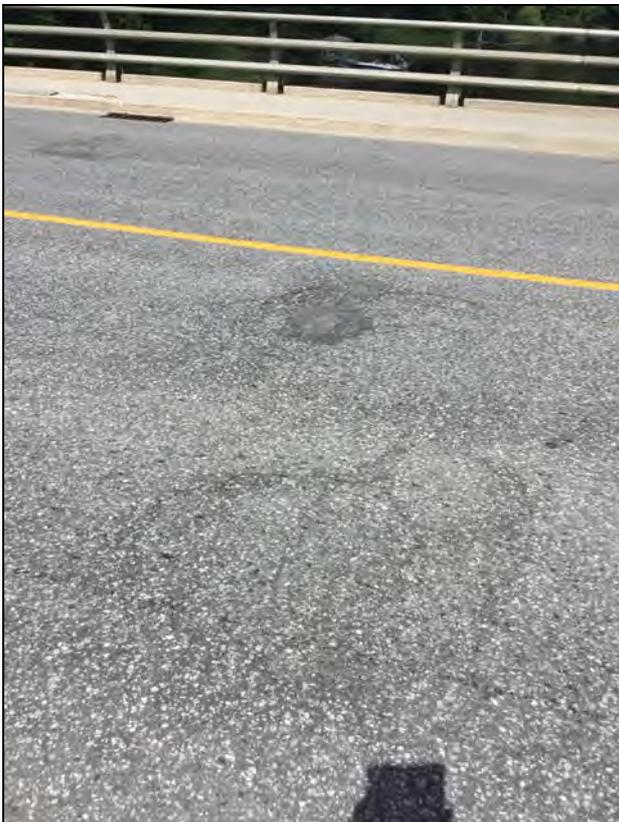
**Description: Sunken patched pot hole**  
**Decks / Wearing Surface**

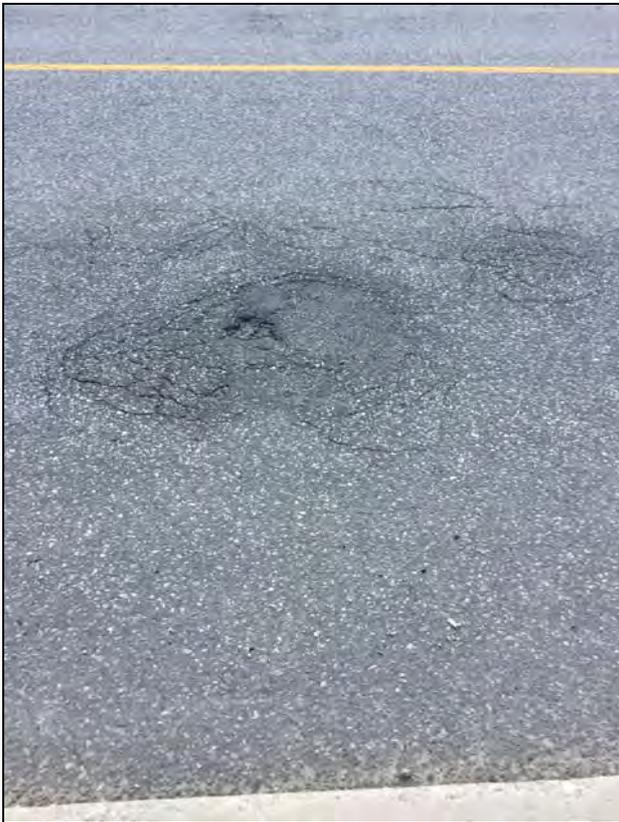
**Description: SE quadrant patch material loss  
Decks / Wearing Surface**

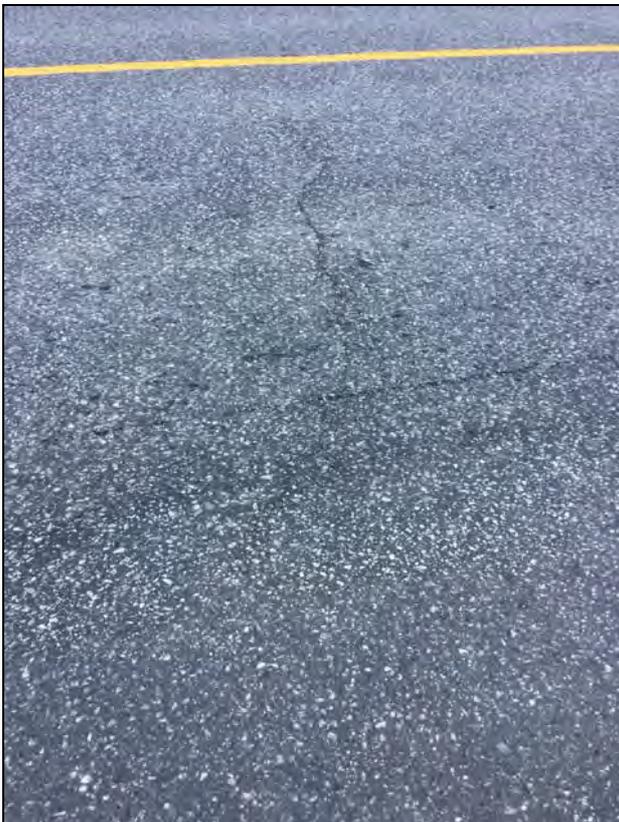
**Description: Transverse cracks N side  
Decks / Wearing Surface**

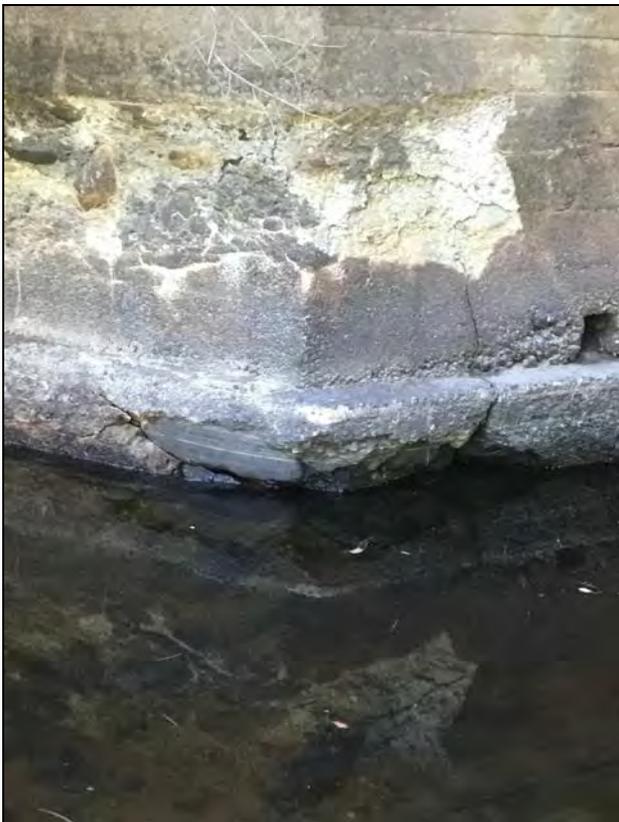
**Abutments / Wingwalls (4 Corners)**

**Description: Severe crack and spalling.**

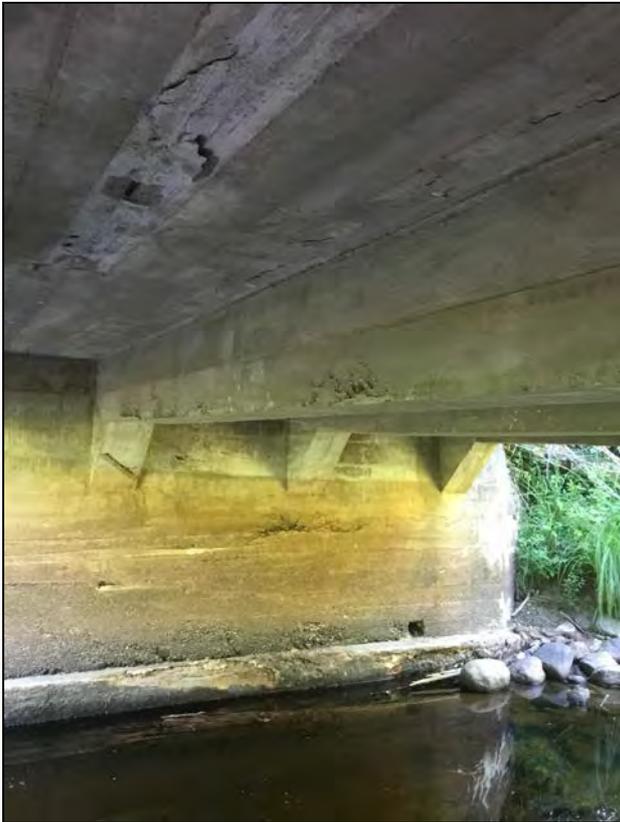
**Description: Spalled areas**  
**Beams/Main Longitudinal Elements / Girders**

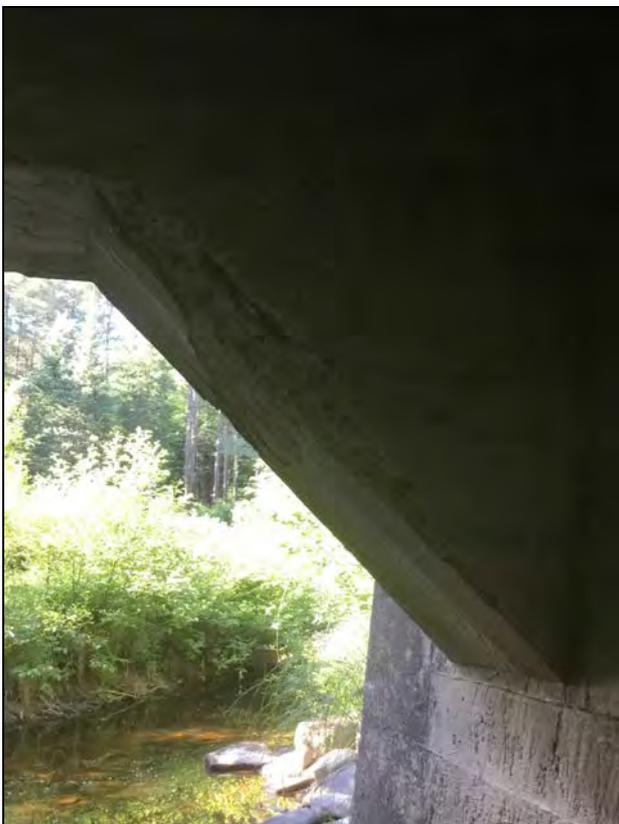
**Description: Late spall w rebar nw**  
**Beams/Main Longitudinal Elements / Girders**

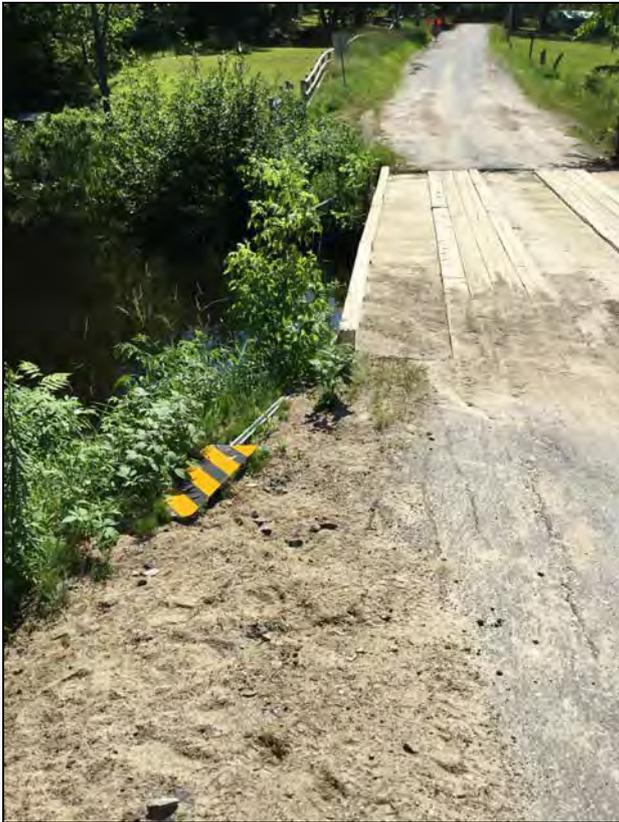
**Accessories / Signs**

**Description: Dislocated SE hazard**

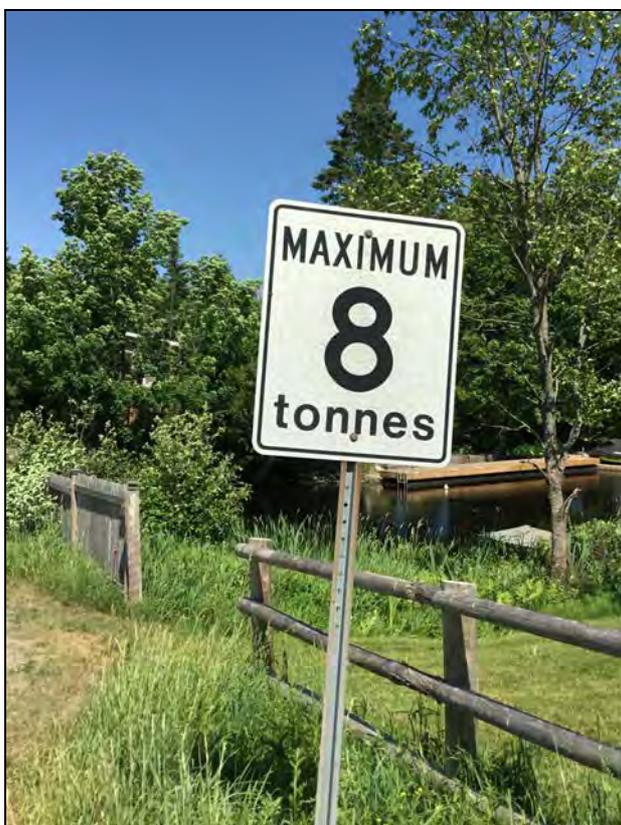
**Accessories / Signs**

**Description: W side Load capacity with surface cracking**
