## TOWN OF HUNTSVILLE BRIDGE INSPECTIONS

Inspection Report

Project # 17-4022-07

November 2018

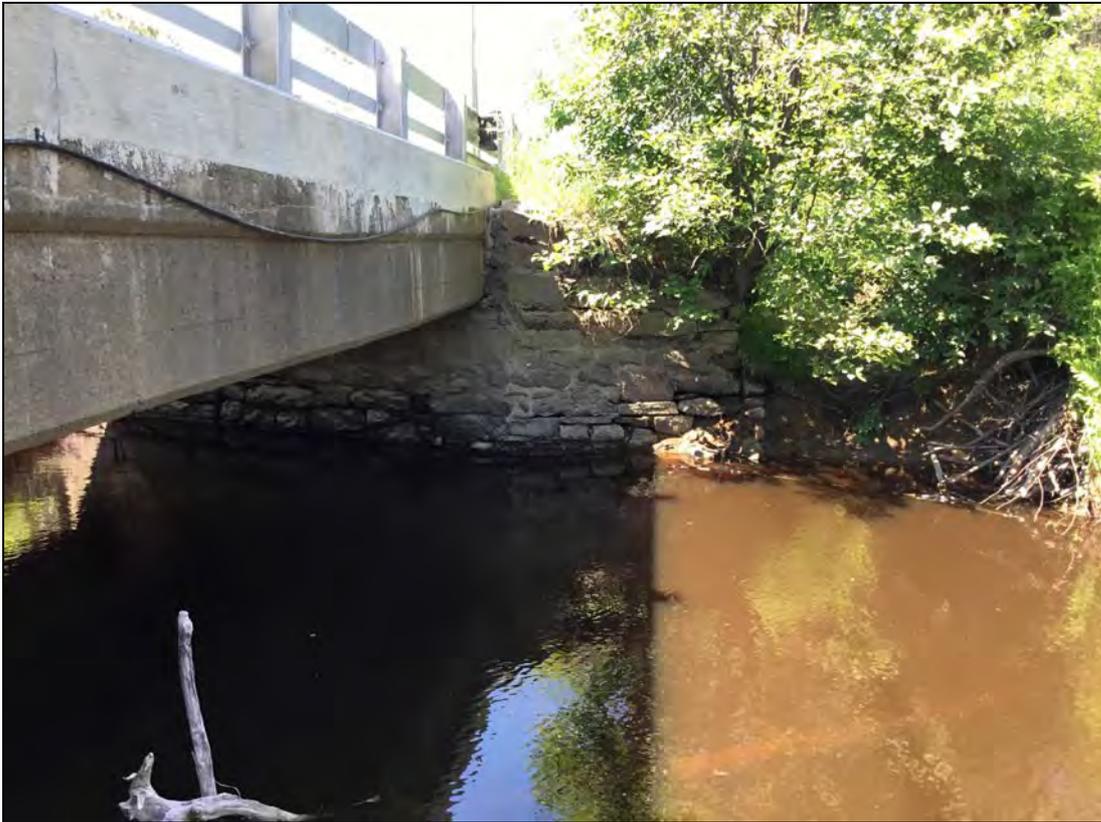
**Description: North east wing wall**  
**Abutments / Wingwalls (4 Corners)**

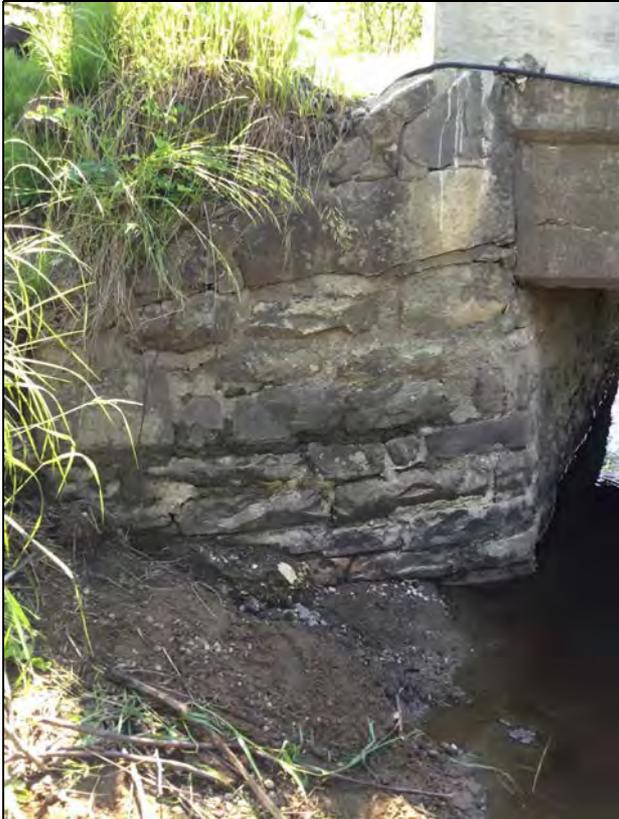
**Description: South east wing wall**  
**Abutments / Wingwalls (4 Corners)**

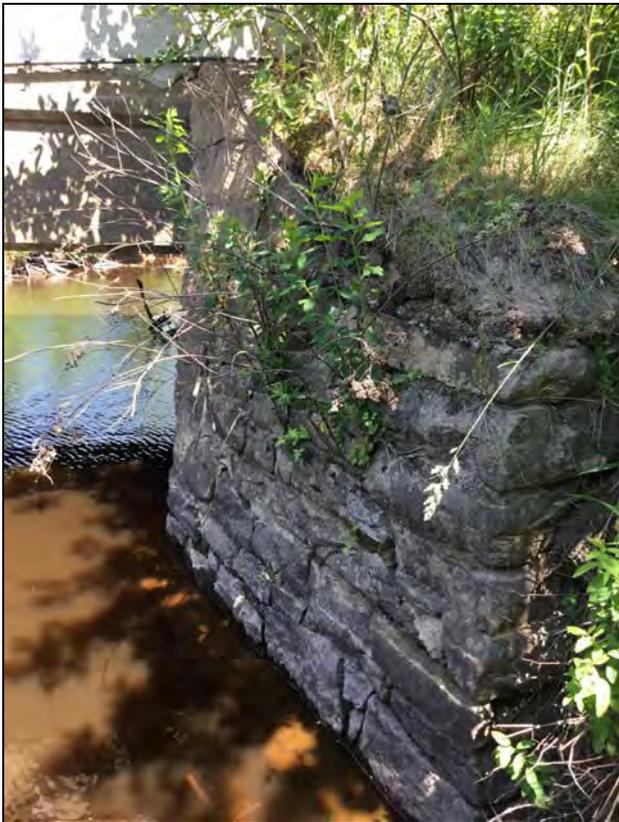
**Description: Vegetation out of south west wing wall**  
**Abutments / Wingwalls (4 Corners)**

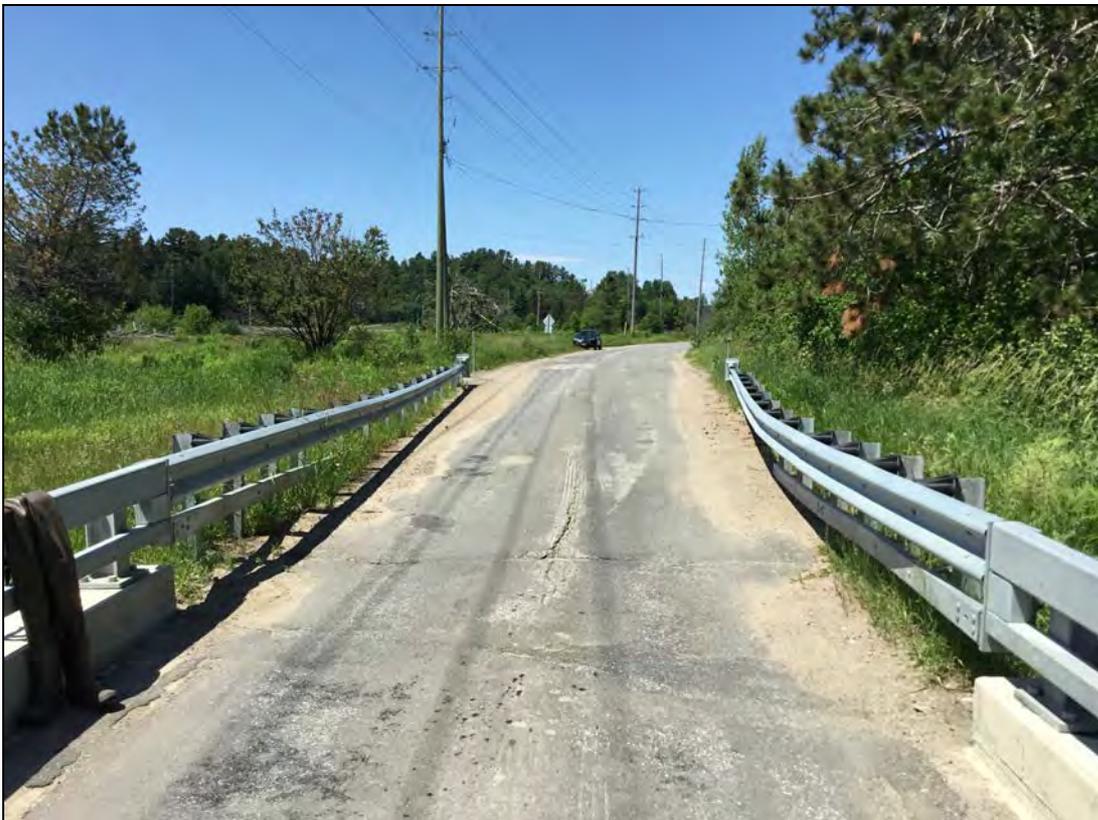
**Description: North end guiderails**  
**Approaches / Barriers**

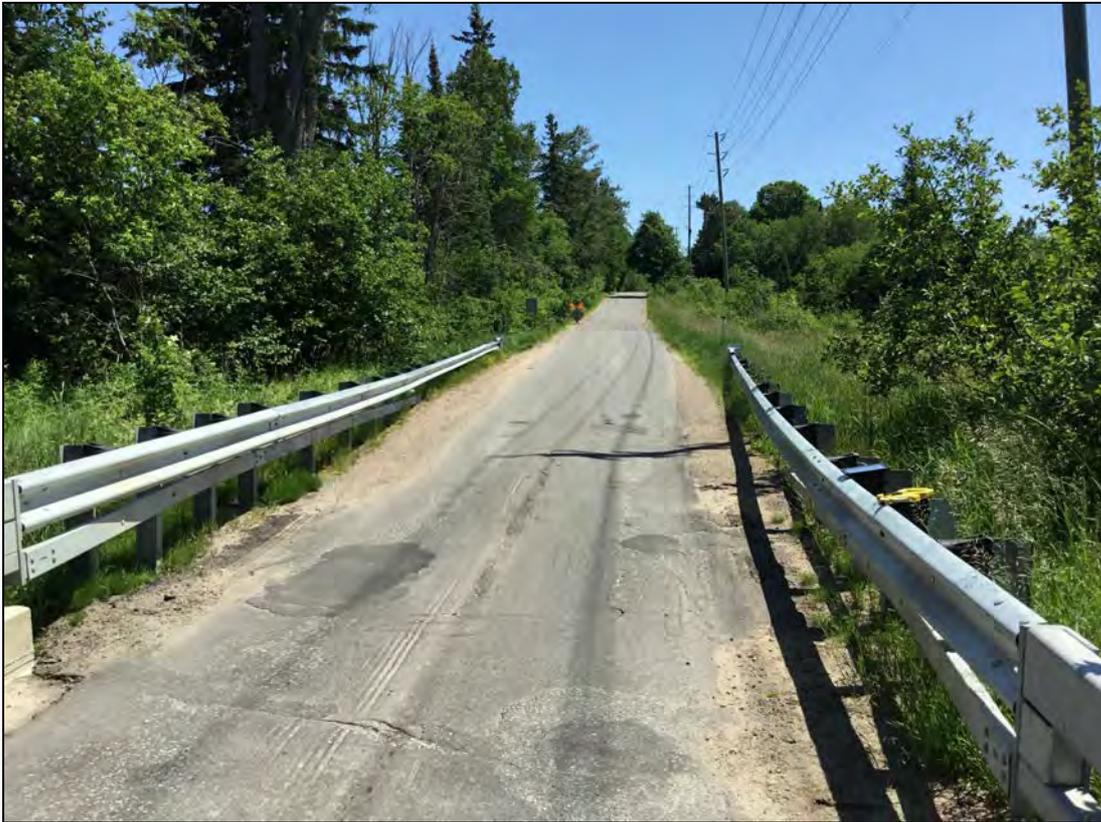
**Description: South end guderail**

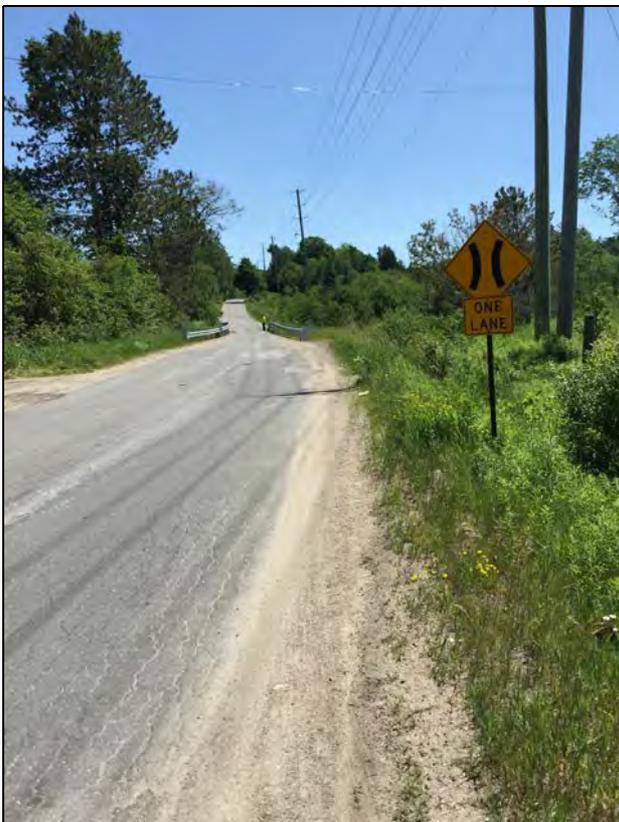
**Description: One lane sign at north end of bridge**

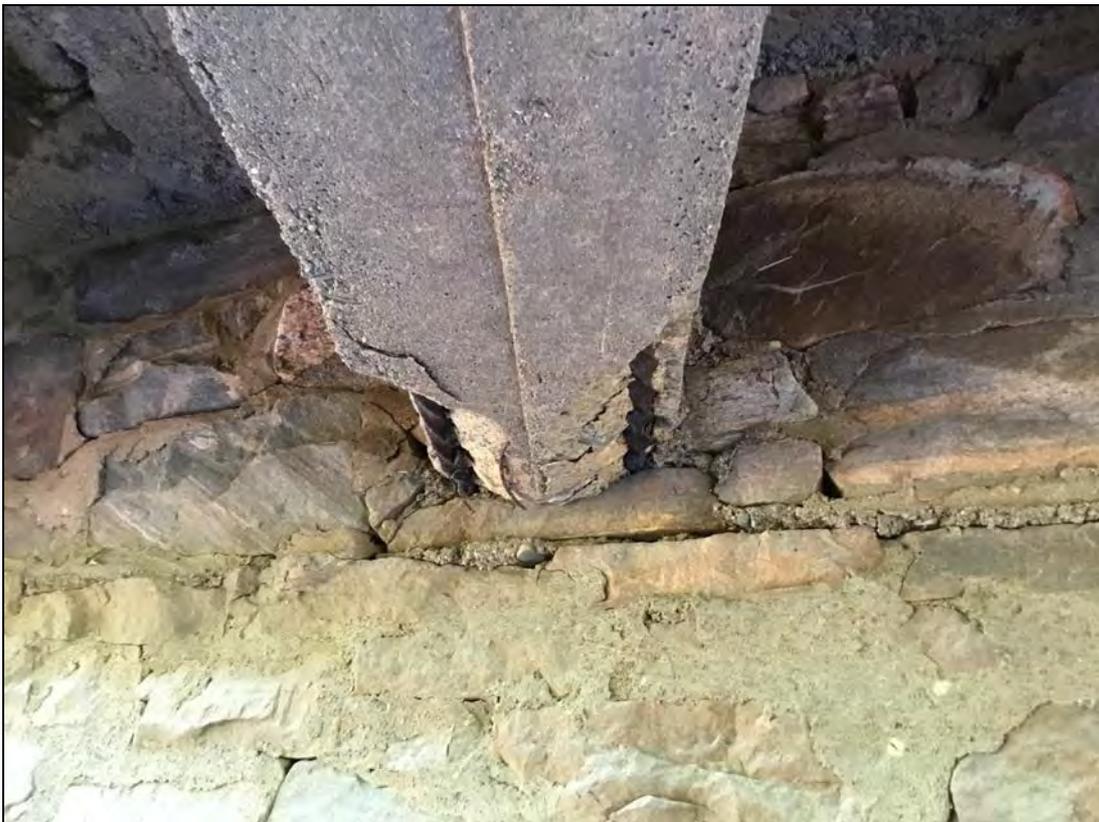
**Description: Exposed rebar on south side of east girder**  
**Beams/Main Longitudinal Elements / Girders**

- Repair mortar on wingwalls
- Replace utilities
- Repave approaches
- Concrete patch repair and galvanized deck drainage at girders
- Repair deck concrete
- Repave deck wearing surface
- Soffit concrete patching

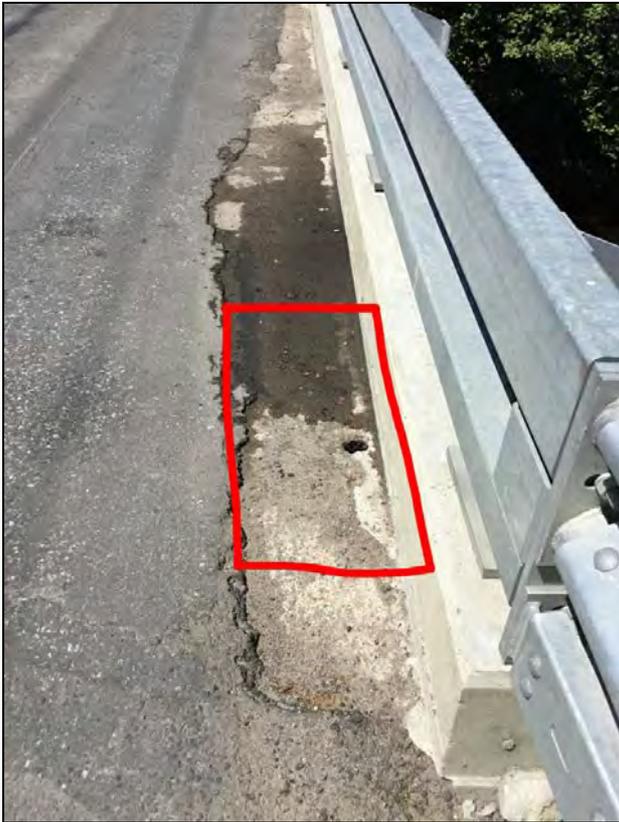
**Description: Delaminated area.**

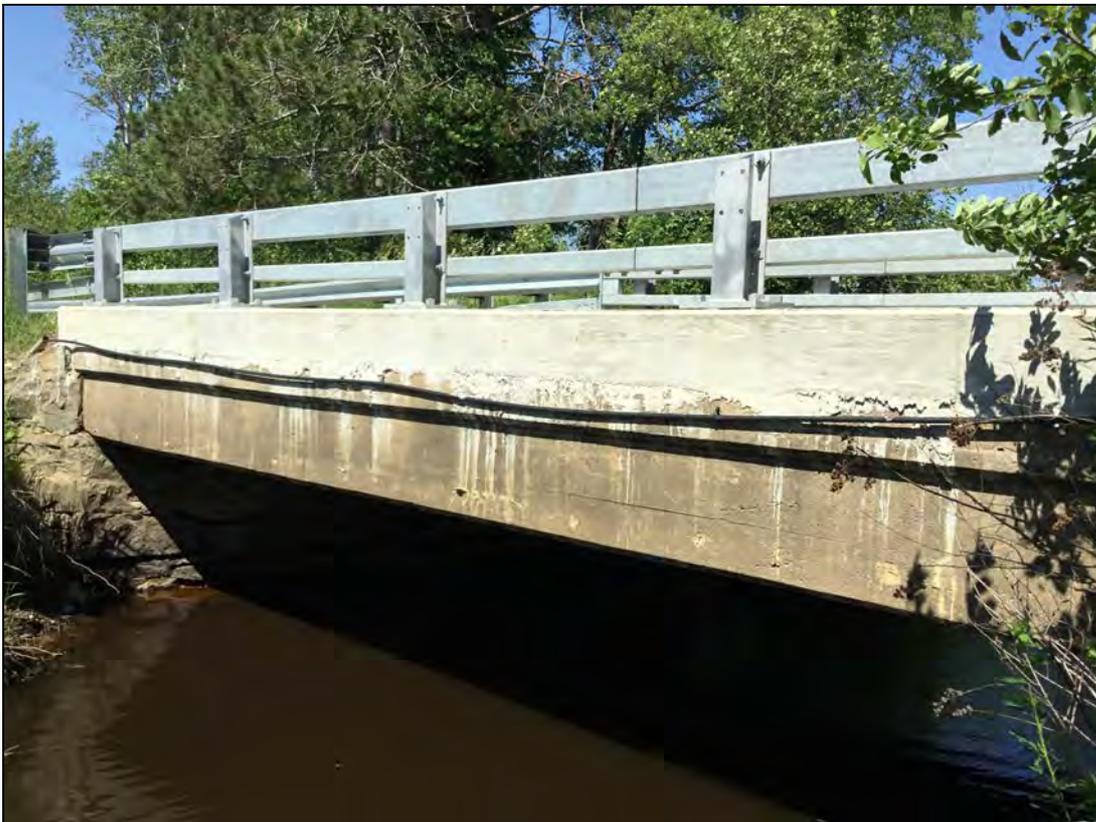
**Description: West utility line**

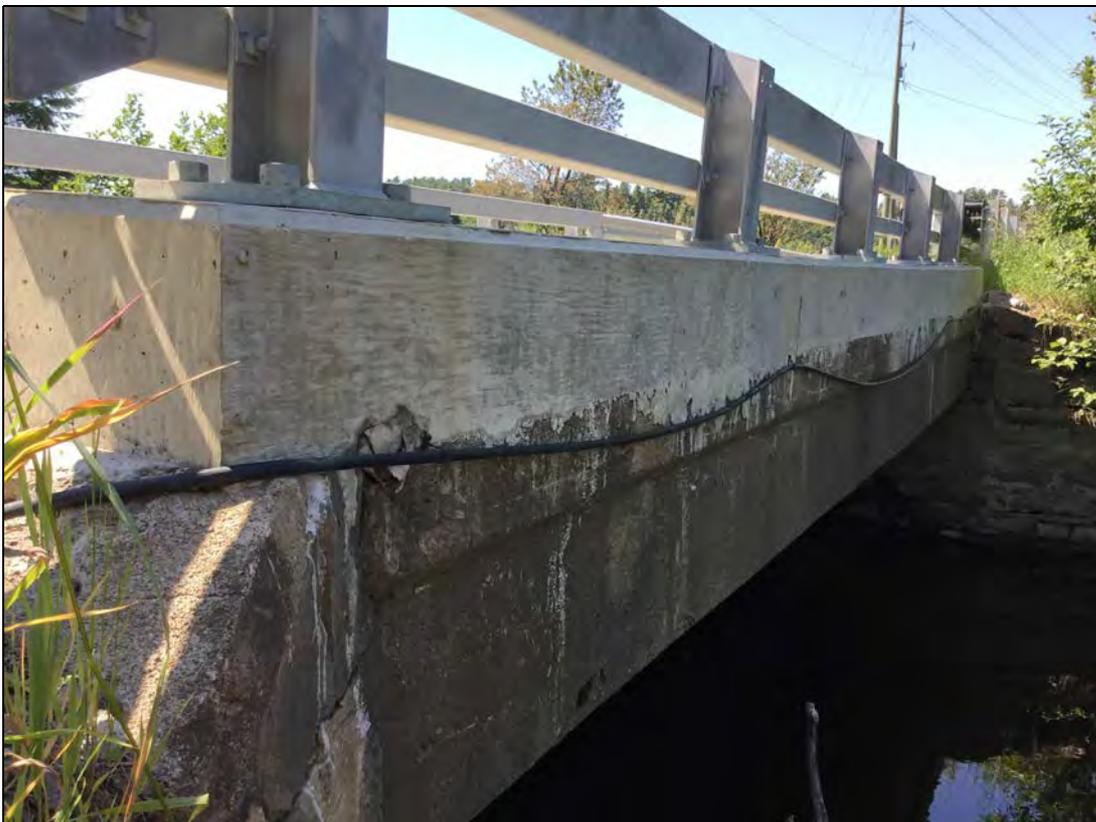
**Description: Utility cable on east side**

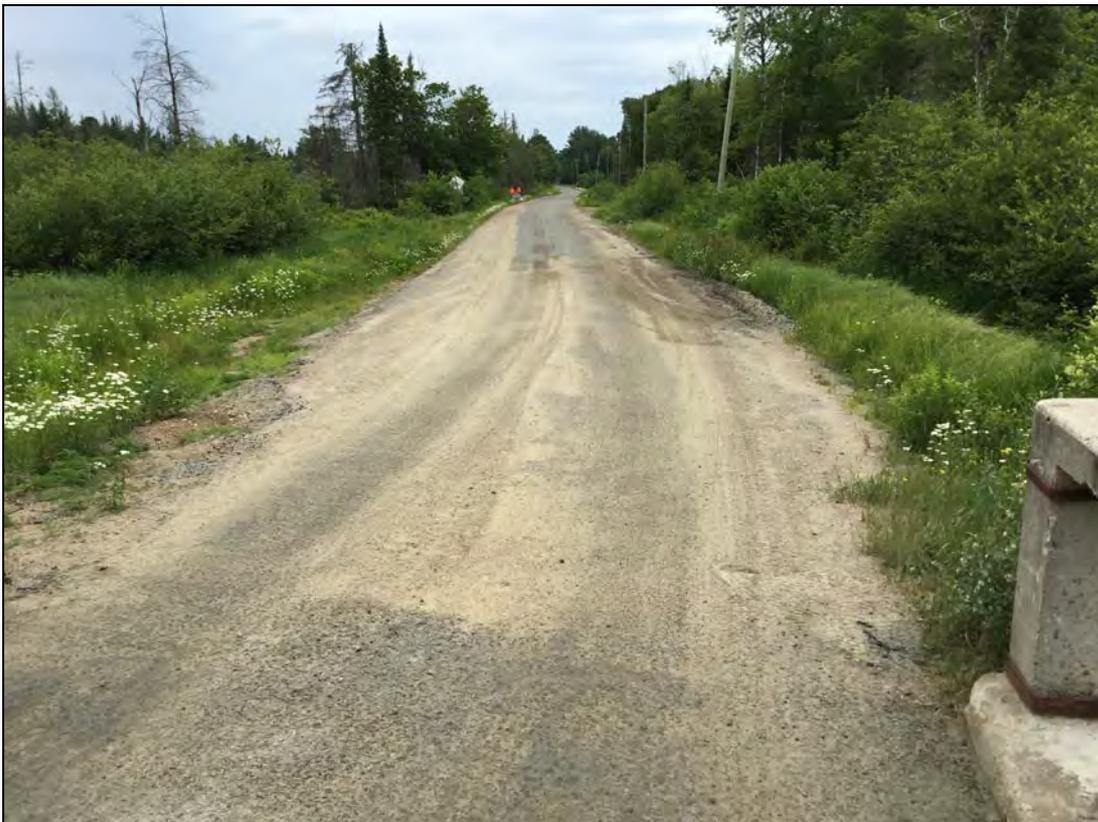
**Description: E wearing surface**

- Replace abutments
- Concrete repair and install scour protection at wingwalls
- Repave east approach
- Concrete repair at girders
- Concrete patch, waterproof and pave deck to
- Concrete patch repair at soffit (thin slab)

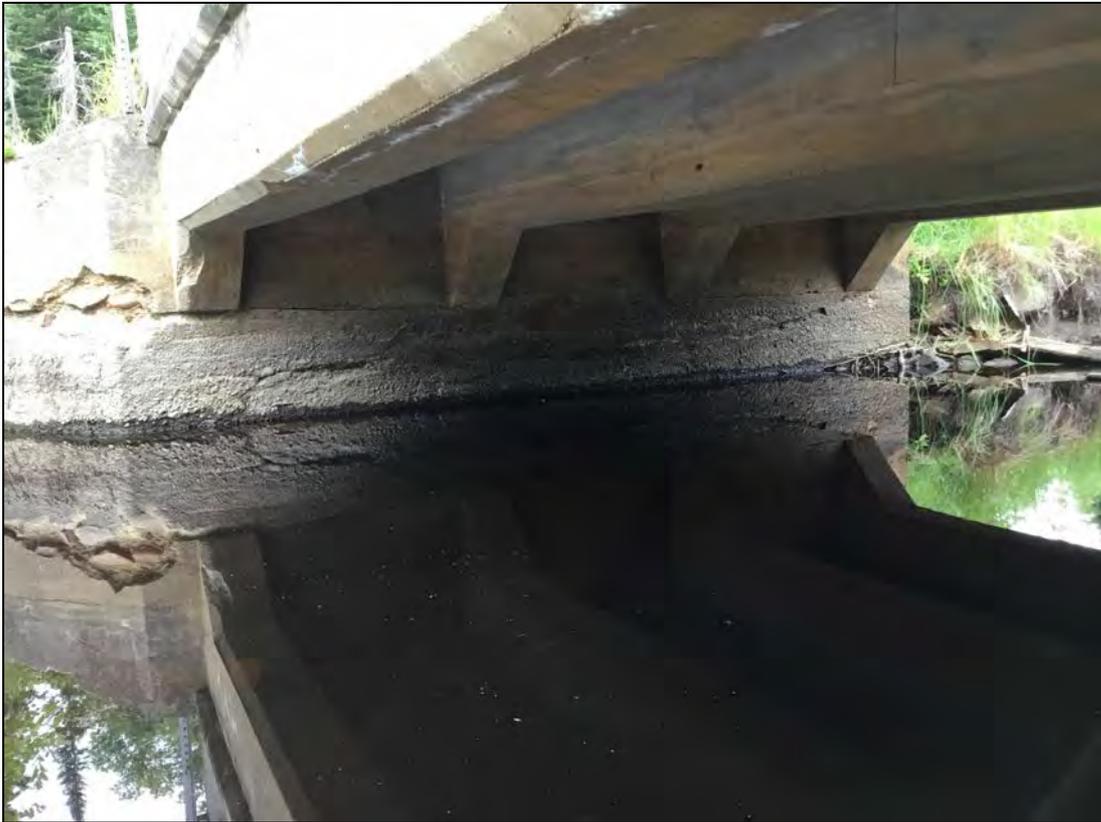
**Description: West**  
**Abutments / Abutment walls (East and West)**

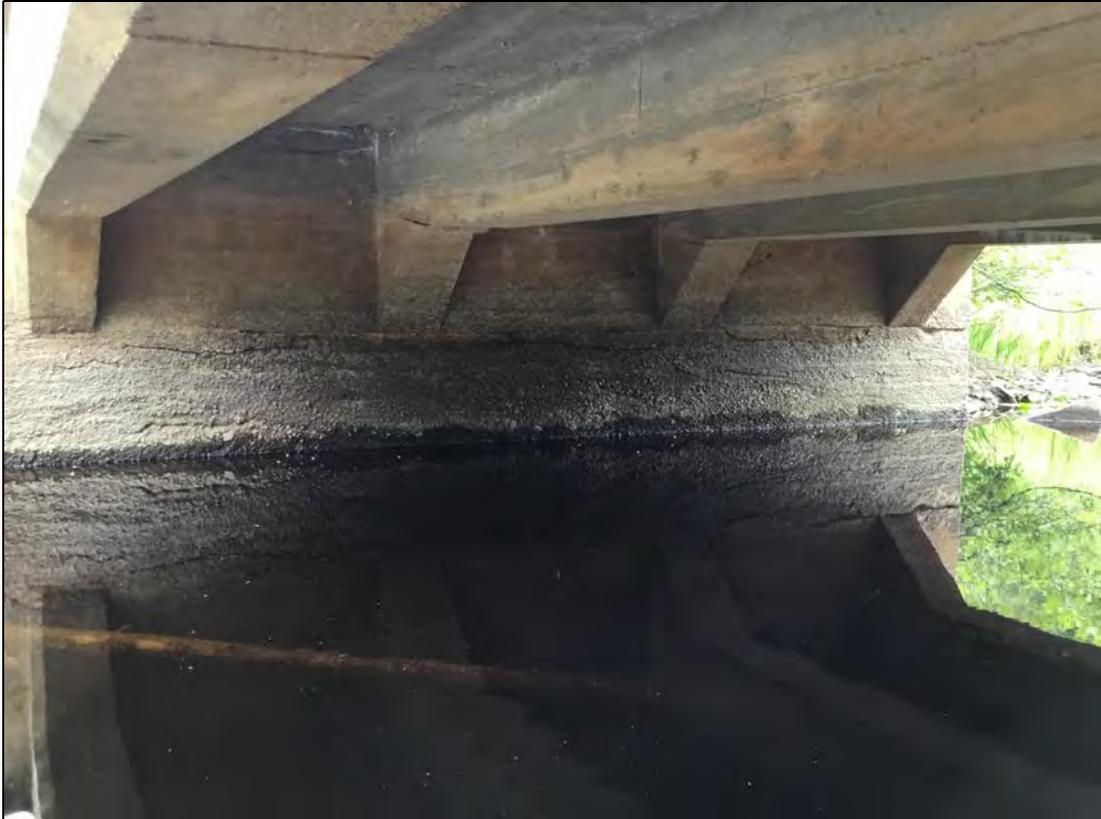
**Description: East**  
**Abutments / Abutment walls (East and West)**

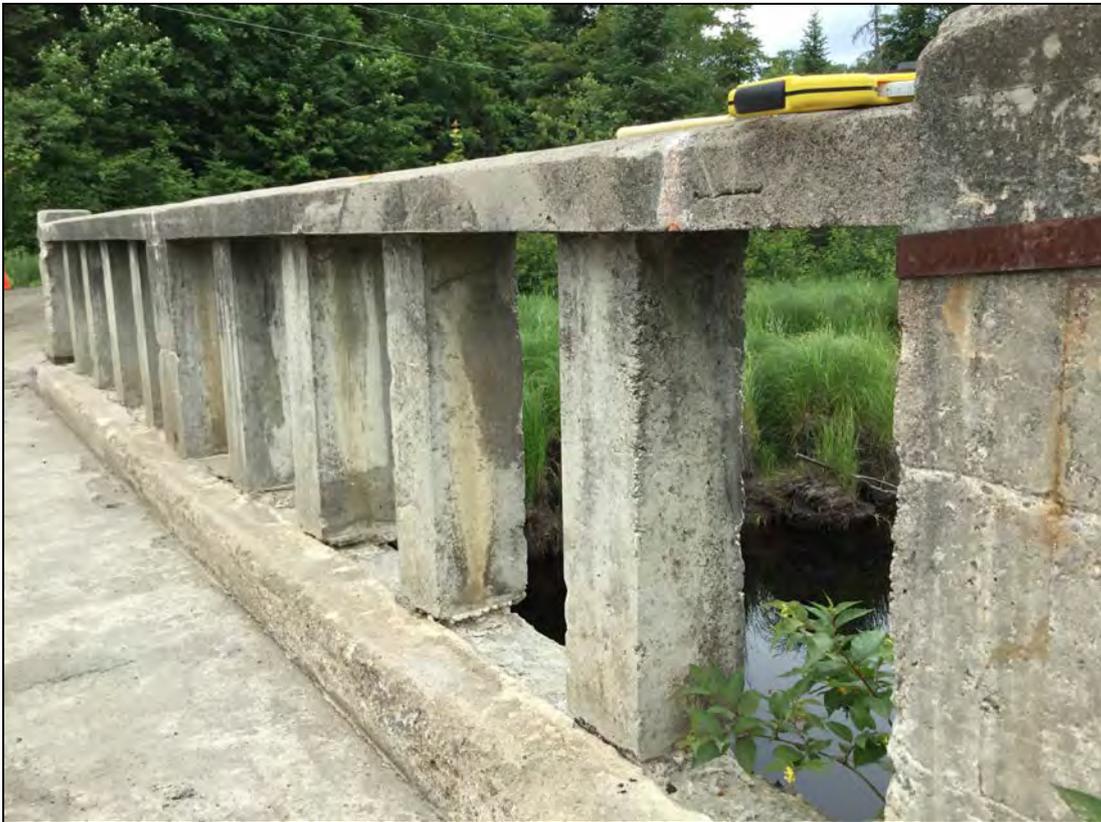
**Description: N Typical**  
**Barriers / Posts (North and South)**

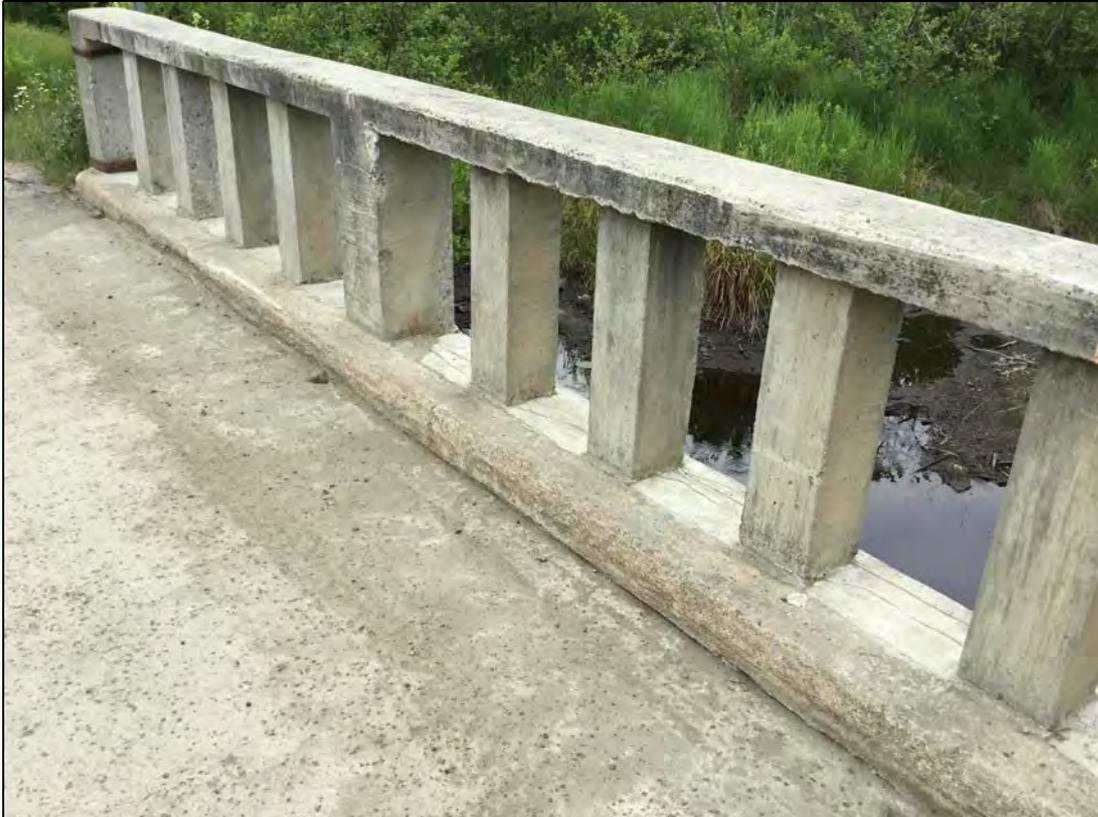
**Description: S curb**  
**Sidewalks/curbs / Curbs (North and South)**

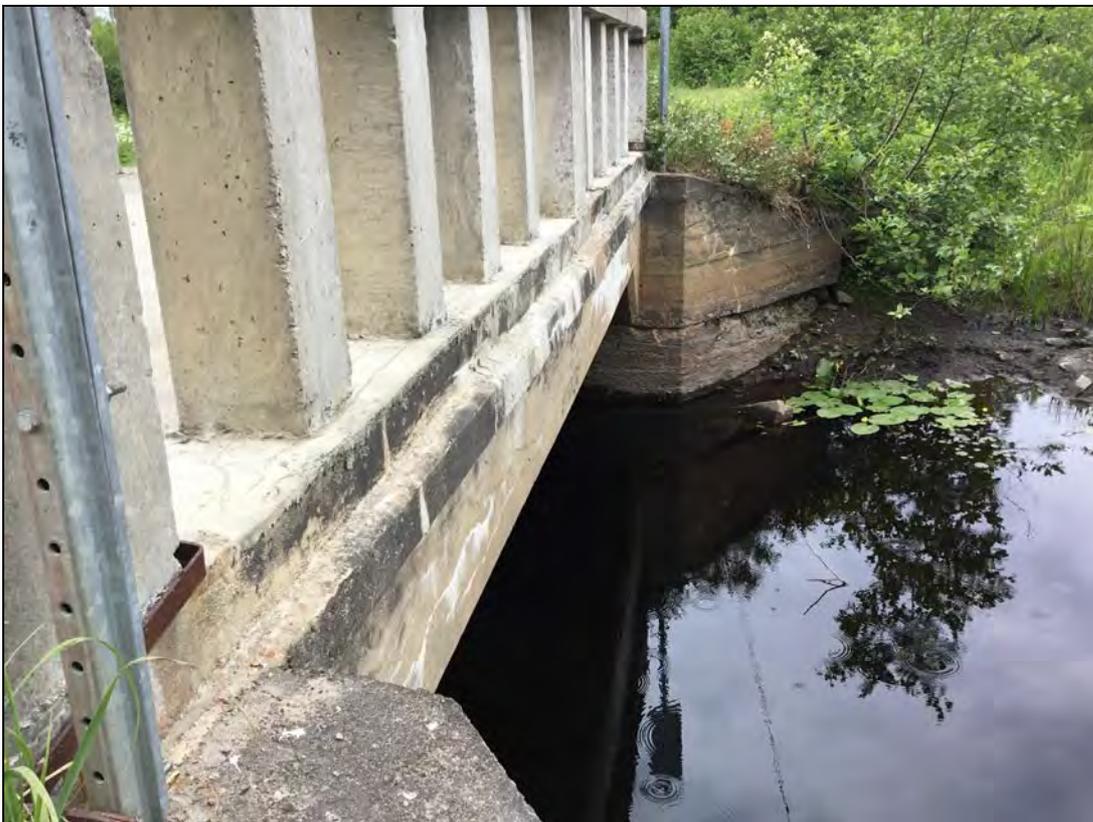
**Description: S exterior**  
**Sidewalks/curbs / Curbs (North and South)**

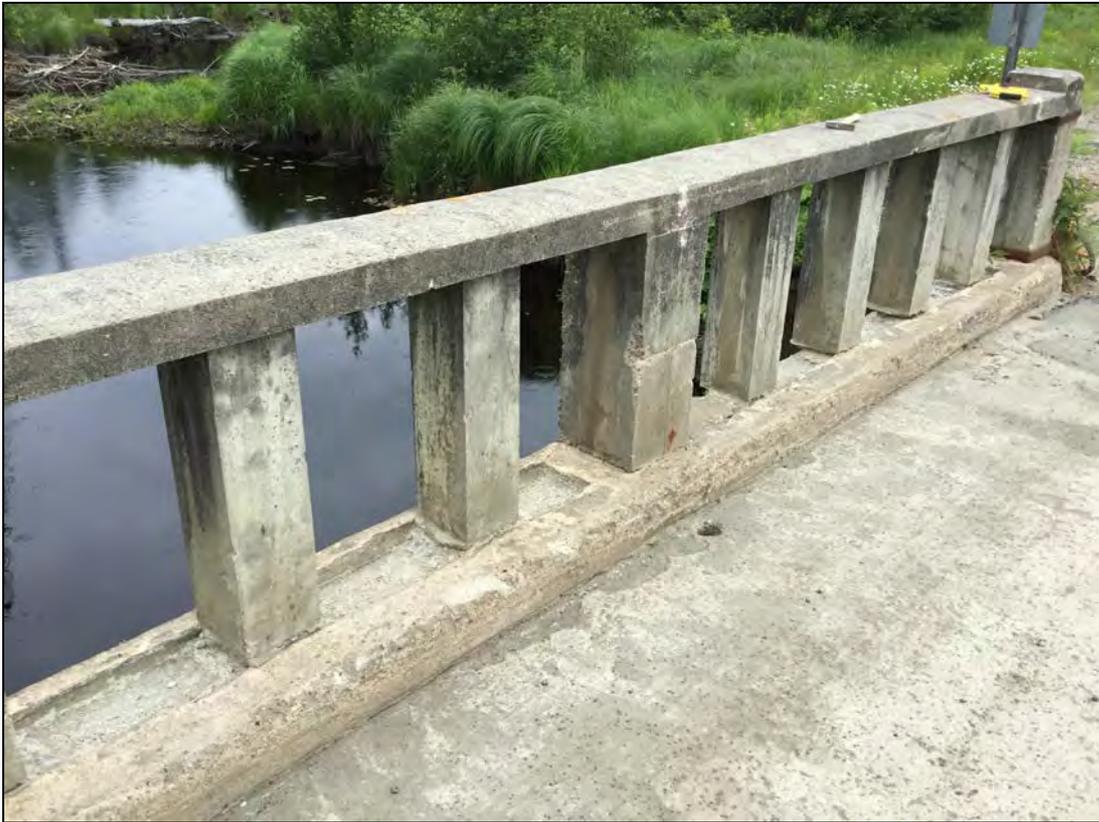
**Description: N curb**  
**Sidewalks/curbs / Curbs (North and South)**

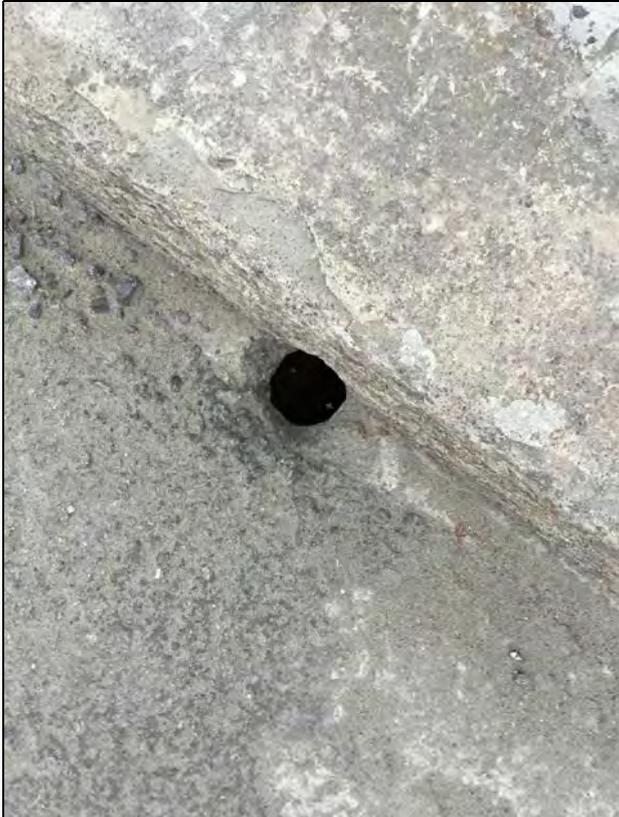
**Description: Typical Deck Drainage**  
**Decks / Drainage System**

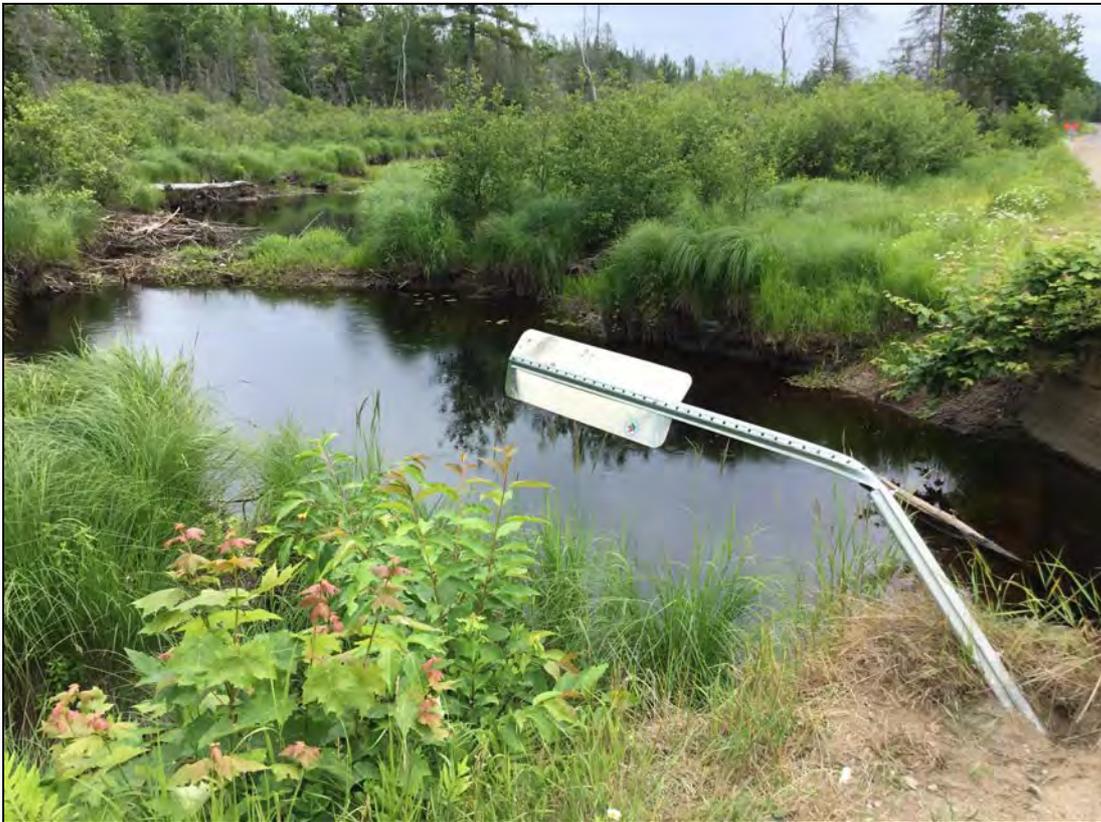
**Description: N embankments**  
**Embankments & Streams / Embankments**

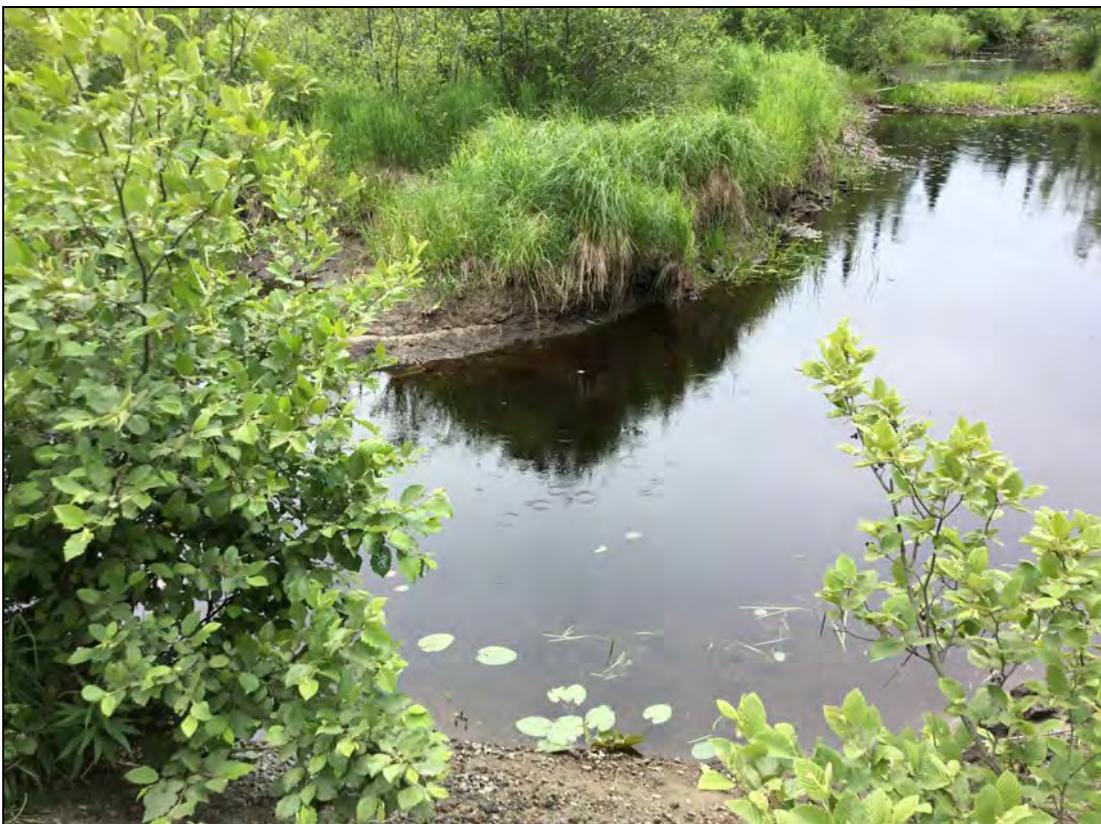
**Description: WE embankment**  
**Embankments & Streams / Embankments**

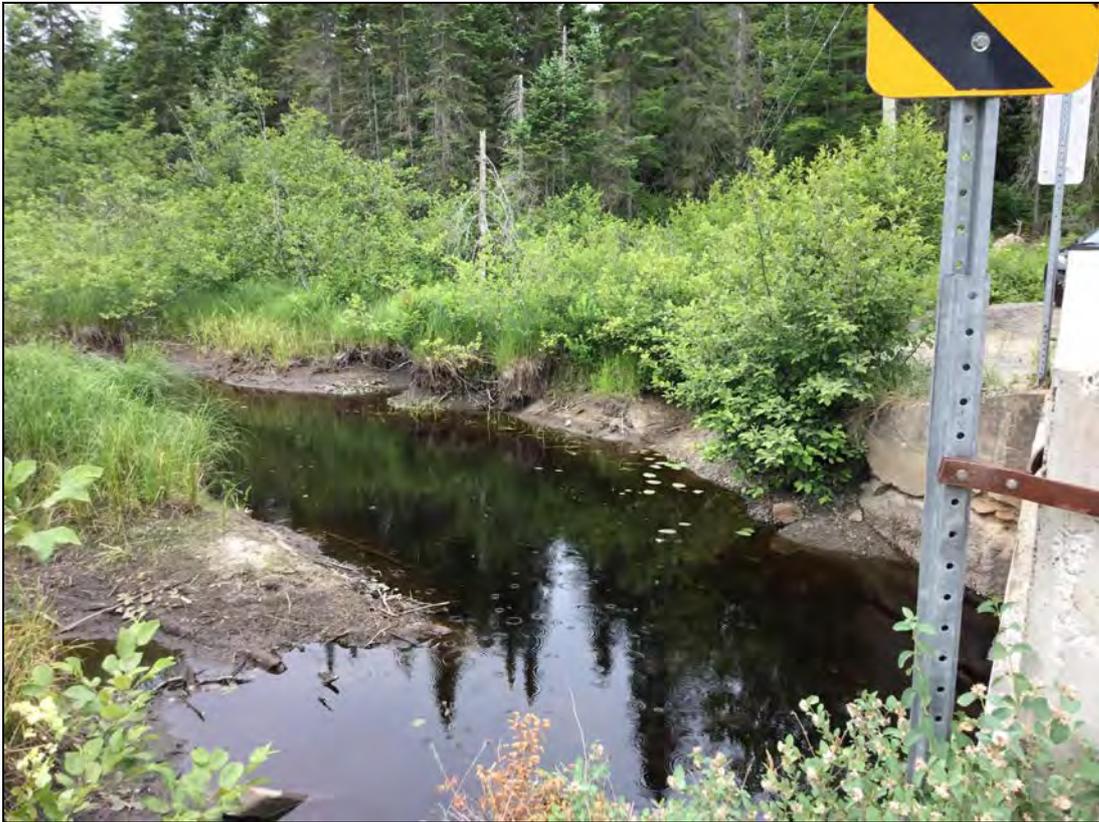
**Description: SE embankment**

**Embankments & Streams / Embankments**

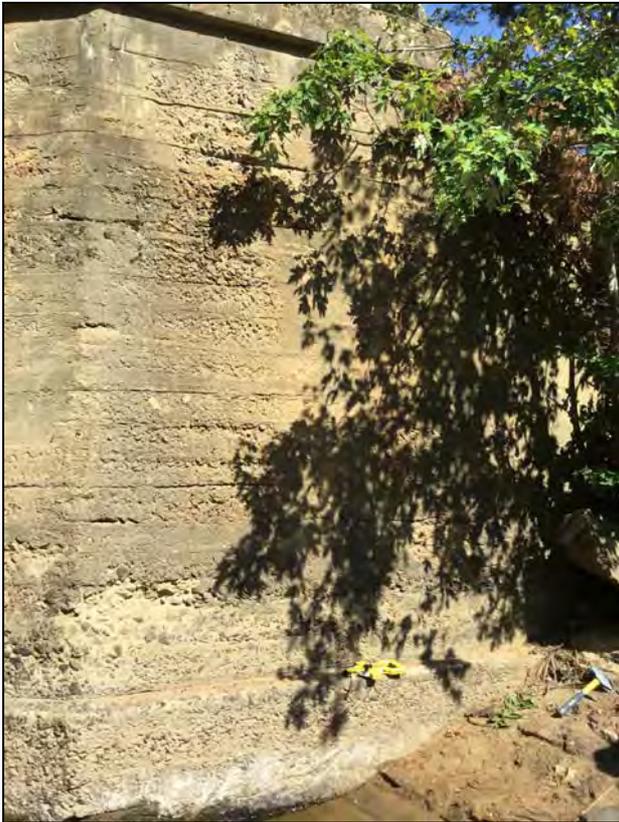
<b>Element Group:</b>	Abutments					<b>Length:</b>	3.2 (m)	
<b>Element Name:</b>	Wingwalls					<b>Width:</b>		
<b>Location:</b>	Northeast and Southeast					<b>Height:</b>	6.2 (m)	
<b>Element Description:</b>	Northeast Wingwall with Cracks and Efflorescence.					<b>Count:</b>	2	
<b>Material:</b>	Cast In Place Concrete					<b>Total Quantity:</b>	39.7 (sq.m)	
<b>Element Type:</b>						<b>Not Inspected:</b>	<input type="checkbox"/>	
<b>Environment:</b>	<input type="checkbox"/> Benign, <input checked="" type="checkbox"/> Moderate, <input type="checkbox"/> Severe					<b>Limited Inspection:</b>	<input type="checkbox"/>	
<b>Protection System:</b>						<b>Perform. Deficiencies</b>		
<b>Condition Data:</b>	<b>Units</b>	<b>Exc.</b>	<b>Good</b>	<b>Fair</b>	<b>Poor*</b>			
	sq.m	0.00	35.7	4.0	1.0	<b>BCI TEV:</b> 13895.0	<b>BCI CEV:</b> 9931.25	
<b>Comments:</b>	Light scaling. medium to wide cracks on north west wing walls with vegetation growth. localized spalling. Light efflorescence

**Description: South east wing wall**  
**Abutments / Wingwalls (Northeast and Southeast)**

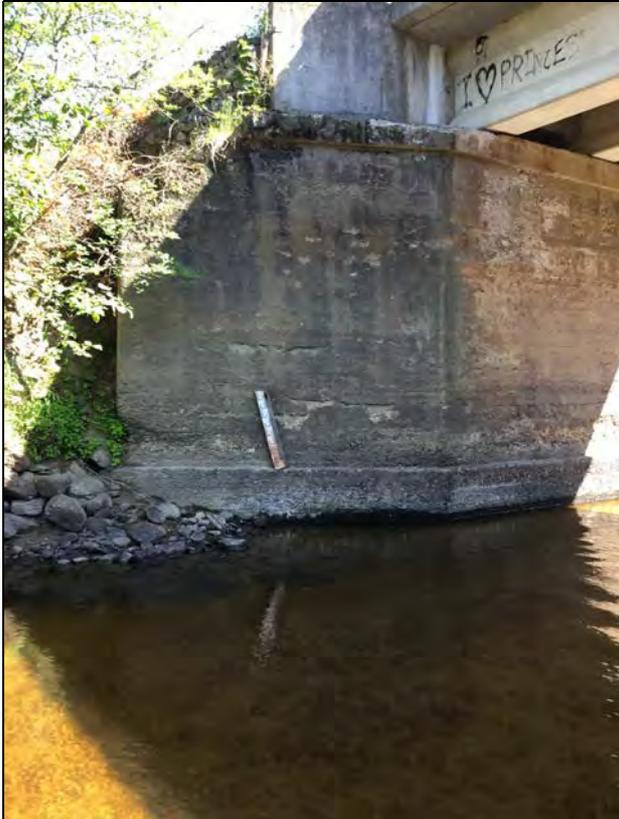
<b>Element Group:</b>	Abutments					<b>Length:</b>	3.0 (m)
<b>Element Name:</b>	Wingwalls					<b>Width:</b>	
<b>Location:</b>	Northwest and Southwest					<b>Height:</b>	5.0 (m)
<b>Element Description:</b>	Crack in Cold Joint At Southwest Wingwall.					<b>Count:</b>	2
<b>Material:</b>	Cast In Place Concrete					<b>Total Quantity:</b>	30.0 (sq.m)
<b>Element Type:</b>						<b>Not Inspected:</b>	<input type="checkbox"/>
<b>Environment:</b>	<input type="checkbox"/> Benign, <input checked="" type="checkbox"/> Moderate, <input type="checkbox"/> Severe					<b>Limited Inspection:</b>	<input type="checkbox"/>
<b>Protection System:</b>						<b>Perform. Deficiencies</b>	
<b>Condition Data:</b>	<b>Units</b>	<b>Exc.</b>	<b>Good</b>	<b>Fair</b>	<b>Poor*</b>		
	sq.m	0.00	23.8	6.0	0.2	<b>BCI TEV:</b> 10500.0	<b>BCI CEV:</b> 7087.5
<b>Comments:</b>	Localized spalling and light to medium scaling.						
<b>Recommended work:</b>						<b>Maintenance Needs:</b>

**Description: Southwest wingwall**  
**Abutments / Wingwalls (Northwest and Southwest)**

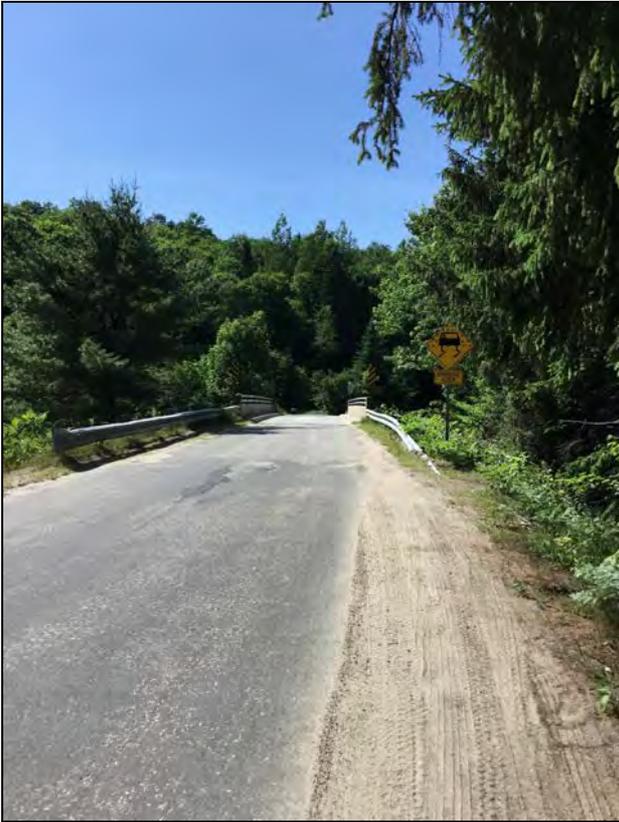
**Accessories / Signs (Both sides extending 30m back for one lane sign.)**

<b>Element Group:</b>	Accessories					<b>Length:</b>		
<b>Element Name:</b>	Signs					<b>Width:</b>		
<b>Location:</b>	Both sides extending 30m back for one lane sign.					<b>Height:</b>		
<b>Element Description:</b>	Bridge ices (2), one lane (2), and hazard (4).					<b>Count:</b>	8	
<b>Material:</b>						<b>Total Quantity:</b>	8.0 (each)	
<b>Element Type:</b>						<b>Not Inspected:</b>	<input type="checkbox"/>	
<b>Environment:</b>	<input type="checkbox"/> Benign, <input type="checkbox"/> Moderate, <input type="checkbox"/> Severe					<b>Limited Inspection:</b>	<input type="checkbox"/>	
<b>Protection System:</b>						<b>Perform. Deficiencies</b>		
<b>Condition Data:</b>	<b>Units</b>	<b>Exc.</b>	<b>Good</b>	<b>Fair</b>	<b>Poor*</b>			
	each	0.00	8.0	0.00	0.00	<b>BCI TEV:</b> 800.0	<b>BCI CEV:</b> 600.0	
<b>Comments:</b>	Four Hazard warning signs, One bridge Ices sign, and Two Narrow Lane signs

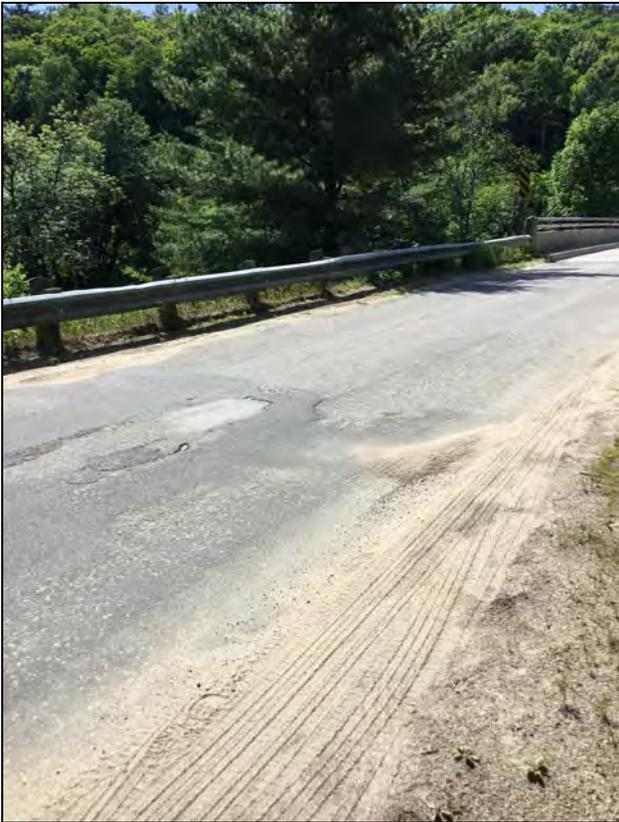
<b>Element Group:</b>	Approaches					<b>Length:</b>	6.0 (m)	
<b>Element Name:</b>	Wearing surface					<b>Width:</b>	4.3 (m)	
<b>Location:</b>	East and West					<b>Height:</b>		
<b>Element Description:</b>	Asphalt approach meeting ballast wall					<b>Count:</b>	2	
<b>Material:</b>	Asphalt					<b>Total Quantity:</b>	51.6 (sq.m)	
<b>Element Type:</b>						<b>Not Inspected:</b>	<input type="checkbox"/>	
<b>Environment:</b>	<input type="checkbox"/> Benign, <input type="checkbox"/> Moderate, <input checked="" type="checkbox"/> Severe					<b>Limited Inspection:</b>	<input type="checkbox"/>	
<b>Protection System:</b>						<b>Perform. Deficiencies</b>		
<b>Condition Data:</b>	<b>Units</b>	<b>Exc.</b>	<b>Good</b>	<b>Fair</b>	<b>Poor*</b>			
	sq.m	0.00	50.0	0.8	0.8	<b>BCI TEV:</b> 309.6	<b>BCI CEV:</b> 226.92	
<b>Comments:</b>	Light potholes throughout. Light patches with depressions, edge cracking, scaling on NE side. Cold patched potholes at South side beginning to stake no at bridge street interface. edging repair at south west side of road.

**Description: S**  
**Approaches / Wearing surface (East and West)**

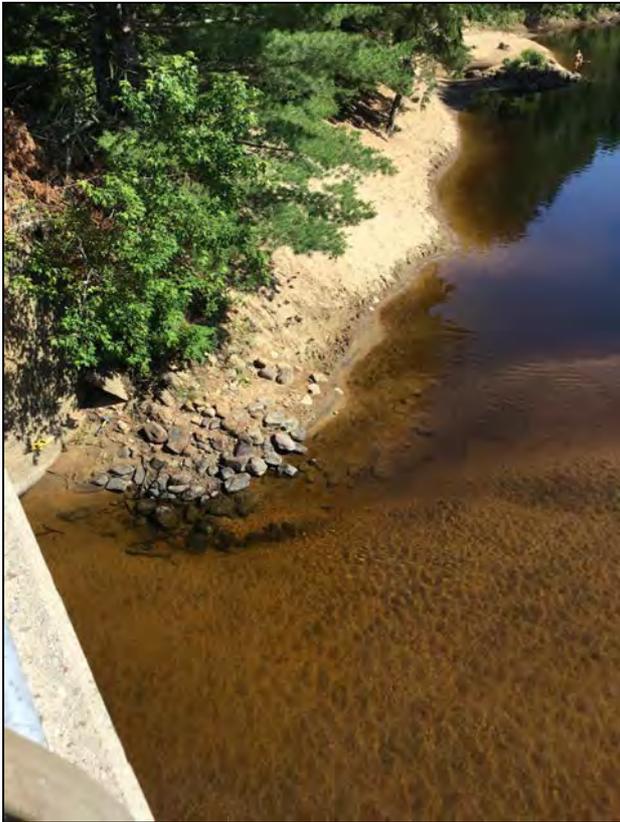
**Description: Sandy sw shoreline**  
**Embankments & Streams / Embankments**

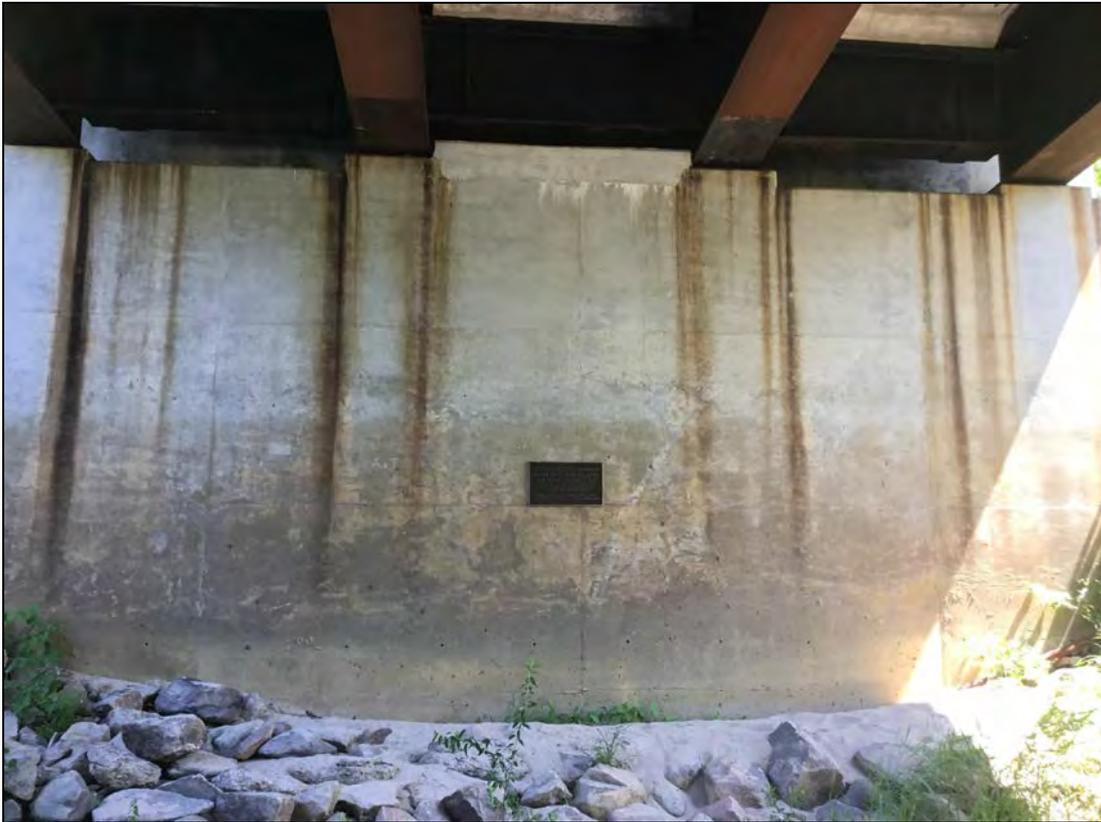
**Abutments / Abutment walls (North and South)**

**Description: East abutment wall**

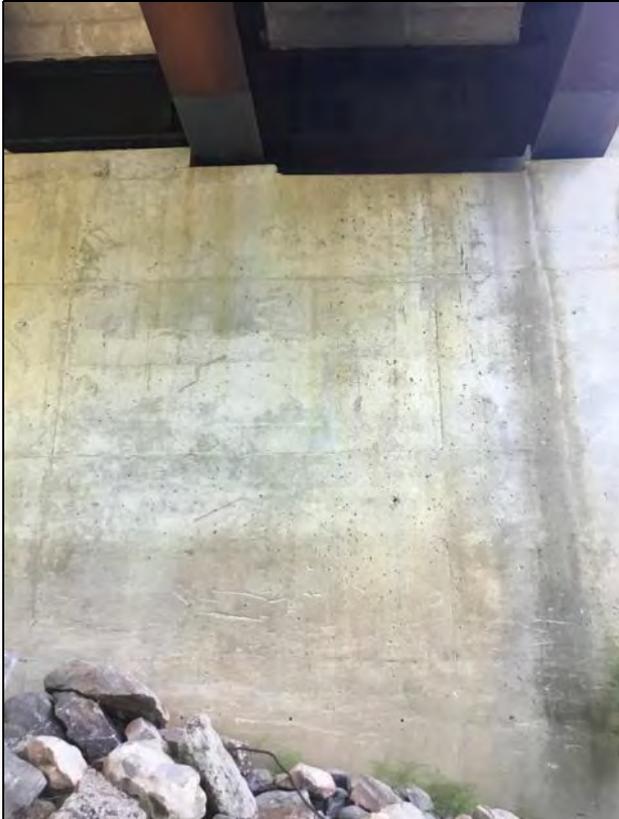
**Abutments / Abutment walls (North and South)**

**Description: West abutment wall**

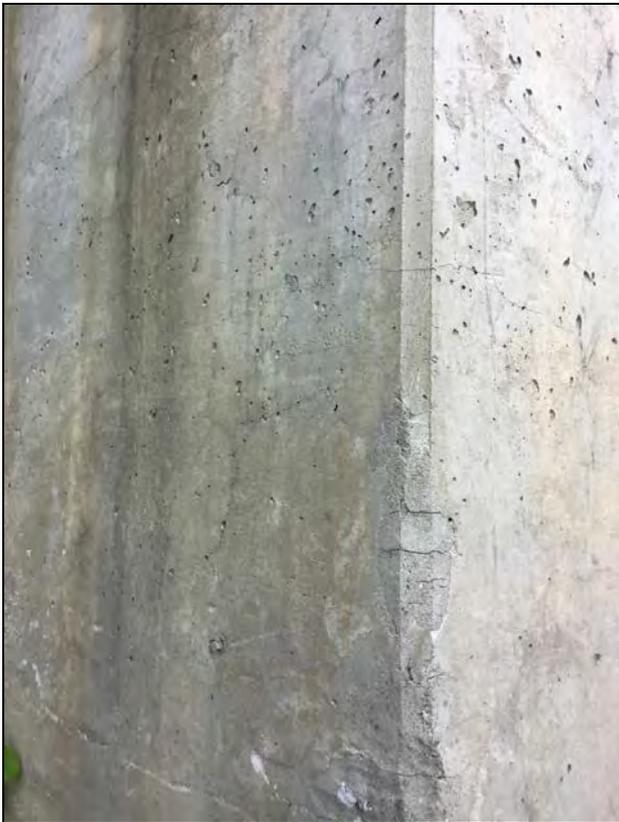
**Description: West abutment**  
**Abutments / Abutment walls (North and South)**
