## TOWN OF HUNTSVILLE BRIDGE INSPECTIONS

Inspection Report

Project # 17-4022-07

November 2018

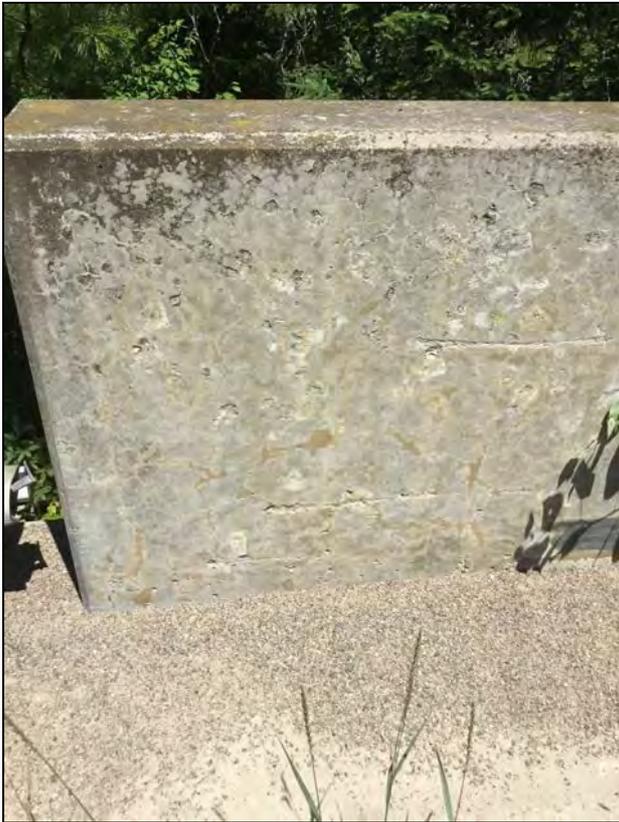
**Description: Ne post**  
**Barriers / Barrier/Parapet Walls (East and West)**

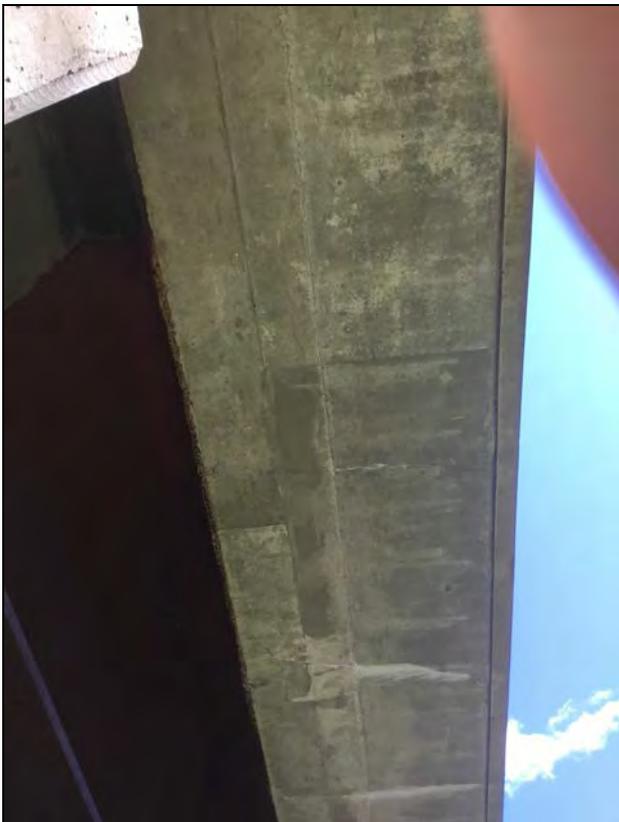
**Description: Southwest quadrant  
Decks / Soffit - Thin Slab (Interior)**

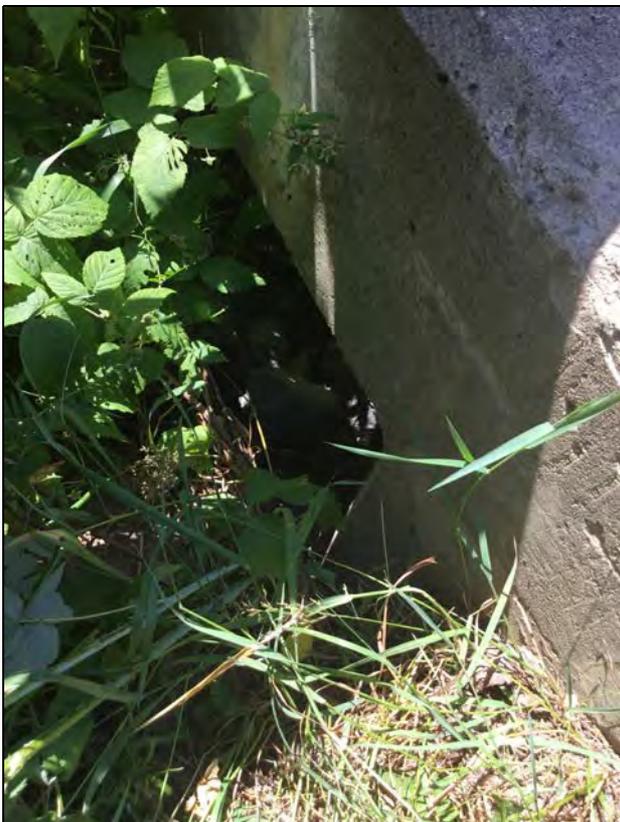
**Embankments & Streams / Embankments (Four quadrants)**

**Description: Eroded embankment at spillway southeast quadrant**

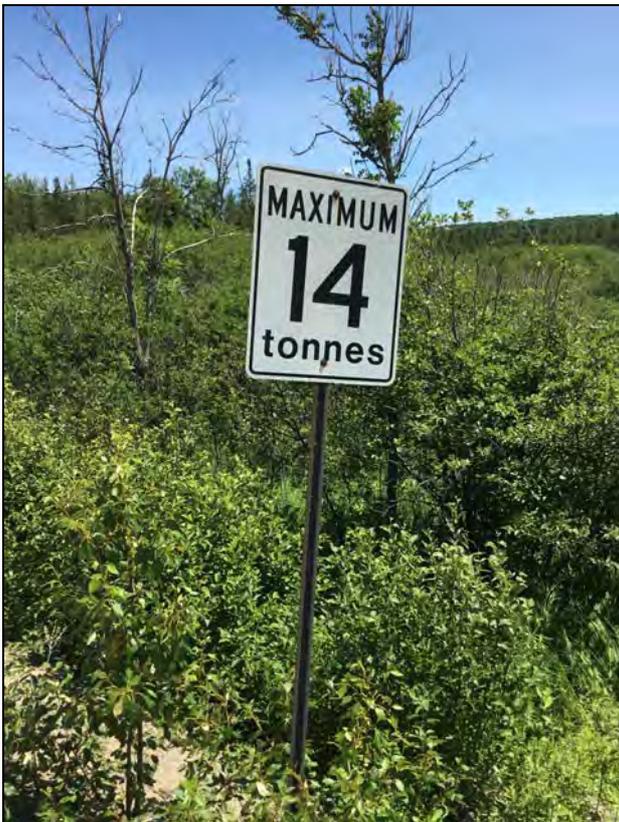
**Accessories / Signs**

**Description: West approach max load sign**

<b>Recommended work:</b>					<b>Maintenance Needs:</b>		
<b>Comments</b>  Replace max load sign					<input type="checkbox"/> 1 year, <input type="checkbox"/> 2 years, <input type="checkbox"/> Urgent		
<b>Type</b>		<b>Timing</b>					
<input type="checkbox"/> Rehab, <input type="checkbox"/> Repair, <input checked="" type="checkbox"/> Replace		<input type="checkbox"/> 1 - 5 years, <input type="checkbox"/> Now < 1 year, <input type="checkbox"/> 6 - 10 years, <input checked="" type="checkbox"/> Urgent

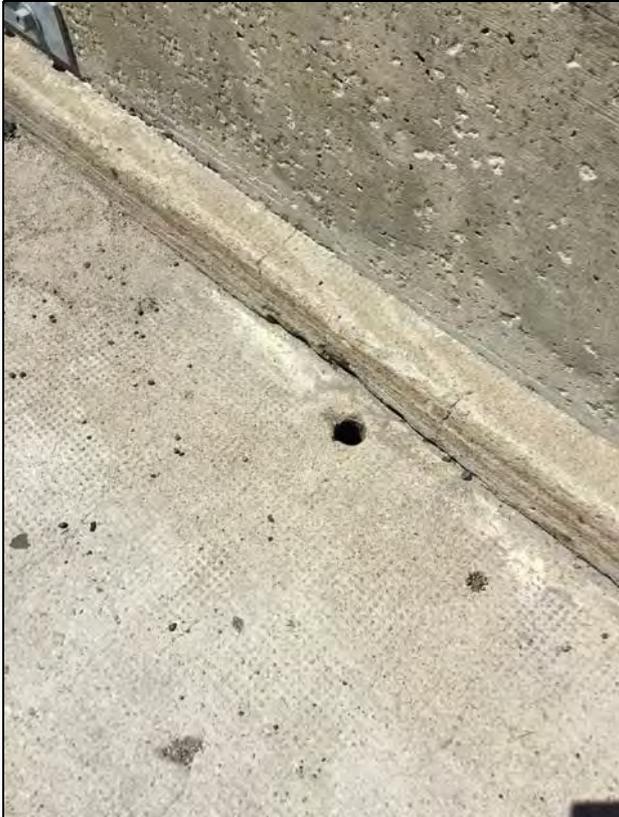
**Decks / Drainage System**

<b>Element Group:</b>	Decks	<b>Length:</b>			
<b>Element Name:</b>	Drainage System	<b>Width:</b>			
<b>Location:</b>		<b>Height:</b>			
<b>Element Description:</b>	Holes in deck uncovered	<b>Count:</b>	4		
<b>Material:</b>	Cast In Place Concrete	<b>Total Quantity:</b>	4.0 (each)		
<b>Element Type:</b>	Holes in Deck	<b>Not Inspected:</b>	<input type="checkbox"/>		
<b>Environment:</b>	<input type="checkbox"/> Benign, <input type="checkbox"/> Moderate, <input checked="" type="checkbox"/> Severe	<b>Limited Inspection:</b>	<input type="checkbox"/>		
<b>Protection System:</b>		<b>Perform. Deficiencies</b>			
<b>Condition Data:</b>	<b>Units</b>	<b>Exc.</b>	<b>Good</b>	<b>Fair</b>	<b>Poor*</b>
	each	0.00	0.00	0.00	4.0
<b>BCI TEV:</b>			<b>BCI CEV:</b>		
<b>Comments:</b>	All are clear and fully functioning.				
<b>Recommended work:</b>			<b>Maintenance Needs:</b>		
<b>Comments</b> Install drains and extend beyond soffit and girders.			<input type="checkbox"/> 1 year, <input type="checkbox"/> 2 years, <input type="checkbox"/> Urgent

<b>Type</b>	<b>Timing</b>				
<input type="checkbox"/> Rehab, <input type="checkbox"/> Repair, <input checked="" type="checkbox"/> Replace	<input type="checkbox"/> 1 - 5 years, <input type="checkbox"/> Now < 1 year, <input type="checkbox"/> 6 - 10 years, <input checked="" type="checkbox"/> Urgent

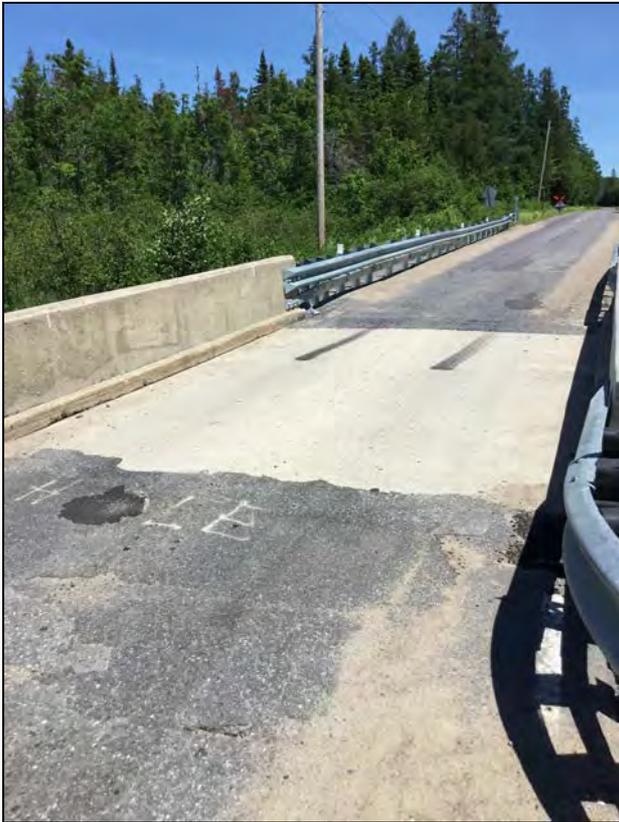
**Decks / Deck Top**

<b>Element Group:</b>	Decks	<b>Length:</b>	7.0 (m)		
<b>Element Name:</b>	Deck Top	<b>Width:</b>	4.9 (m)		
<b>Location:</b>		<b>Height:</b>			
<b>Element Description:</b>	Desk top, concrete	<b>Count:</b>	1		
<b>Material:</b>	Cast-In-Place Concrete	<b>Total Quantity:</b>	34.3 (sq.m)		
<b>Element Type:</b>		<b>Not Inspected:</b>	<input type="checkbox"/>		
<b>Environment:</b>	<input type="checkbox"/> Benign, <input type="checkbox"/> Moderate, <input checked="" type="checkbox"/> Severe	<b>Limited Inspection:</b>	<input type="checkbox"/>		
<b>Protection System:</b>		<b>Perform. Deficiencies</b>			
<b>Condition Data:</b>	<b>Units</b>	<b>Exc.</b>	<b>Good</b>	<b>Fair</b>	<b>Poor*</b>
	sq.m	0.00	0.00	34.0	0.3
<b>BCI TEV:</b>	4116.0		<b>BCI CEV:</b>		1632.0
<b>Comments:</b>	Exposed concrete deck top. One severe and one medium transverse crack. Small web products through predominately on the west side.				
<b>Recommended work:</b>			<b>Maintenance Needs:</b>

<b>Comments</b> Concrete crack repair.			<input type="checkbox"/> 1 year, <input type="checkbox"/> 2 years, <input type="checkbox"/> Urgent		
<b>Type</b>	<b>Timing</b>				
<input checked="" type="checkbox"/> Rehab, <input type="checkbox"/> Repair, <input type="checkbox"/> Replace	<input checked="" type="checkbox"/> 1 - 5 years, <input type="checkbox"/> Now < 1 year, <input type="checkbox"/> 6 - 10 years, <input type="checkbox"/> Urgent

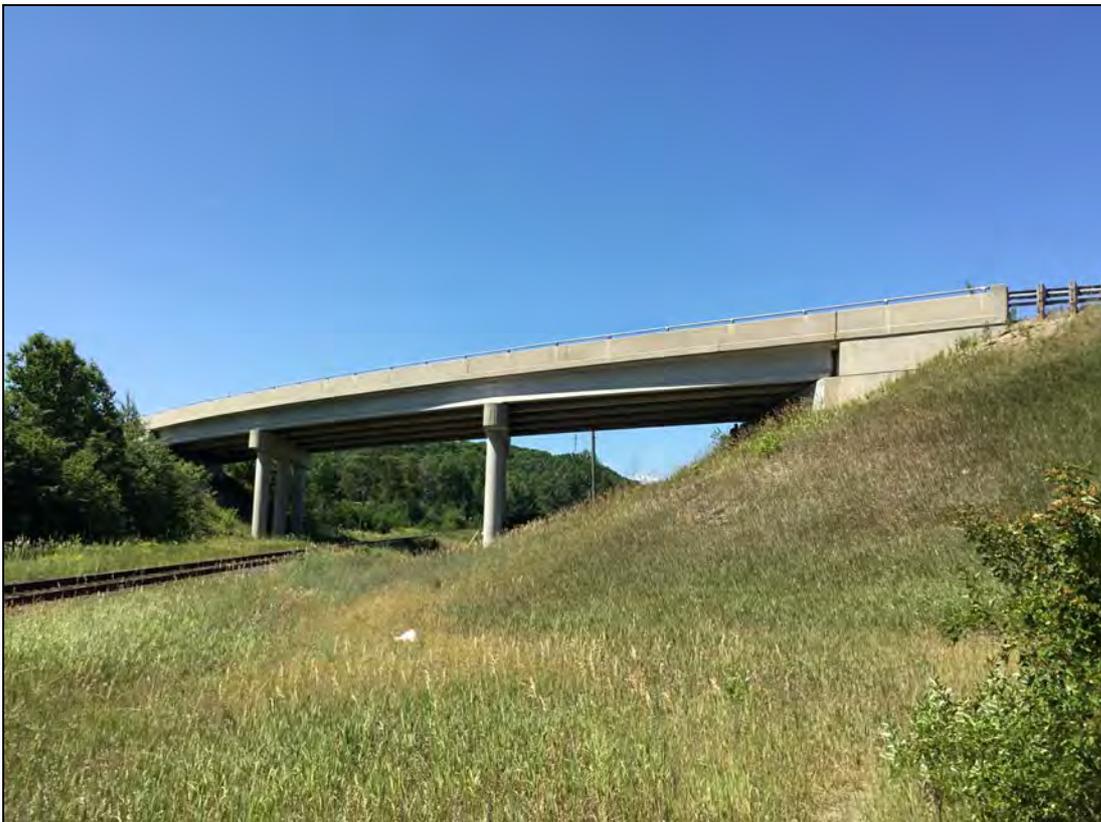
**Description: East elevation**

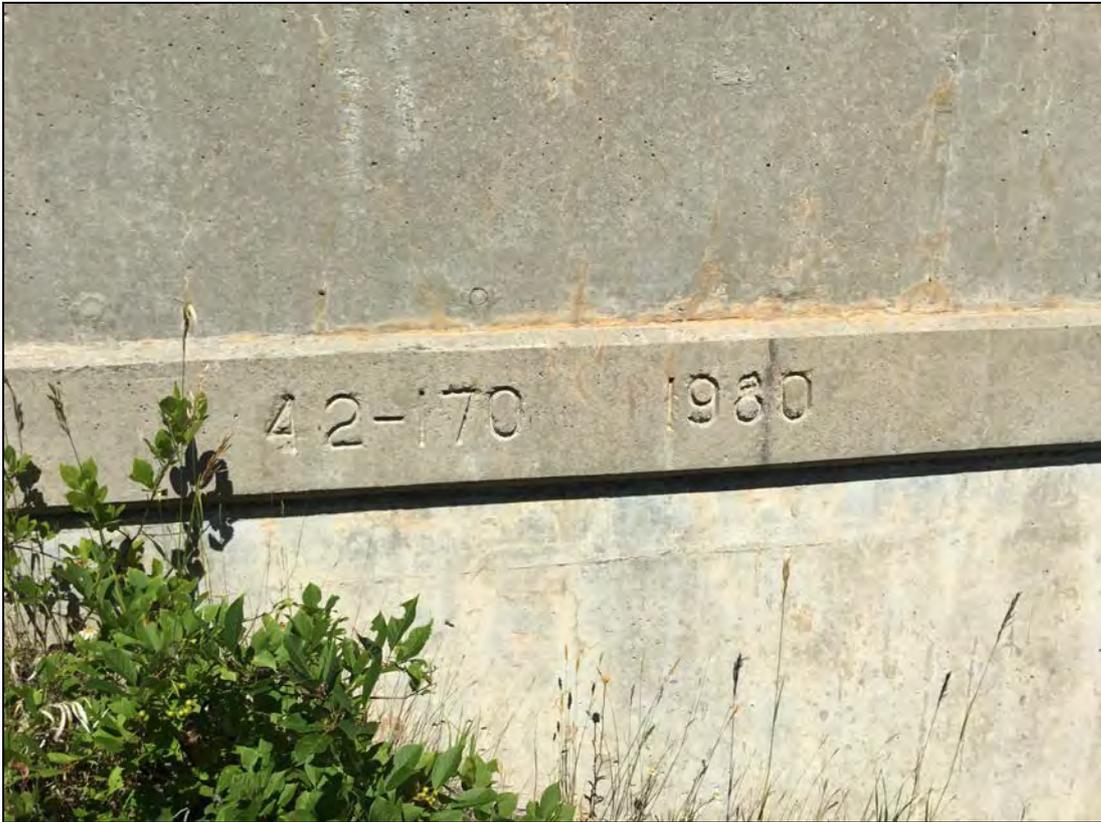
**Description: ID**

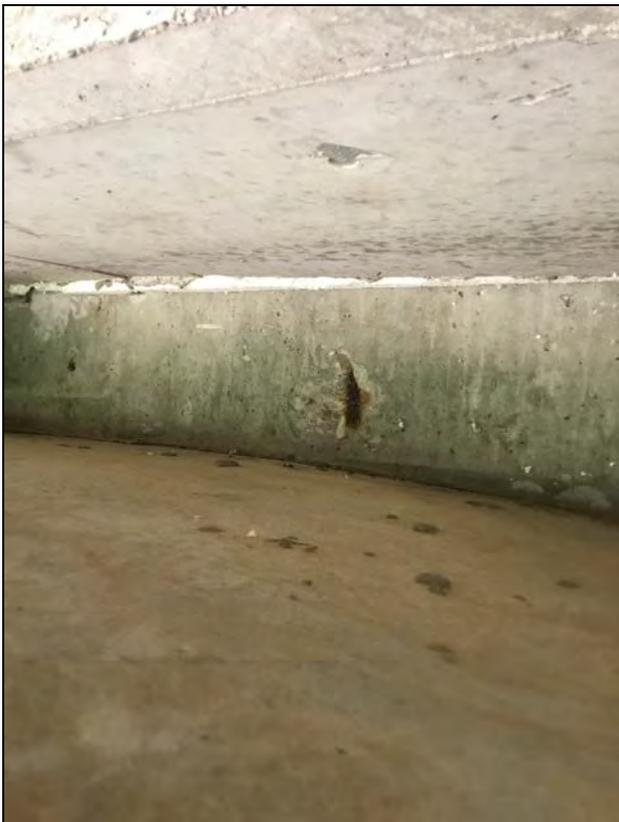
**Description: South wall exposed rebar**  
**Abutments / Ballast Walls (North and South)**

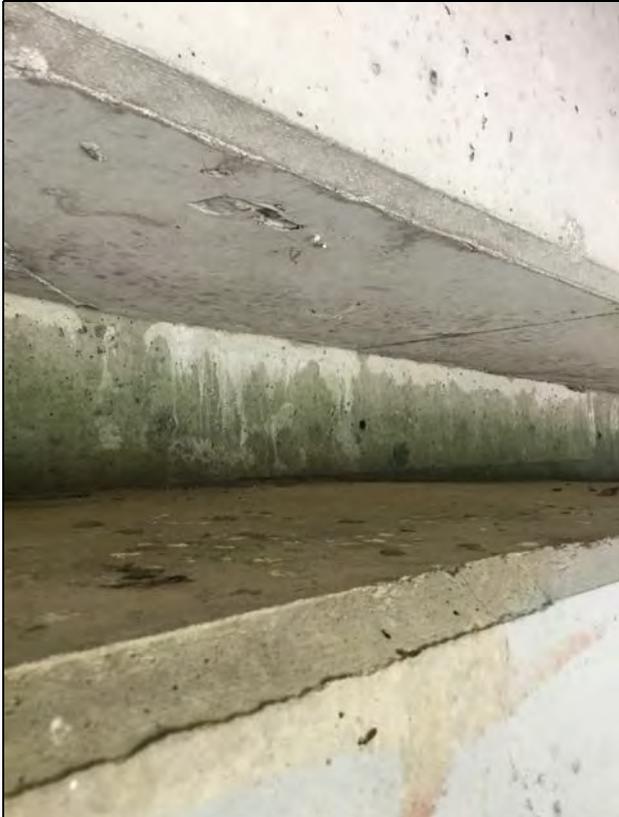
**Description: South wall typ  
Abutments / Ballast Walls (North and South)**

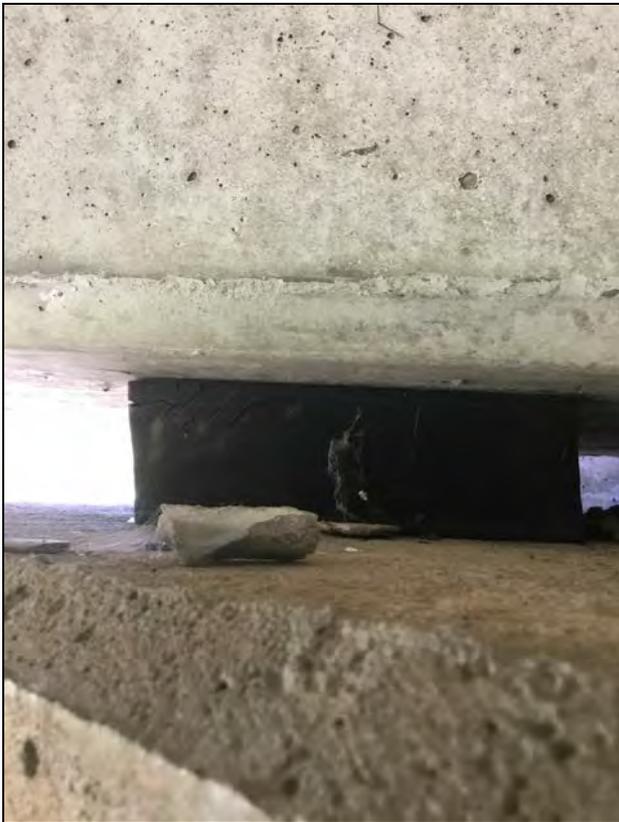
**Description: Typical Bearing**  
**Abutments / Bearings (North and South)**

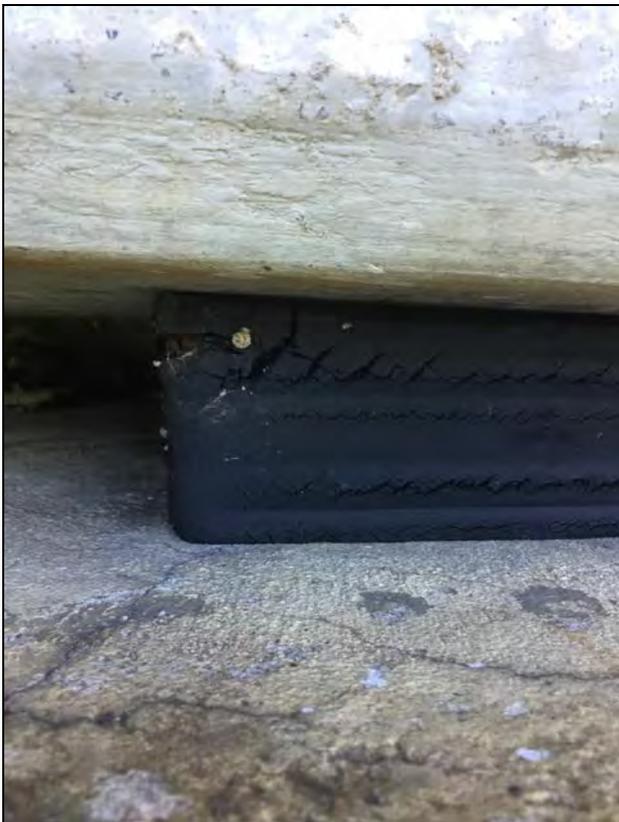
**Description: Southwest bearing**  
**Abutments / Bearings (North and South)**

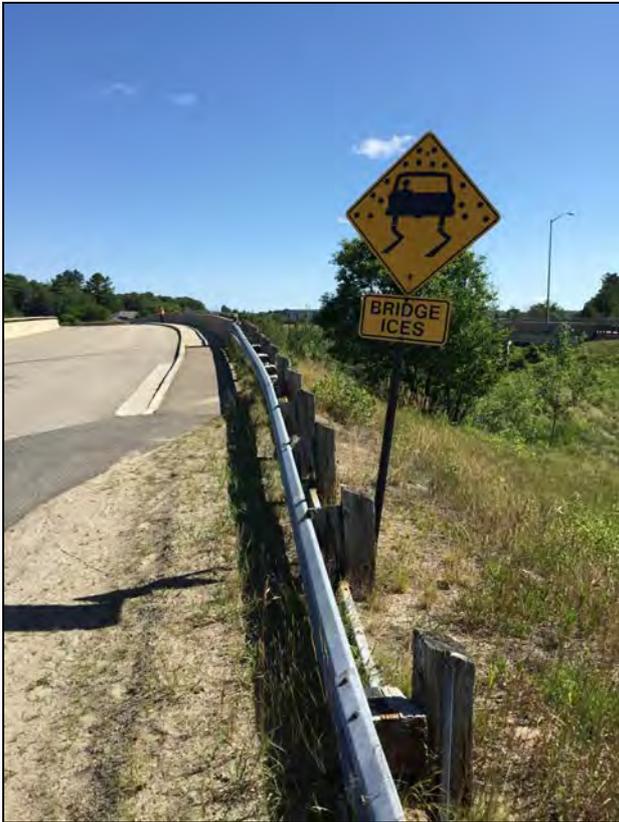
**Accessories / Signs**

**Description: South approach bridge ices leaning sign**

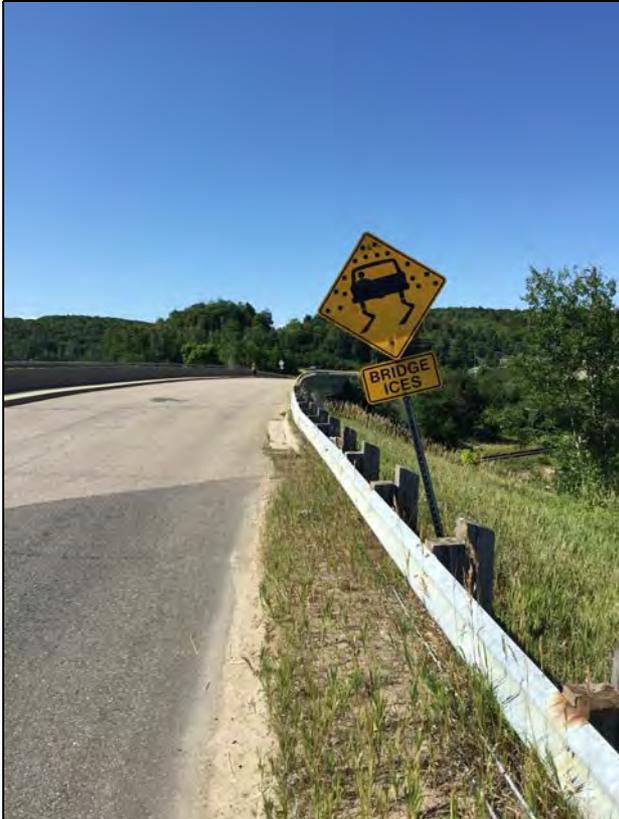
**Accessories / Signs**

**Description: North approach bridges ices sign leaning and bent at post location**

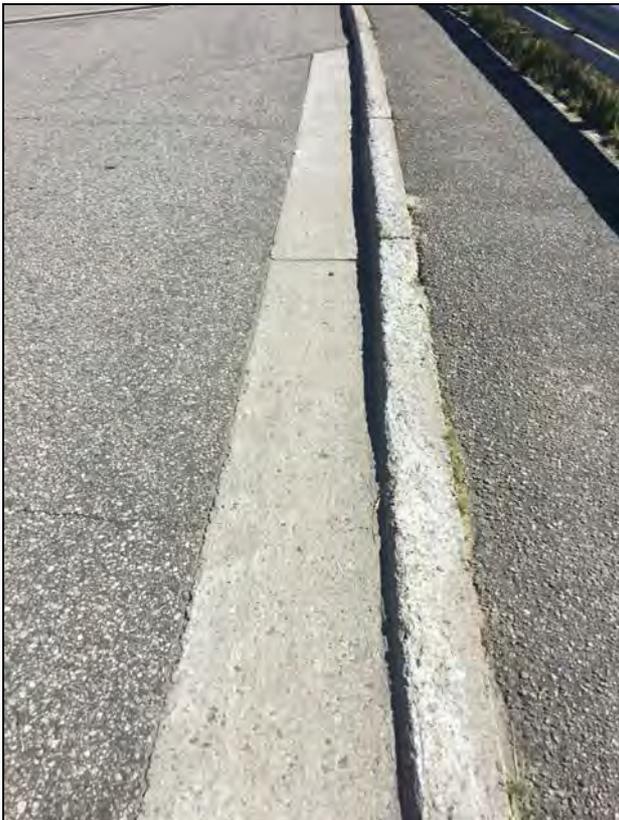
**Approaches / Curb and Gutters**

**Description: SE curb**

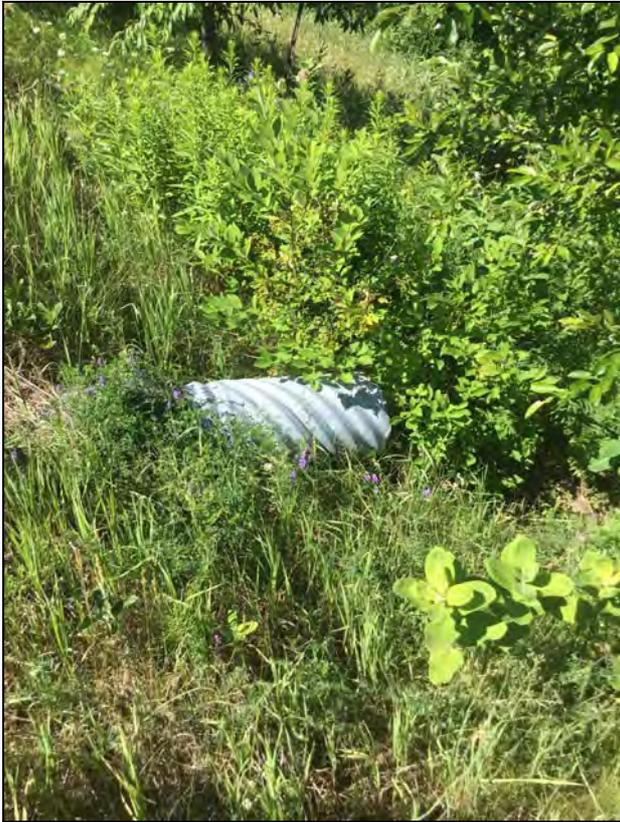
**Approaches / Drainage System (NW, SE, SW)**

**Description: Severe outfall typ**

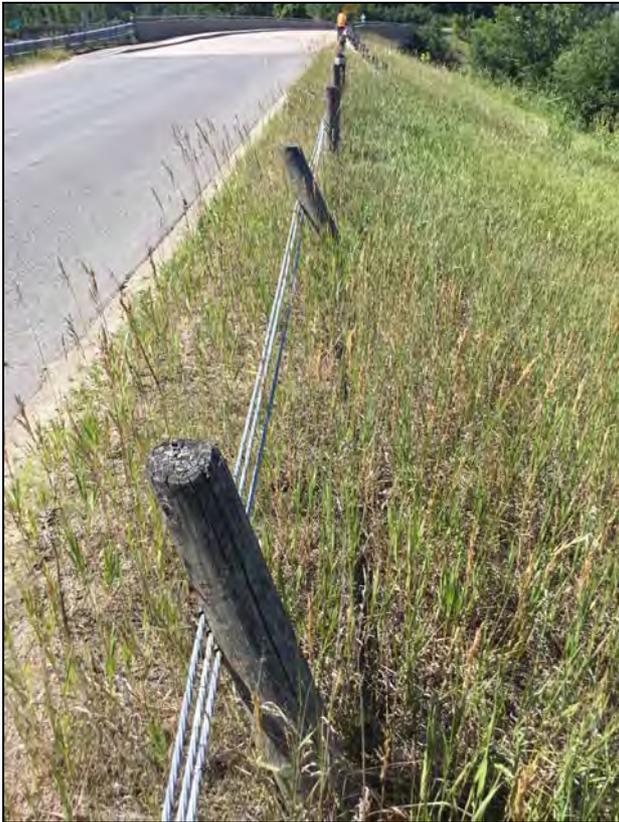
**Description: Rotten and leaning posts NW side  
Approaches / Barriers (West)**

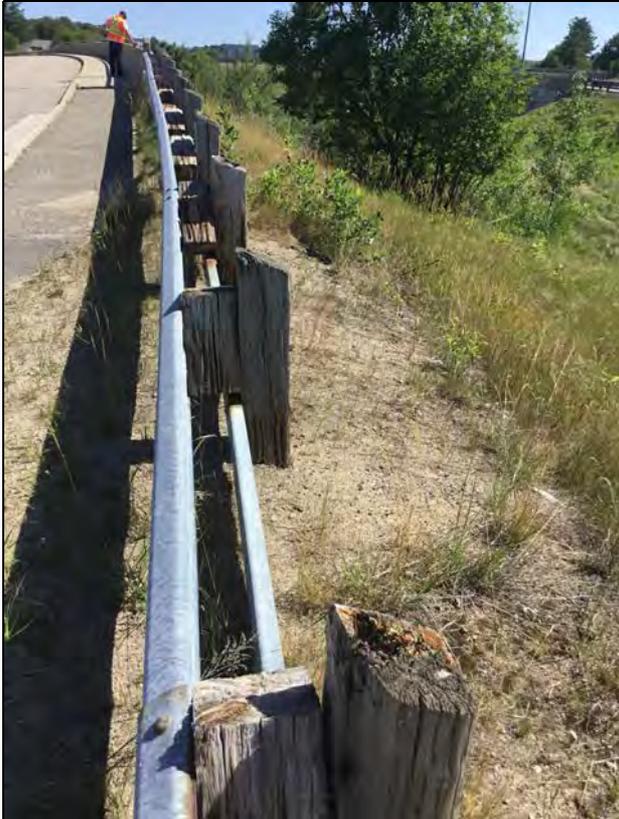
**Description: Rotated blocks and rot  
Approaches / Barriers (West)**

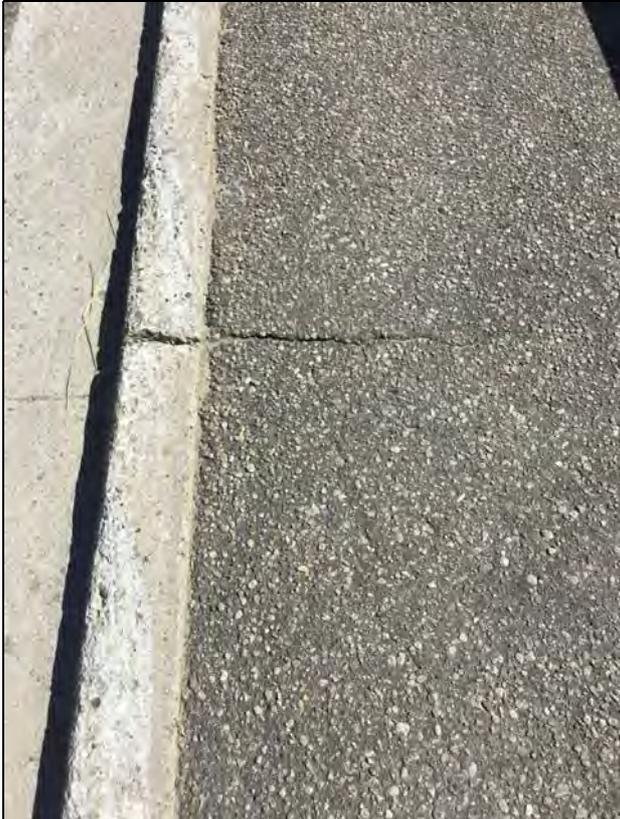
**Description: Light crack southeast side**  
**Approaches / Sidewalk/Curbs (NW & SW Approaches)**

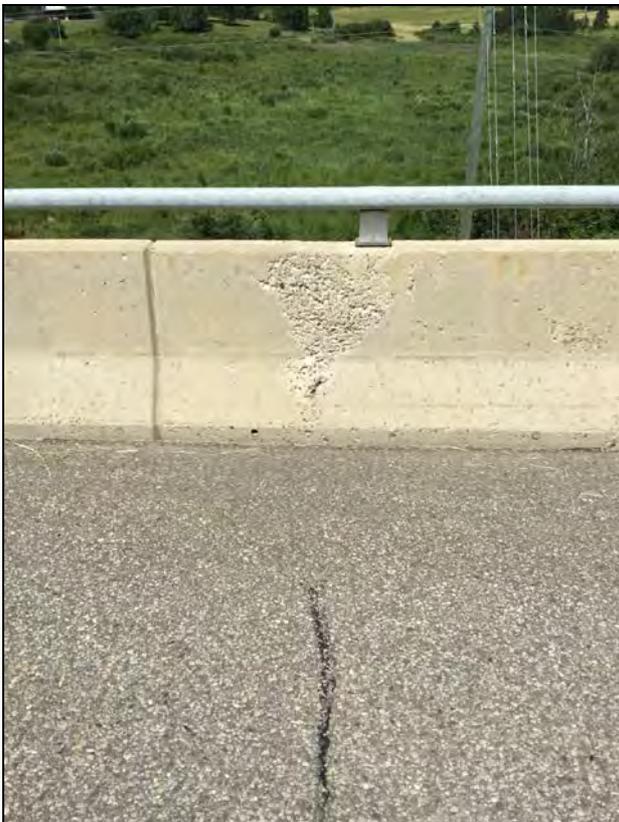
**Description: Honeycombing mid way on west parapet  
Barriers / Barrier/Parapet Walls (Interior)**

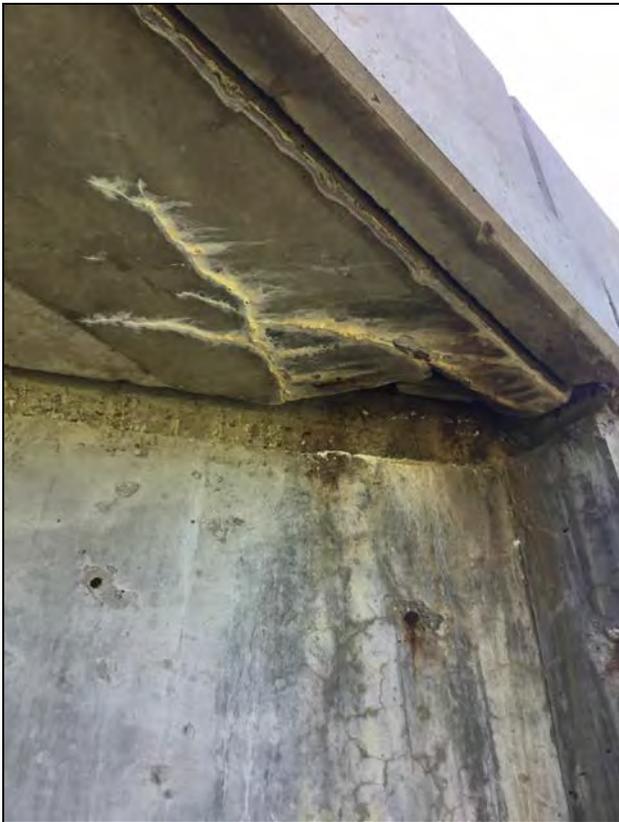
**Description: Severe side popout**  
**Decks / Soffit - Thin Slab (Ends)**

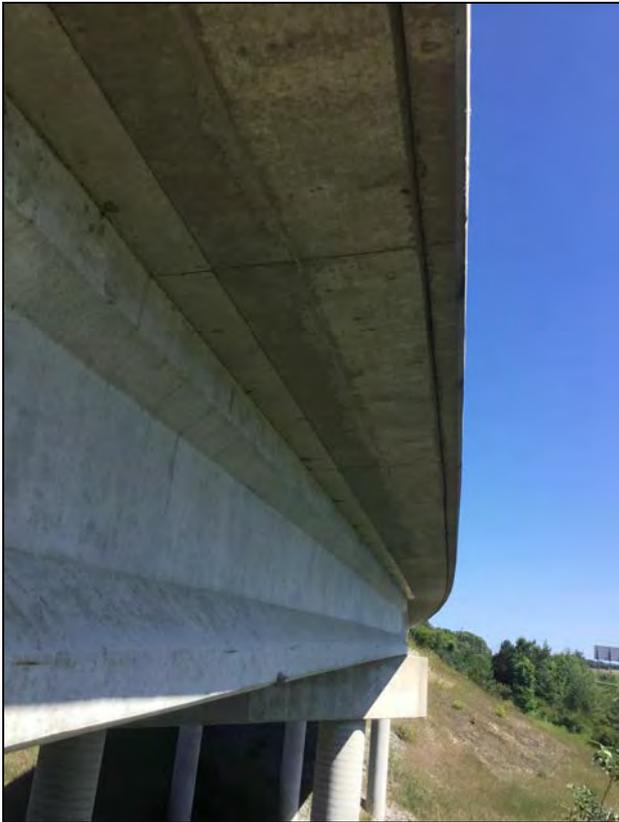
**Description: Past cracking and leaking. Minor spall SE side**  
**Decks / Soffit - Thin Slab (Ends)**

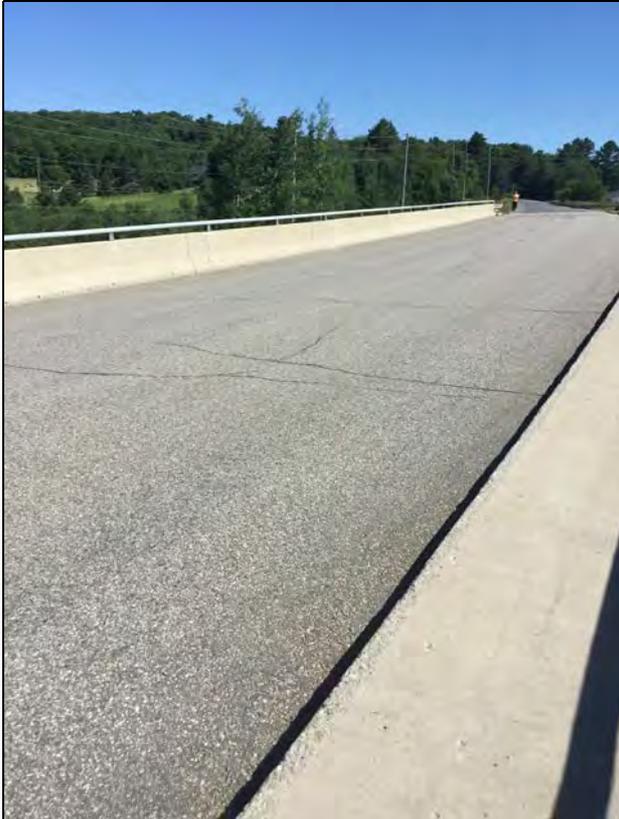
**Description: Patched pothole N end  
Decks / Wearing Surface**

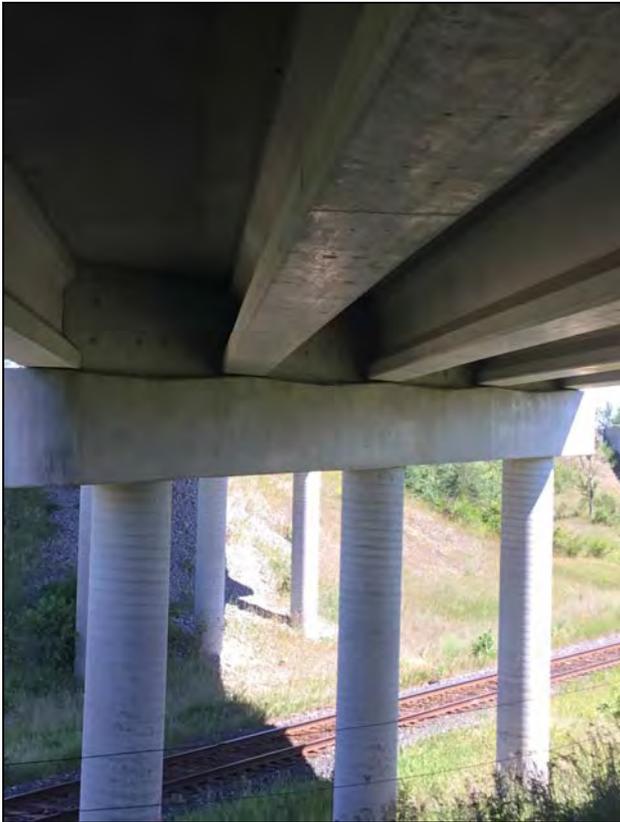
**Piers / Bearings**

**Description: S pier bearings.**

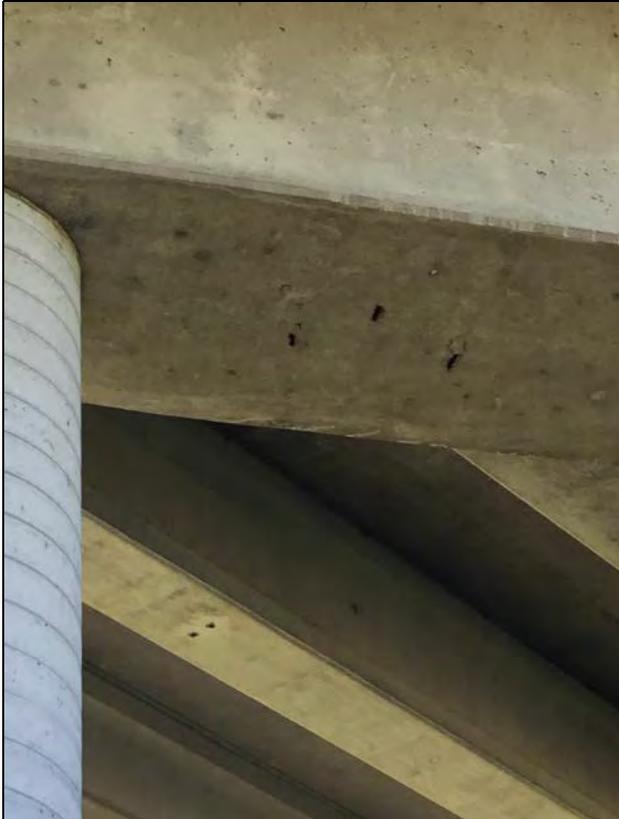
**Description: Minor spall w exposed rebar**  
**Piers / Caps (North and South Piers)**

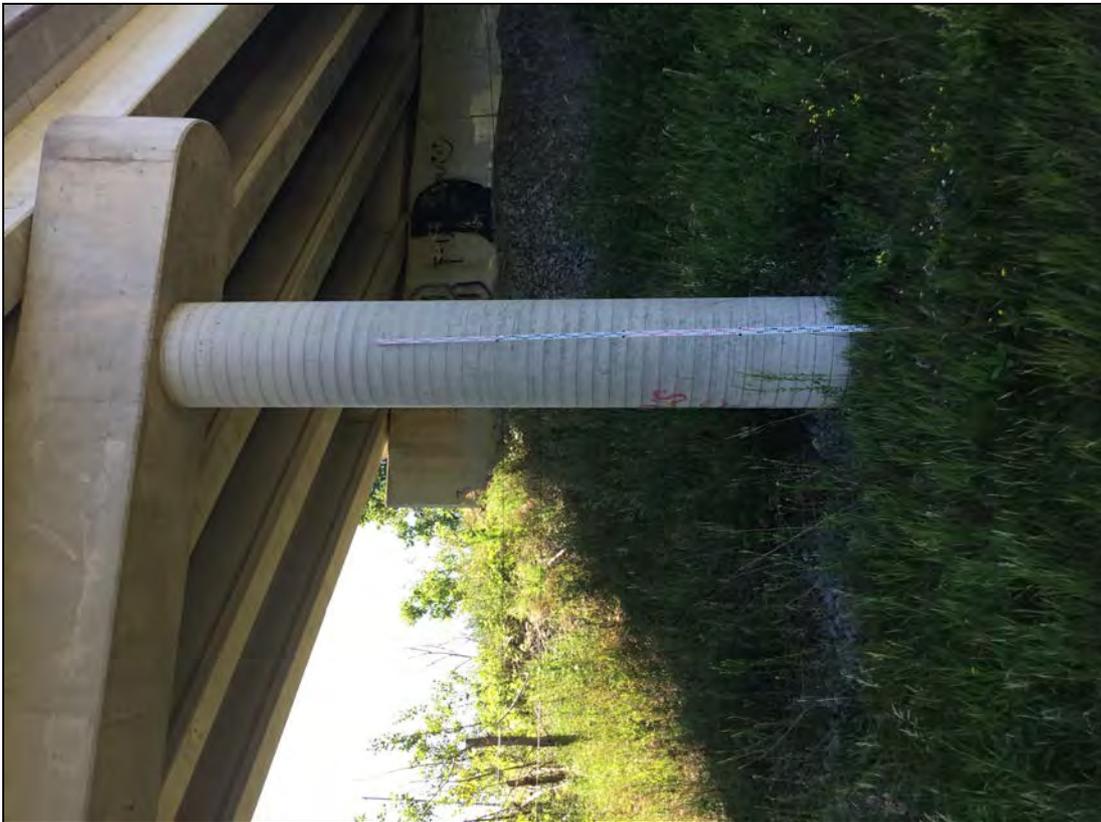
**Description: Pier typ**

**Piers / Shafts/columns/Pile Bents (North and South Piers)**

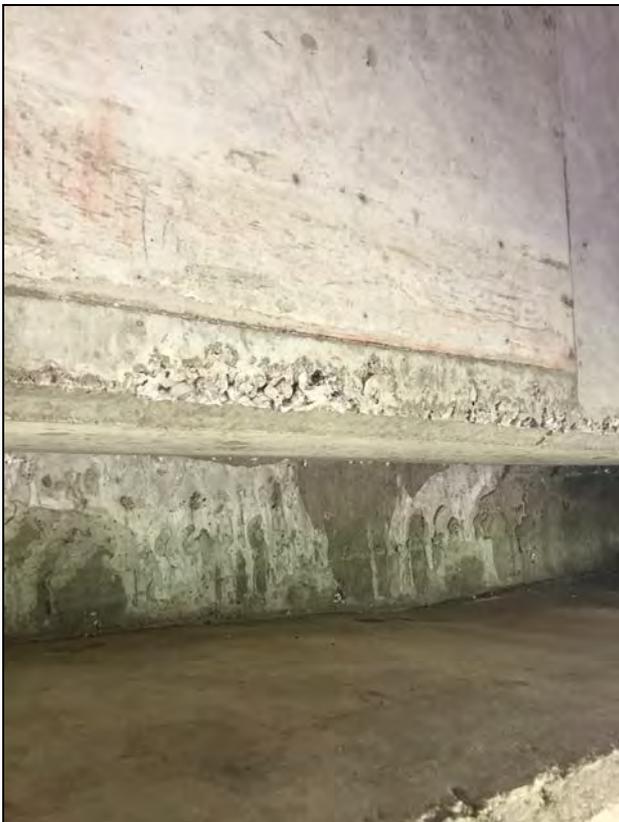
**Description: Southwest corner**

**Beams/Main Longitudinal Elements / Diaphragms (At north and south abutments.)**

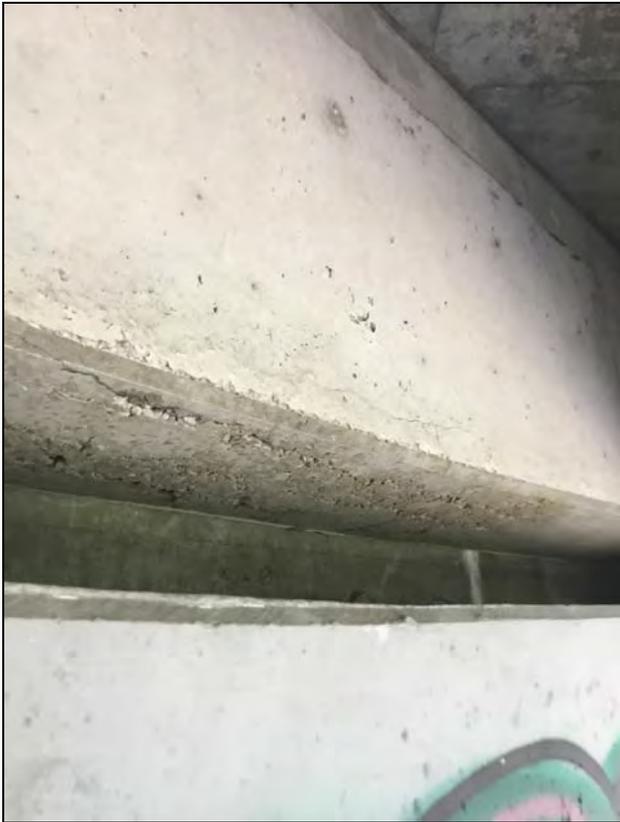
**Description: Scaling and delamination - north side third in Beams/Main Longitudinal Elements / Diaphragms (At north and south abutments.)**

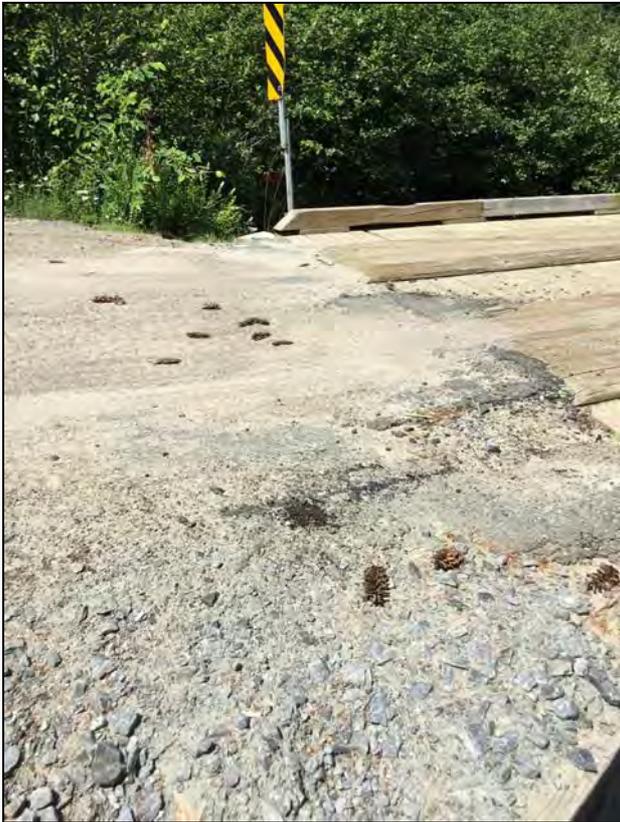
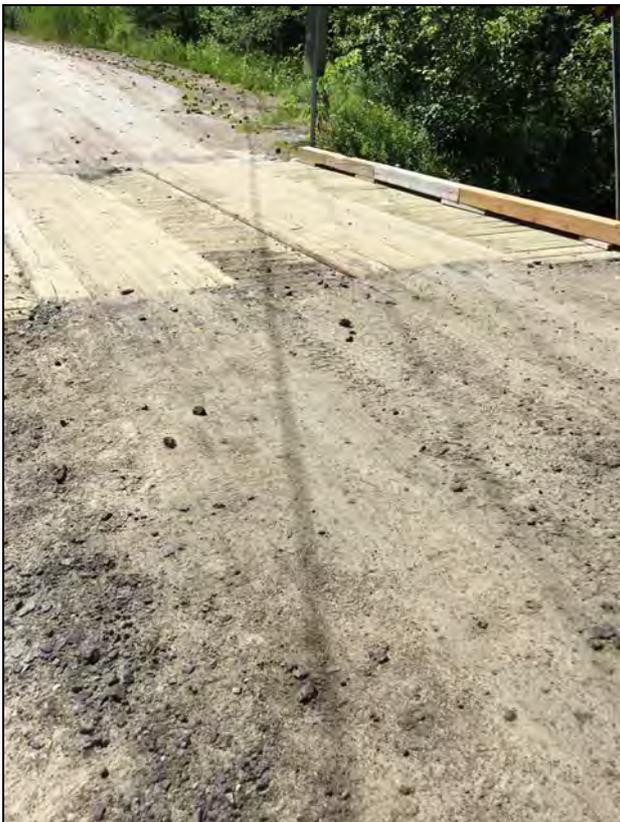
**Approaches / Wearing surface (East/West)**

<b>Element Group:</b>	Approaches					<b>Length:</b>	6.0 (m)	
<b>Element Name:</b>	Wearing surface					<b>Width:</b>	2.7 (m)	
<b>Location:</b>	East/West					<b>Height:</b>		
<b>Element Description:</b>						<b>Count:</b>	2	
<b>Material:</b>	Gravel/Asphalt					<b>Total Quantity:</b>	32.4 (sq.m)	
<b>Element Type:</b>						<b>Not Inspected:</b>	<input type="checkbox"/>	
<b>Environment:</b>	<input type="checkbox"/> Benign, <input type="checkbox"/> Moderate, <input checked="" type="checkbox"/> Severe					<b>Limited Inspection:</b>	<input type="checkbox"/>	
<b>Protection System:</b>						<b>Perform. Deficiencies</b>		
<b>Condition Data:</b>	<b>Units</b>	<b>Exc.</b>	<b>Good</b>	<b>Fair</b>	<b>Poor*</b>			
	sq.m	0.00	0.00	30.0	2.4	<b>BCI TEV:</b> 194.4		<b>BCI CEV:</b> 72.0
<b>Comments:</b>	Gravel on east side is compacted at wheel tracks and loose in the centerline. Asphalt on west side has depressions and patch work immediately in front of deck that results in ponding and a lip to bridge. Asphalt also has longitudinal narrow-medium cracks throughout.

<b>Recommended work:</b>						<b>Maintenance Needs:</b> 16. Bridge Deck Drainage		
<b>Comments</b>						<input checked="" type="checkbox"/> 1 year, <input type="checkbox"/> 2 years, <input type="checkbox"/> Urgent		
<b>Type Timing</b>						Blend to road on west side to provide sufficient drainage. Regrade east approach.

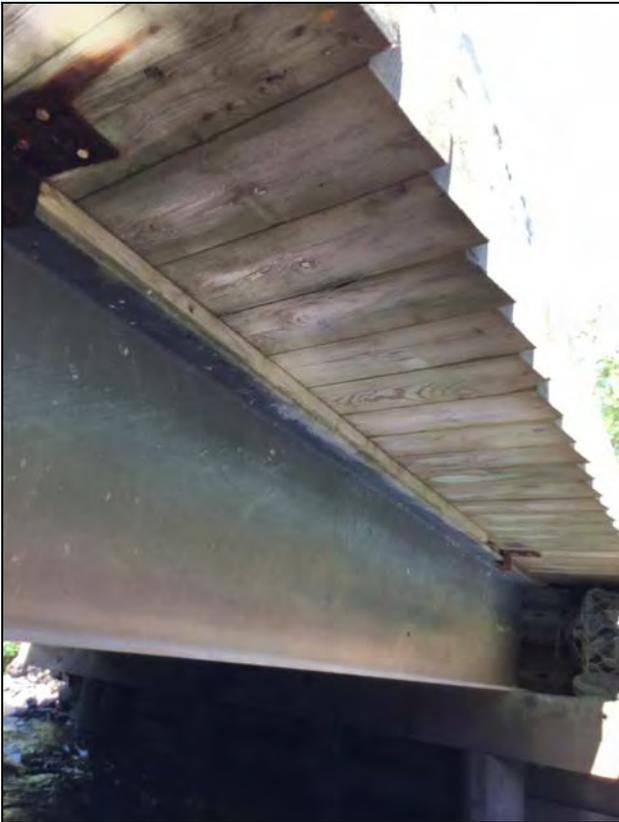
**Decks / Soffit - Thin Slab**

<b>Element Group:</b>	Decks					<b>Length:</b>	5.4 (m)	
<b>Element Name:</b>	Soffit - Thin Slab					<b>Width:</b>	4.1 (m)	
<b>Location:</b>						<b>Height:</b>		
<b>Element Description:</b>						<b>Count:</b>	0	
<b>Material:</b>	Wood					<b>Total Quantity:</b>	22.1 (sq.m)	
<b>Element Type:</b>						<b>Not Inspected:</b>	<input type="checkbox"/>	
<b>Environment:</b>	<input type="checkbox"/> Benign, <input checked="" type="checkbox"/> Moderate, <input type="checkbox"/> Severe					<b>Limited Inspection:</b>	<input checked="" type="checkbox"/>	
<b>Protection System:</b>						<b>Perform. Deficiencies</b>		
<b>Condition Data:</b>	<b>Units</b>	<b>Exc.</b>	<b>Good</b>	<b>Fair</b>	<b>Poor*</b>			
	sq.m	0.00	19.89	2.21	0.00	<b>BCI TEV:</b> 2652.0	<b>BCI CEV:</b> 1896.18	
<b>Comments:</b>	Limited inspection due to high water level. Visible portions were in good condition, 10% had moisture seeping through from the deck top.

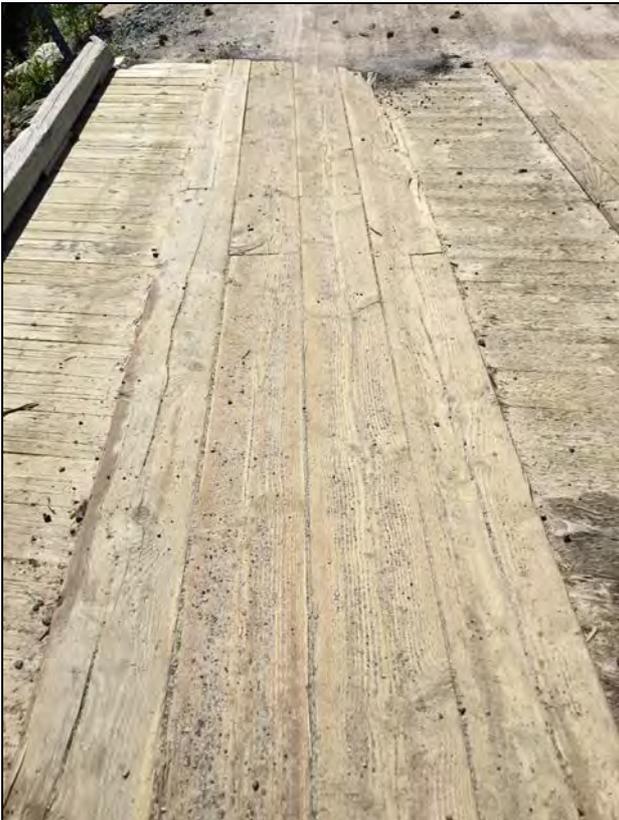
**Decks / Wearing Surface**

<b>Element Group:</b>	Decks					<b>Length:</b>	5.5 (m)		
<b>Element Name:</b>	Wearing Surface					<b>Width:</b>	0.9 (m)		
<b>Location:</b>						<b>Height:</b>			
<b>Element Description:</b>	Longitudinal PT 2x8 boards					<b>Count:</b>	2		
<b>Material:</b>	Wood					<b>Total Quantity:</b>	9.9 (sq.m)		
<b>Element Type:</b>						<b>Not Inspected:</b>	<input type="checkbox"/>		
<b>Environment:</b>	<input type="checkbox"/> Benign, <input type="checkbox"/> Moderate, <input checked="" type="checkbox"/> Severe					<b>Limited Inspection:</b>	<input type="checkbox"/>		
<b>Protection System:</b>						<b>Perform. Deficiencies</b>			
<b>Condition Data:</b>	<b>Units</b>	<b>Exc.</b>	<b>Good</b>	<b>Fair</b>	<b>Poor*</b>				
	sq.m	0.00	9.0	0.9	0.00	<b>BCI TEV:</b> 247.5		<b>BCI CEV:</b> 177.75	
<b>Comments:</b>	Running boards in good condition boards at the edge of wearing surface have split.								
<b>Recommended work:</b>						<b>Maintenance Needs:</b> 12. Bridge Surface Repair

<b>Comments</b>						<input checked="" type="checkbox"/> 1 year, <input type="checkbox"/> 2 years, <input type="checkbox"/> Urgent			
<b>Type Timing</b>						Replace all four edge boards.

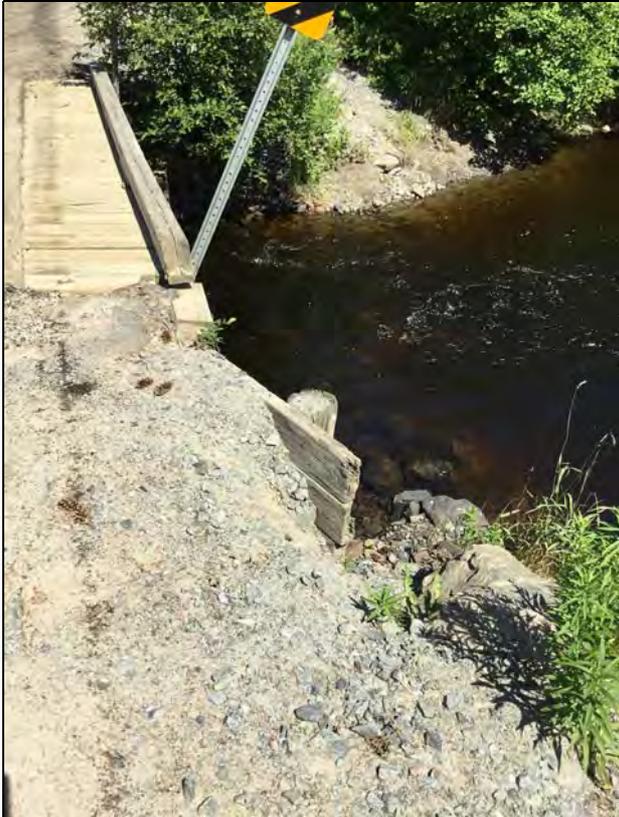
**Description: SW embankment  
Embankments & Streams / Embankments**

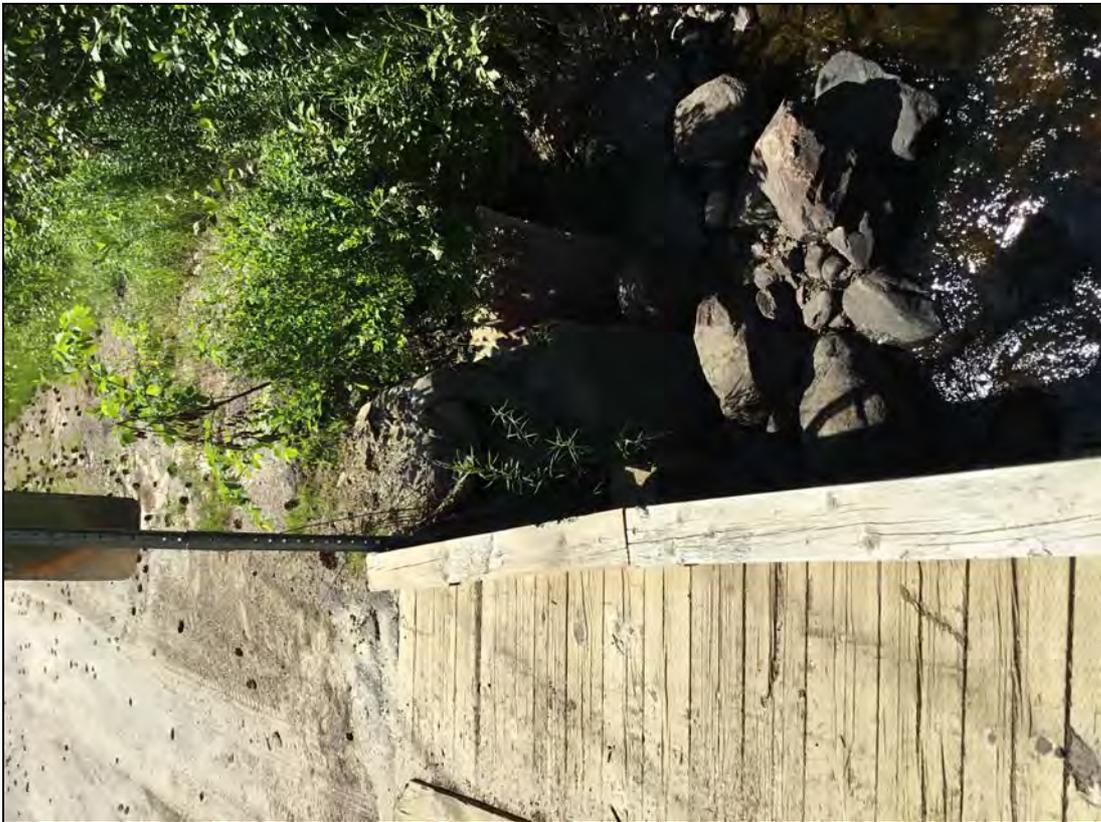
**Description: NW embankment with exposed geotextile**  
**Embankments & Streams / Embankments**

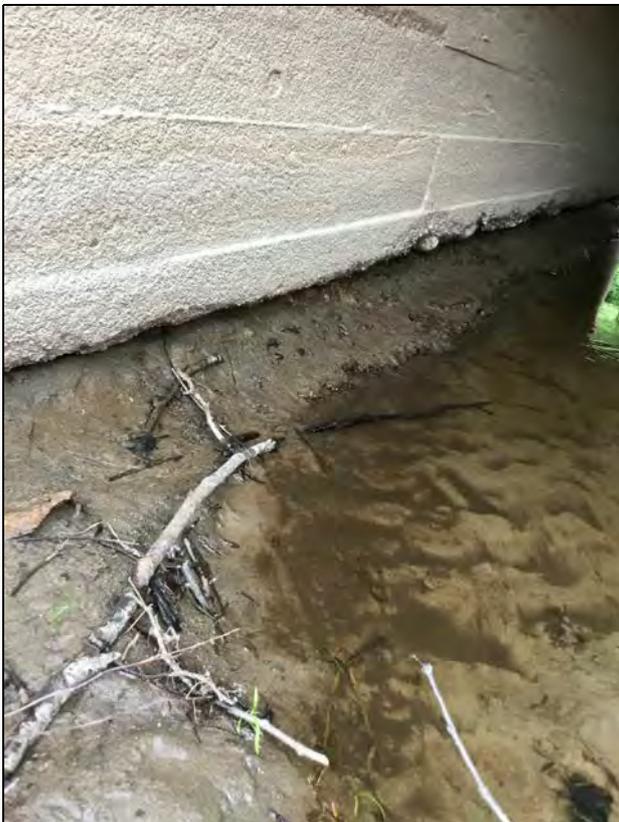
**Description: South abutment erosion.**  
**Abutments / Abutment Walls (East and West)**

Repair and Rehabilitation Required		Priority					Estimated Cost
Element	Repair and Rehabilitation Required	> 10 years	6 - 10 years	1 - 5 years	Now < 1 year	Urgent	
Structure	Replace structure		✓				\$300,000.00
<b>Total</b>							\$300,000.00

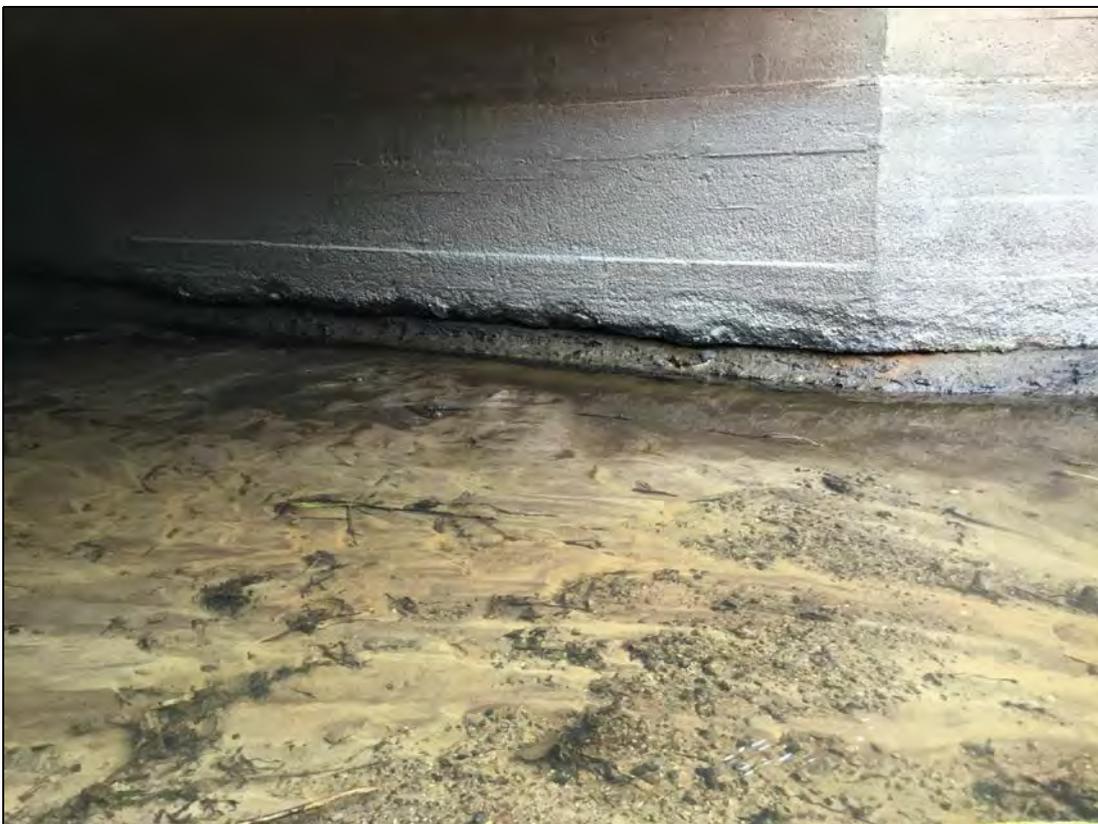
**Description: North abutment erosion at footing interface.**

**Abutments / Abutment Walls (East and West)**
