## TOWN OF HUNTSVILLE BRIDGE INSPECTIONS

Inspection Report

Project # 17-4022-07

November 2018

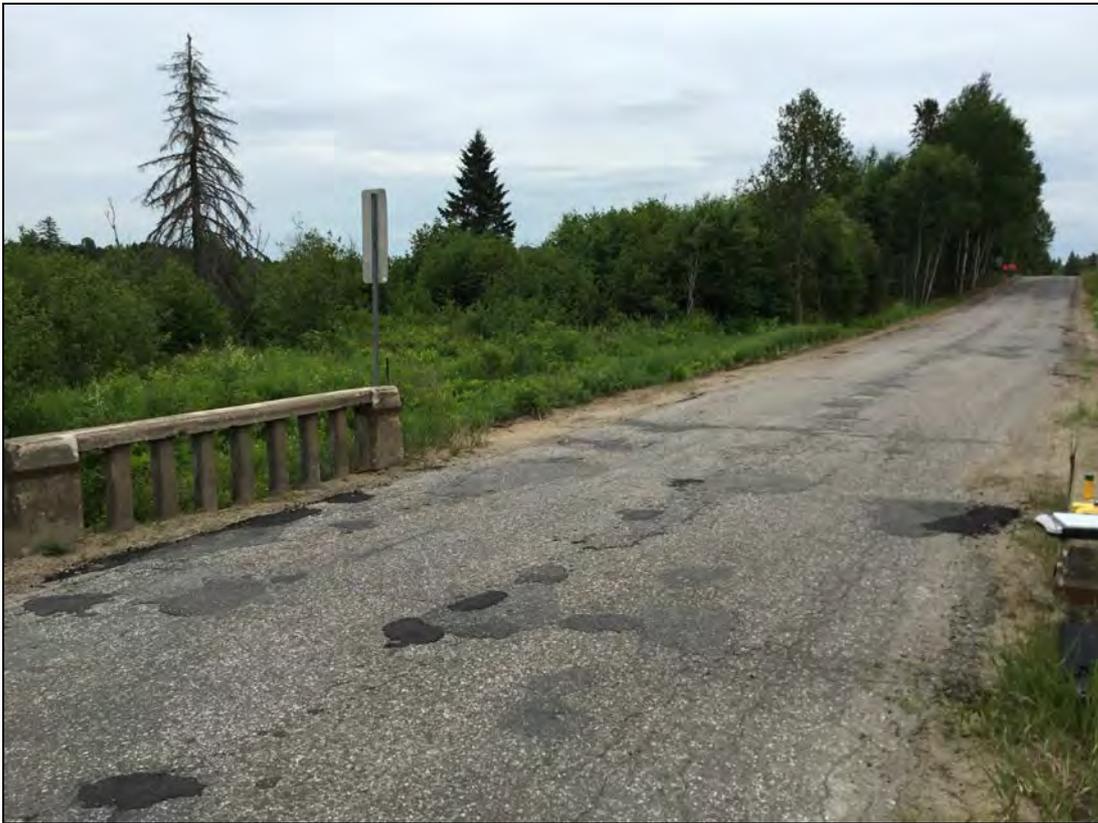
**Description: Wearing surface above decktop**

**Decks / Deck Top**

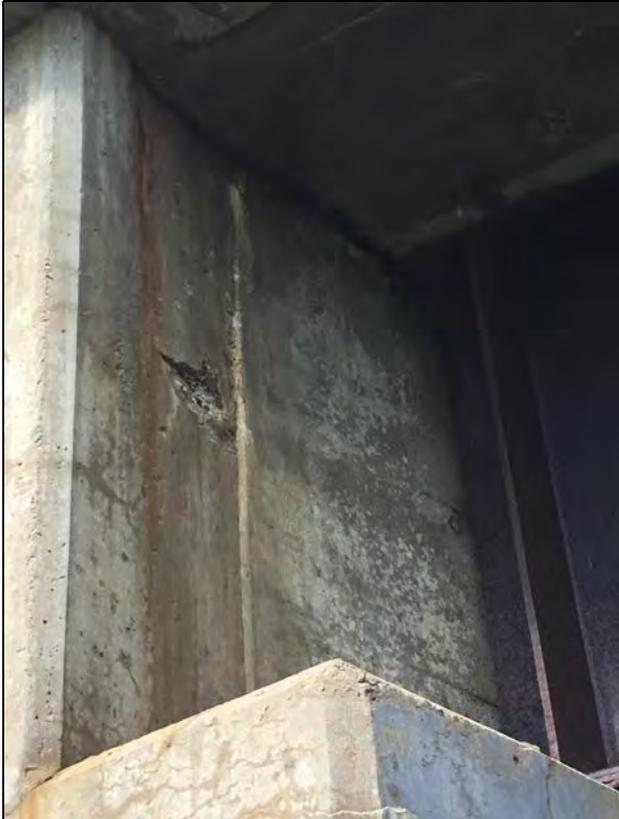
**Description: Spall at NW quadrant**

**Abutments / Ballast Walls (North and South Abutment)**

<b>Recommended work:</b>					<b>Maintenance Needs:</b>				
<b>Comments</b>					<input type="checkbox"/> 1 year, <input type="checkbox"/> 2 years, <input type="checkbox"/> Urgent				
<b>Type Timing</b>									
Repair ballast wall.  <input checked="" type="checkbox"/> Rehab, <input type="checkbox"/> Repair, <input type="checkbox"/> Replace					<input type="checkbox"/> 1 - 5 years, <input type="checkbox"/> Now < 1 year, <input checked="" type="checkbox"/> 6 - 10 years, <input type="checkbox"/> Urgent

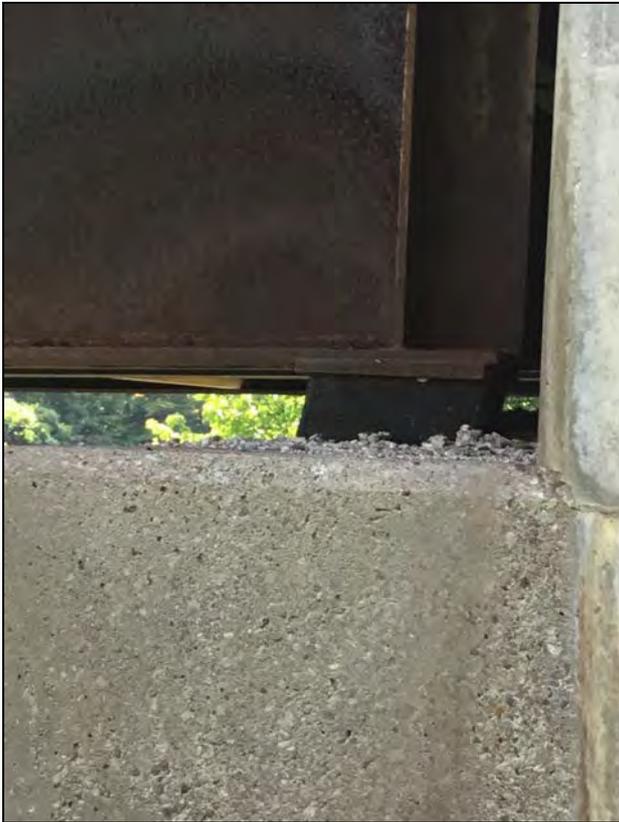
**Description: NE bearing**  
**Abutments / Bearings (North and South)**

<b>Recommended work:</b>						<b>Maintenance Needs:</b>		
<b>Comments</b> When seals and joints are replaced, replace the bearings.						<input type="checkbox"/> 1 year, <input type="checkbox"/> 2 years, <input type="checkbox"/> Urgent		
<b>Type</b>		<b>Timing</b>						
<input type="checkbox"/> Rehab, <input type="checkbox"/> Repair, <input checked="" type="checkbox"/> Replace		<input type="checkbox"/> 1 - 5 years, <input type="checkbox"/> Now < 1 year, <input checked="" type="checkbox"/> 6 - 10 years, <input type="checkbox"/> Urgent

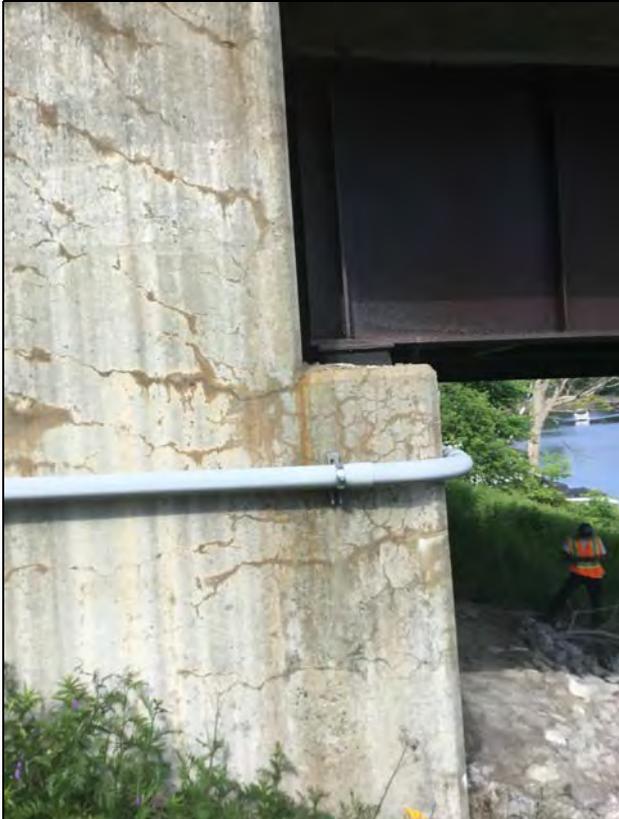
**Description: NW bearing**  
**Abutments / Bearings (North and South)**

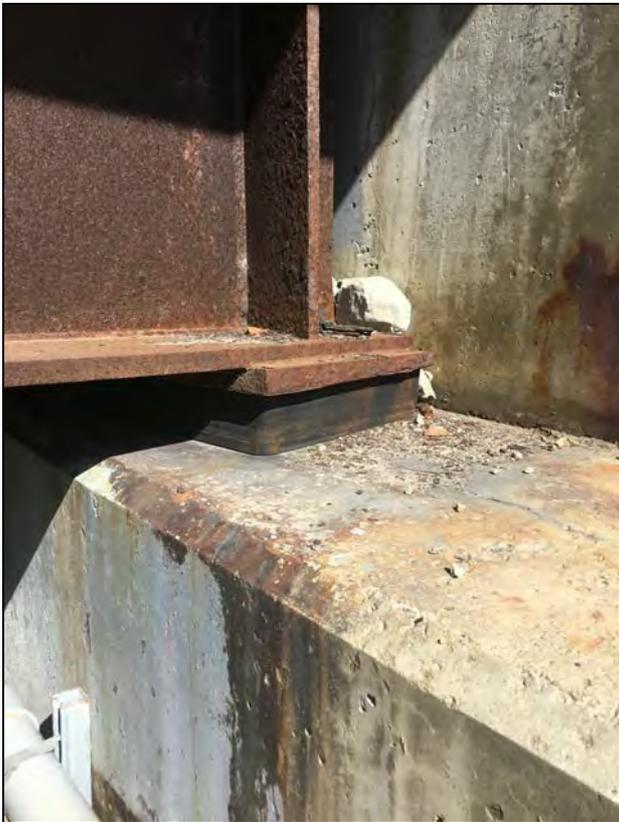
**Description: SW outer bearing.**  
**Abutments / Bearings (North and South)**

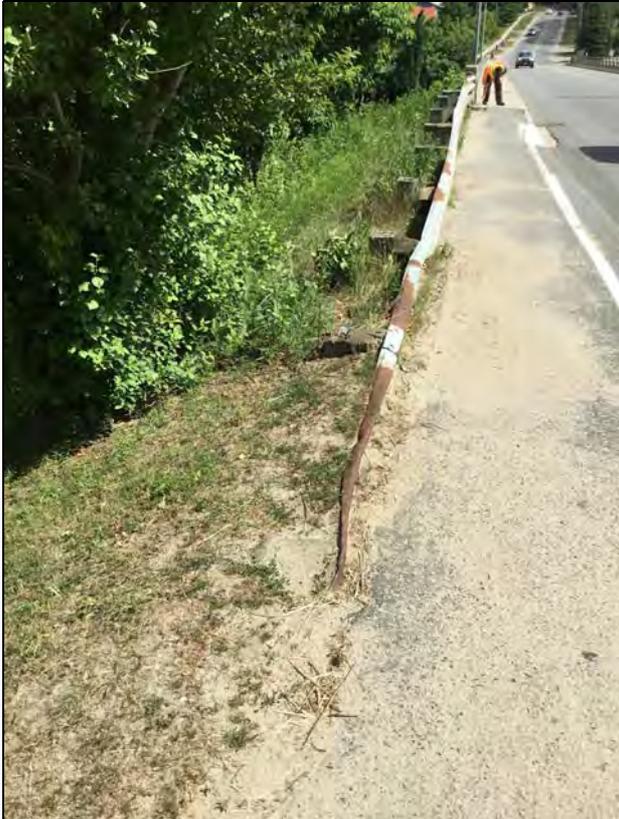
**Description: Bent NE steel beam guiderail**

**Approaches / Barriers (NE, NW)**

<b>Recommended work:</b>					<b>Maintenance Needs:</b>				
<b>Comments</b>  Install new guide rail to current code.					<input type="checkbox"/> 1 year, <input type="checkbox"/> 2 years, <input type="checkbox"/> Urgent				
<b>Type</b>  <input type="checkbox"/> Rehab, <input type="checkbox"/> Repair, <input checked="" type="checkbox"/> Replace		<b>Timing</b>  <input type="checkbox"/> 1 - 5 years, <input type="checkbox"/> Now < 1 year, <input type="checkbox"/> 6 - 10 years, <input checked="" type="checkbox"/> Urgent

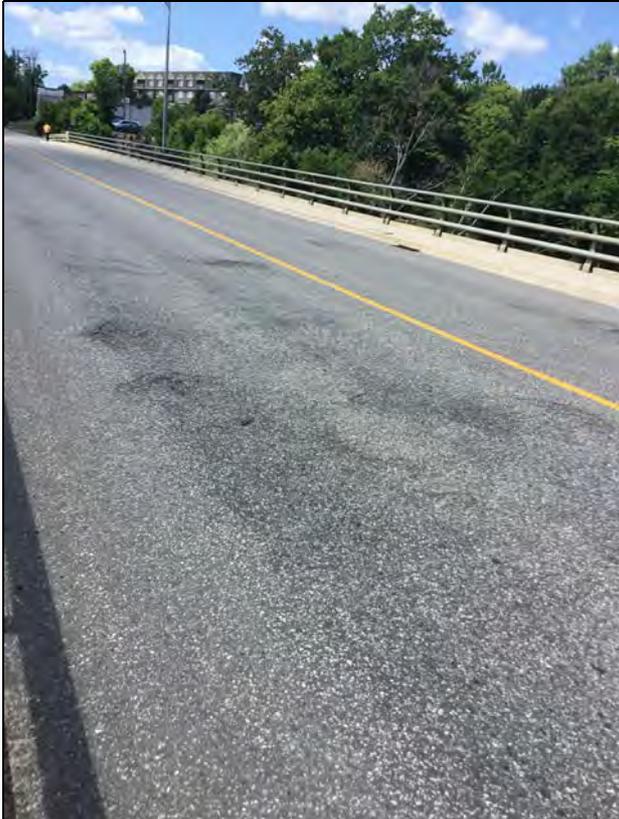
**Description: Depressions forming at mid point**  
**Decks / Wearing Surface**

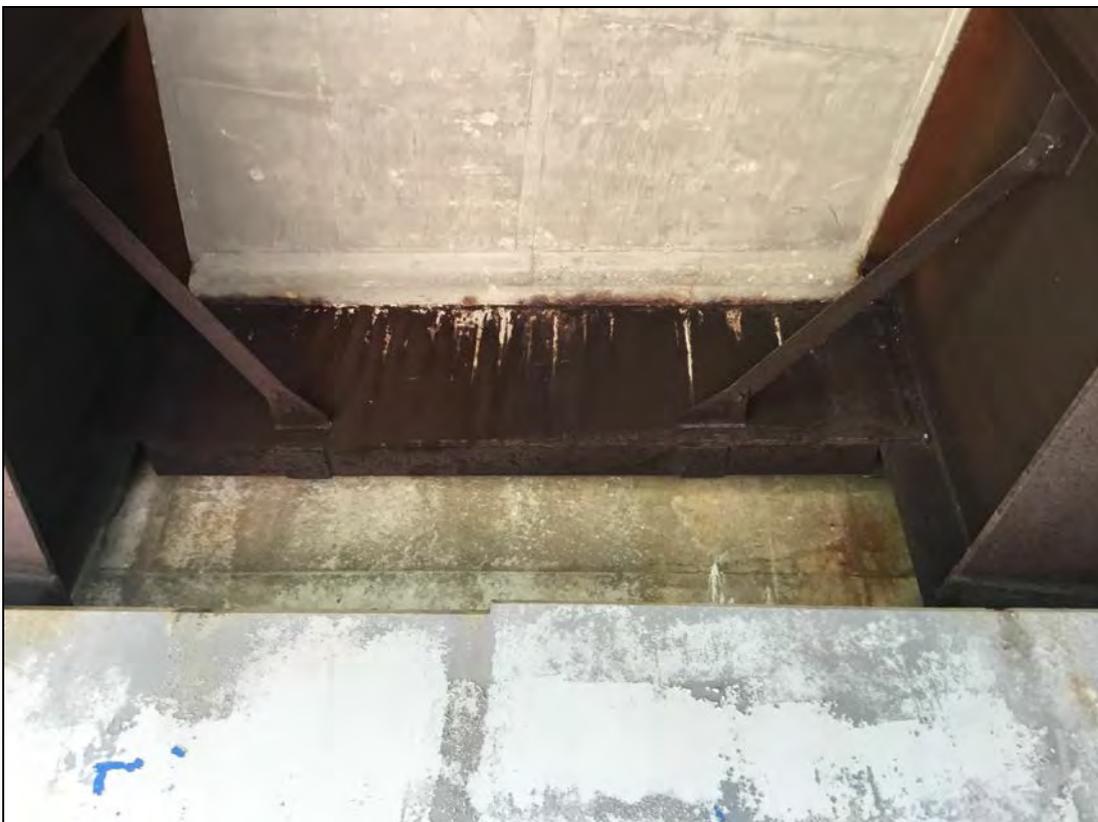
**Description: North middle diaphragm. ( typical weathered abutment diaphragm)**  
**Beams/Main Longitudinal Elements / Diaphragms (Abutments)**

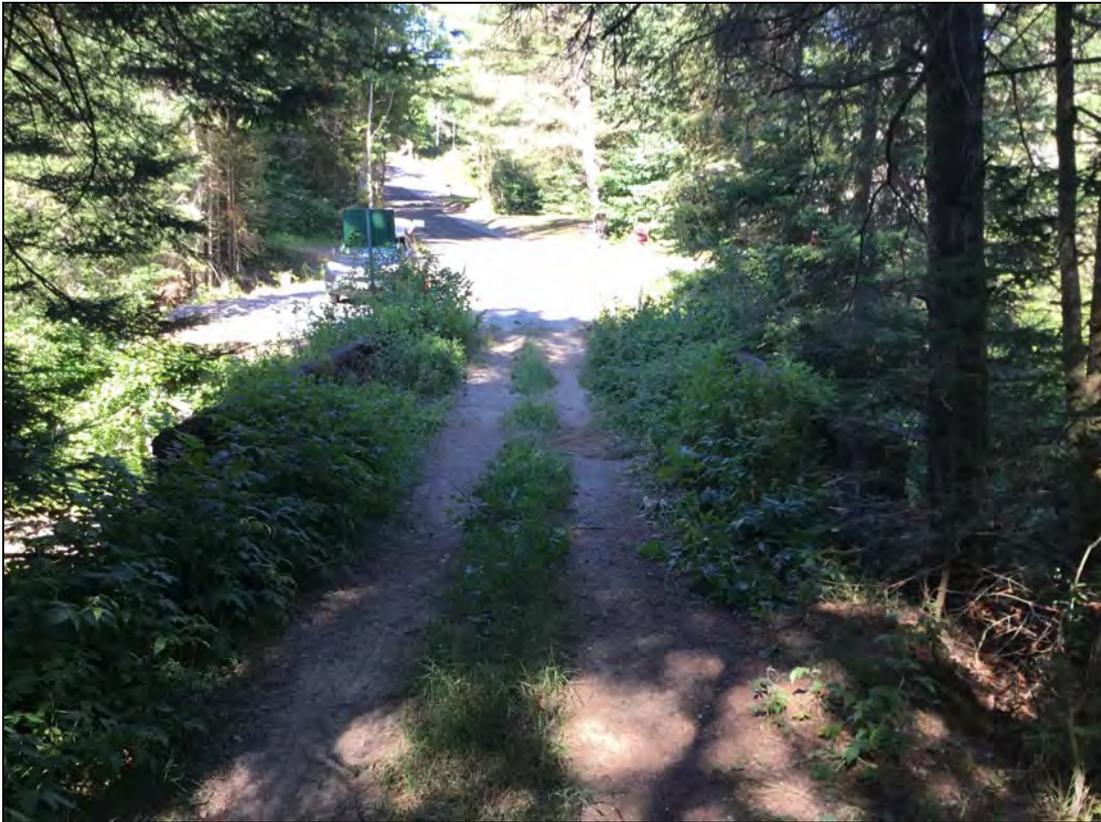
**Description: Looking west**

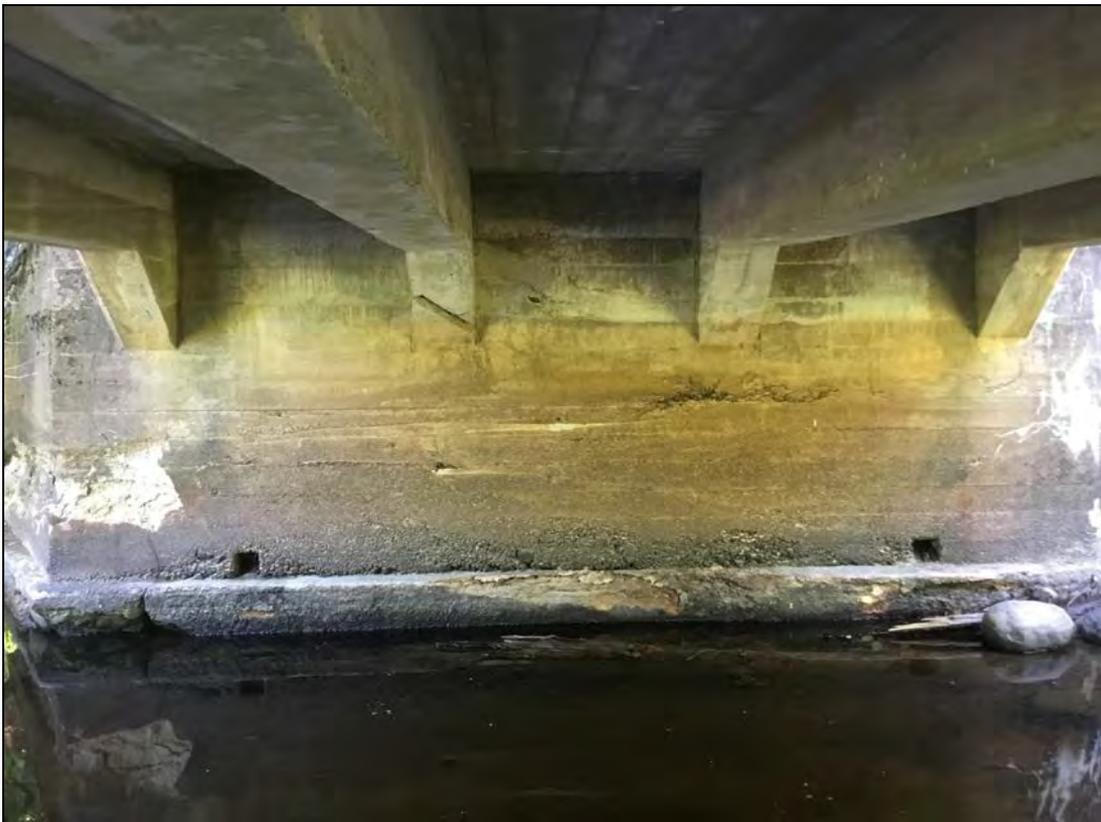
**Description: East**  
**Abutments / Abutment Walls (East and West)**

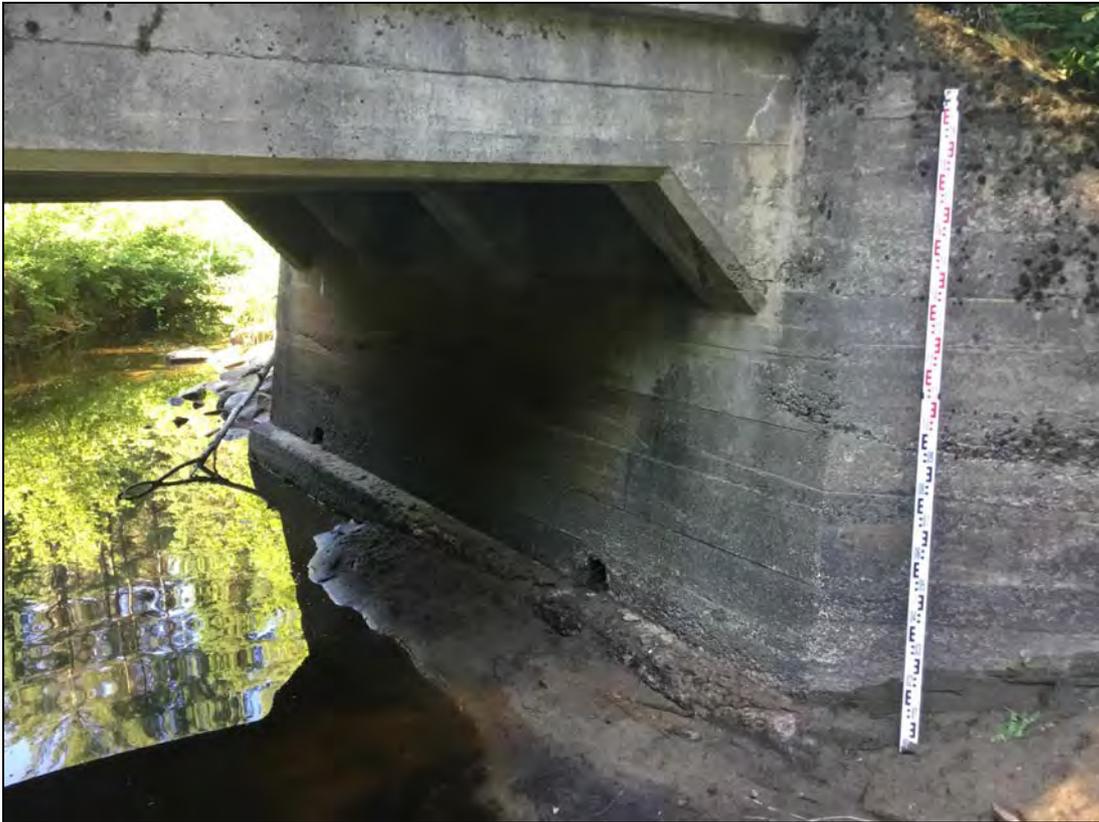
**Description: West**  
**Abutments / Abutment Walls (East and West)**

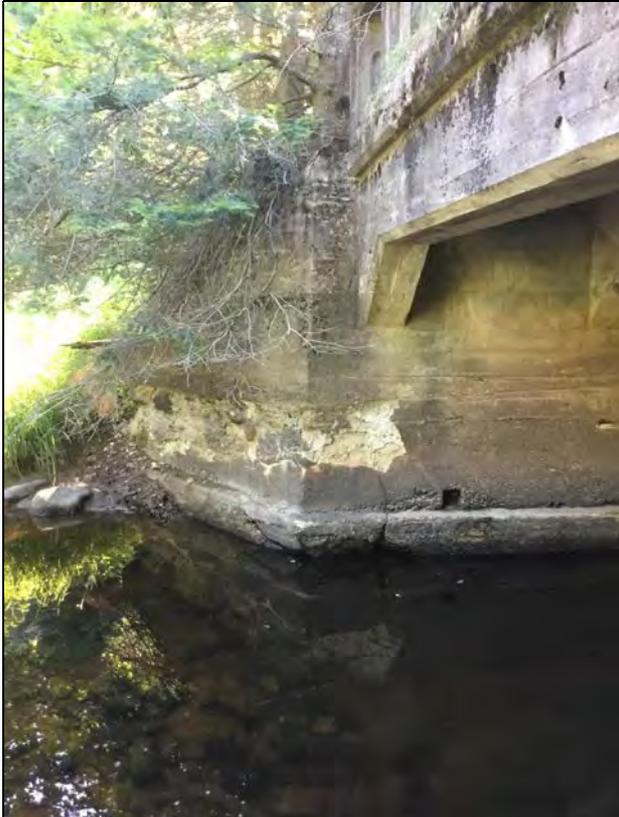
**Description: Ne quadrant**  
**Abutments / Wingwalls (4 Corners)**

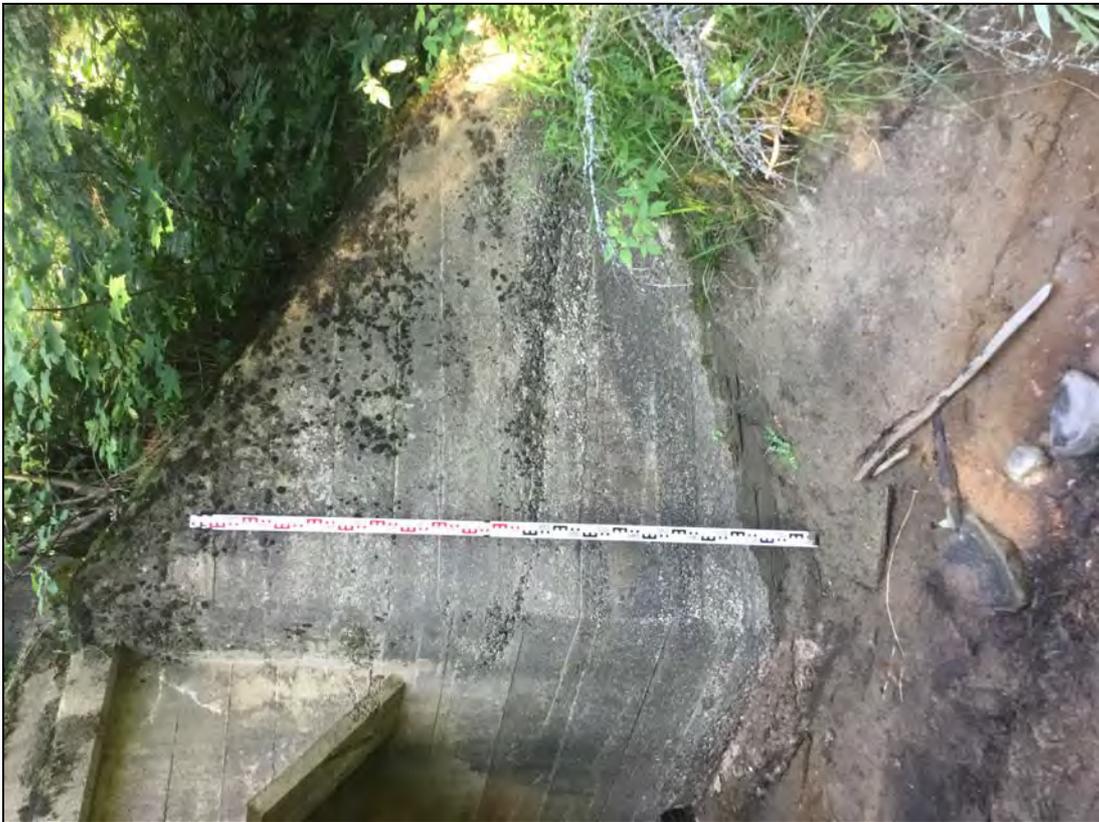
**Description: Nw wall**

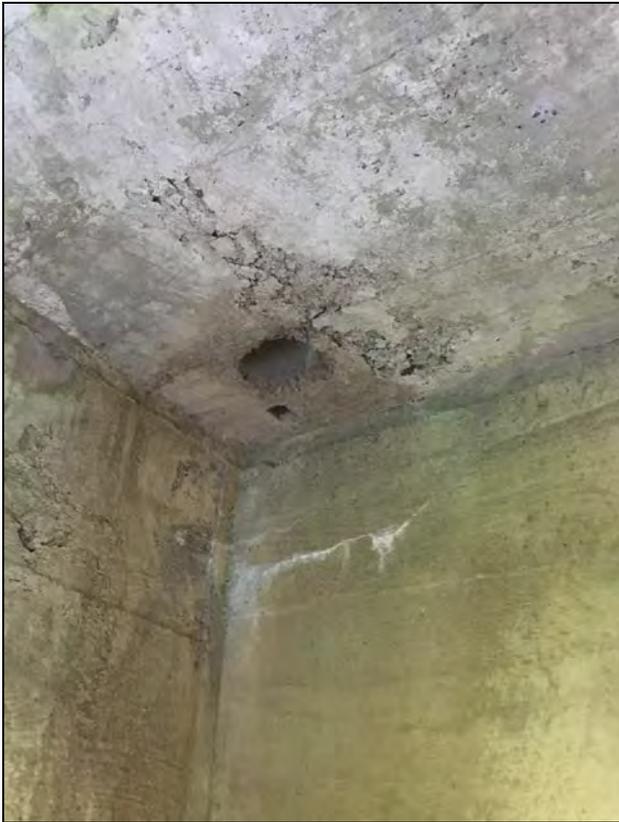
**Description: Nw drain**  
**Decks / Drainage System**

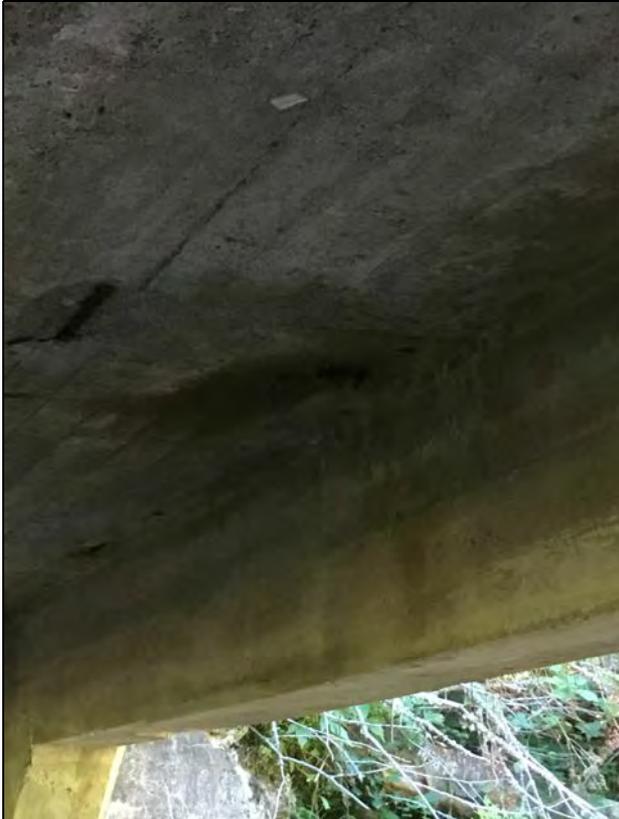
**Description: Mid drain South Side (wet)**  
**Decks / Drainage System**

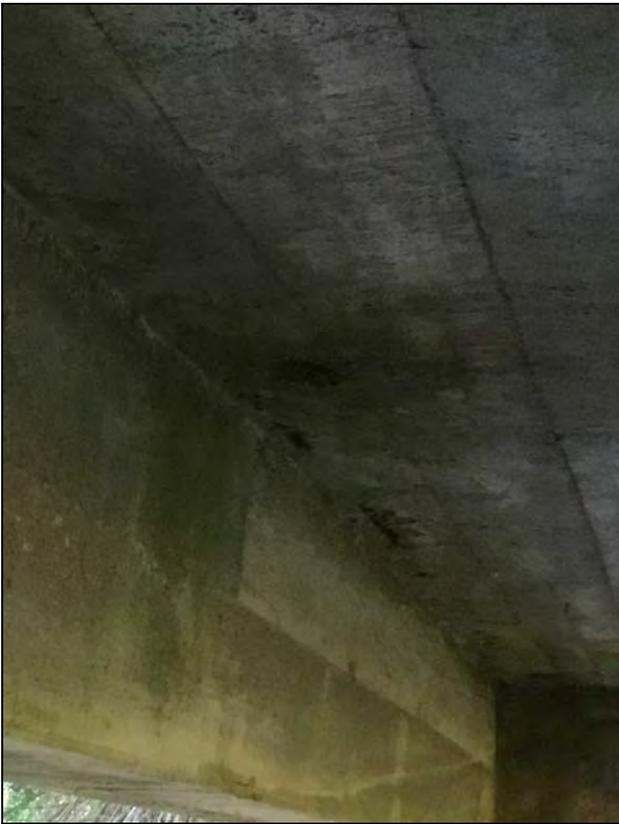
**Description: NE drain**  
**Decks / Drainage System**

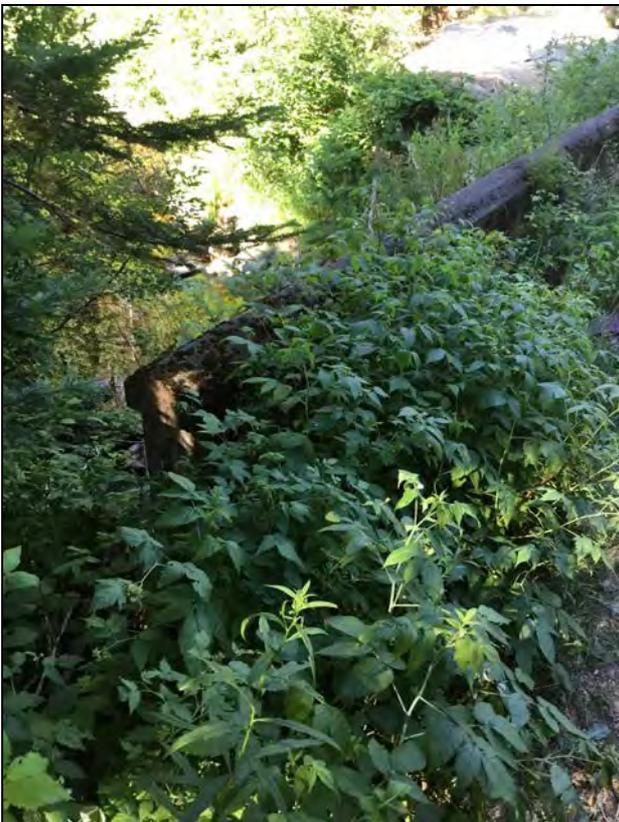
**Description: SE end post**  
**Barriers / Posts (North and South)**

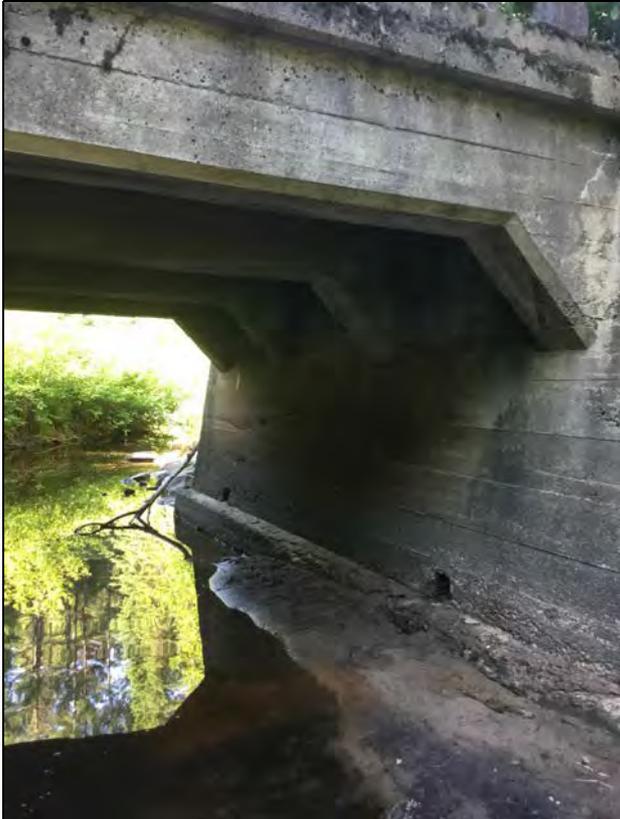
**Description: East side**  
**Beams/Main Longitudinal Elements / Girders**

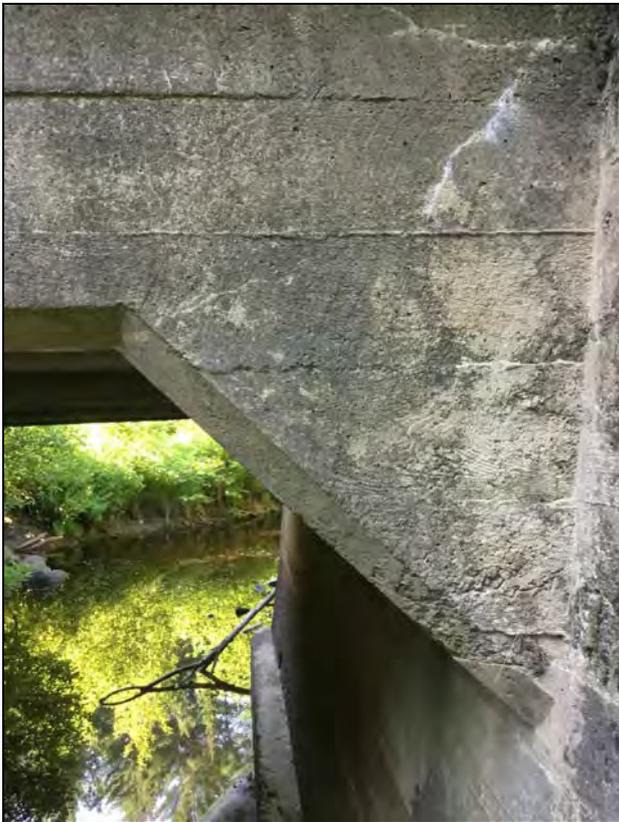
**Description: Nw (typ.)**  
**Beams/Main Longitudinal Elements / Girders**

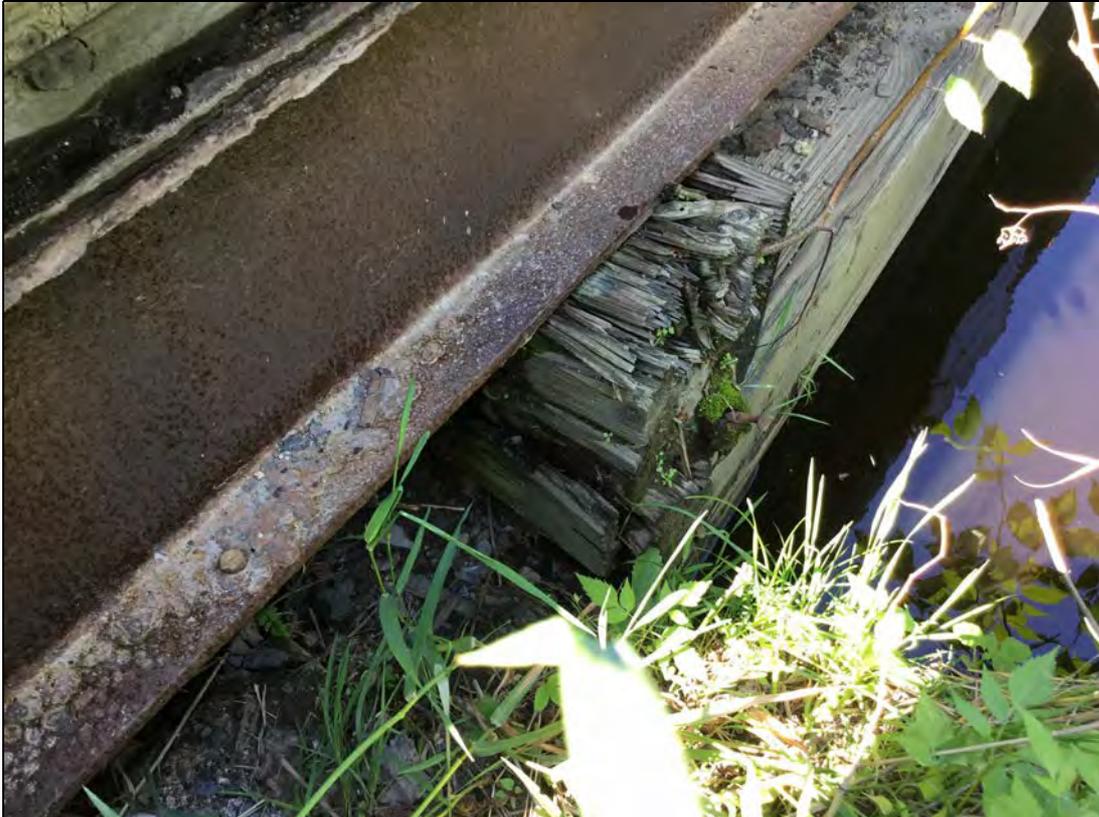
<b>Element Group:</b>	Abutments					<b>Length:</b>		
<b>Element Name:</b>	Bearings					<b>Width:</b>		
<b>Location:</b>	East and West Abutments					<b>Height:</b>		
<b>Element Description:</b>						<b>Count:</b>	12	
<b>Material:</b>	Wood					<b>Total Quantity:</b>	12.0 (each)	
<b>Element Type:</b>						<b>Not Inspected:</b>	<input type="checkbox"/>	
<b>Environment:</b>	<input type="checkbox"/> Benign, <input checked="" type="checkbox"/> Moderate, <input type="checkbox"/> Severe					<b>Limited Inspection:</b>	<input type="checkbox"/>	
<b>Protection System:</b>						<b>Perform. Deficiencies</b>		
<b>Condition Data:</b>	<b>Units</b>	<b>Exc.</b>	<b>Good</b>	<b>Fair</b>	<b>Poor*</b>			
	each	0.00	9.0	3.0	0.00	<b>BCI TEV: 12000.0</b>		<b>BCI CEV: 7950.0</b>
<b>Comments:</b>	Bearings appear to be wooden shims placed under each girder. Crushing and permanent indentation of the shims was observed in some locations. Southeastern inner bearing block showing signs of rot and crushing. Southwest inner bearing crushing approximately 20%.

**Description: SW inner bearing**

<b>Recommended work:</b>						<b>Maintenance Needs:</b>		
<p><b>Comments</b></p> <p>Replacing deficient bearings in required locations during crib rehabilitation.</p> <p><b>Type</b></p> <p><input type="checkbox"/> Rehab, <input type="checkbox"/> Repair, <input checked="" type="checkbox"/> Replace</p> <p><b>Timing</b></p> <p><input checked="" type="checkbox"/> 1 - 5 years, <input type="checkbox"/> Now &lt; 1 year, <input type="checkbox"/> 6 - 10 years, <input type="checkbox"/> Urgent</p>						<p><input type="checkbox"/> 1 year, <input type="checkbox"/> 2 years, <input type="checkbox"/> Urgent</p>

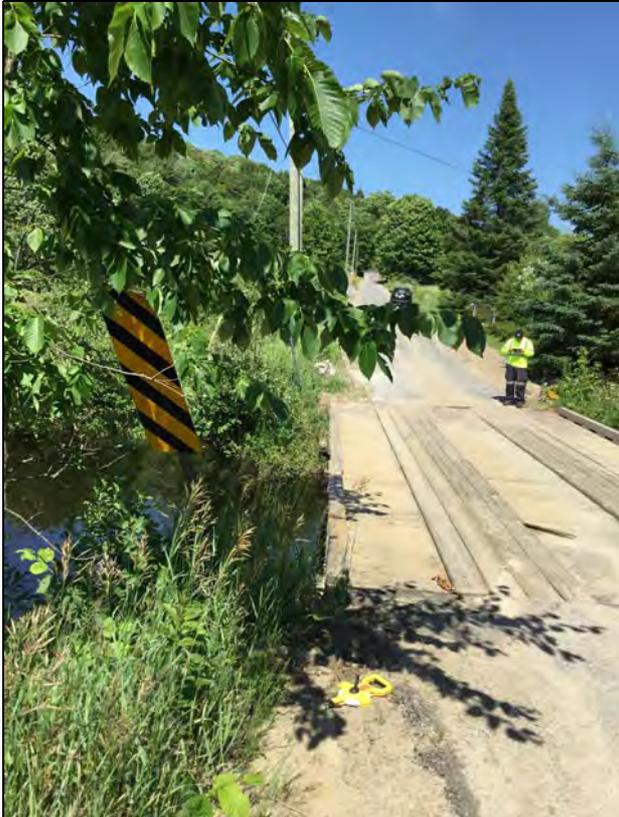
**Description: NW dislocated hazard sign**

<b>Recommended work:</b>						<b>Maintenance Needs:</b> 17. Other			
<b>Comments</b> Replace all hazard signs.						<input type="checkbox"/> 1 year, <input type="checkbox"/> 2 years, <input checked="" type="checkbox"/> Urgent  Restore signs to their correct orientation. Clear vegetation from one lane and speed warning signs.			
<b>Type</b>	<b>Timing</b>								
<input type="checkbox"/> Rehab, <input type="checkbox"/> Repair, <input checked="" type="checkbox"/> Replace	<input type="checkbox"/> 1 - 5 years, <input type="checkbox"/> Now < 1 year, <input type="checkbox"/> 6 - 10 years, <input checked="" type="checkbox"/> Urgent

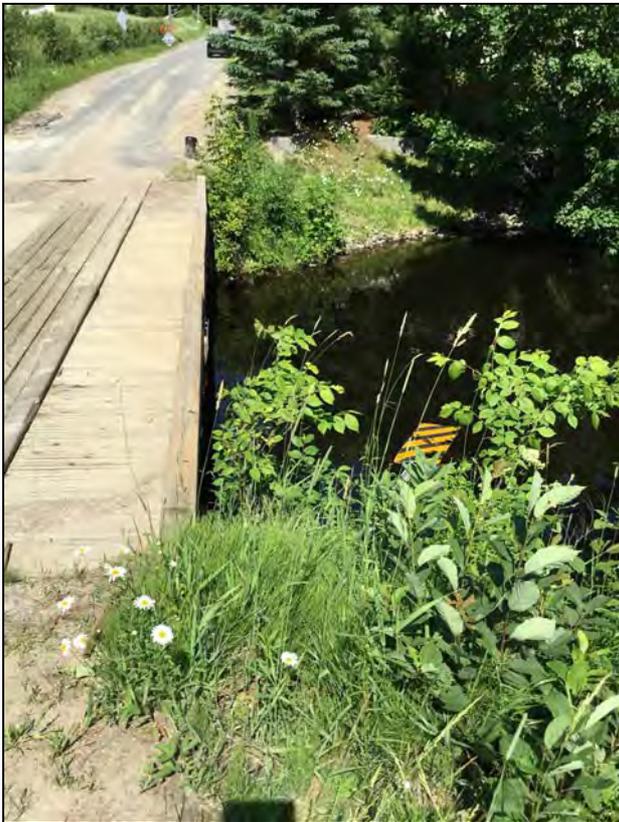
**Description: Dislocated SW hazard**

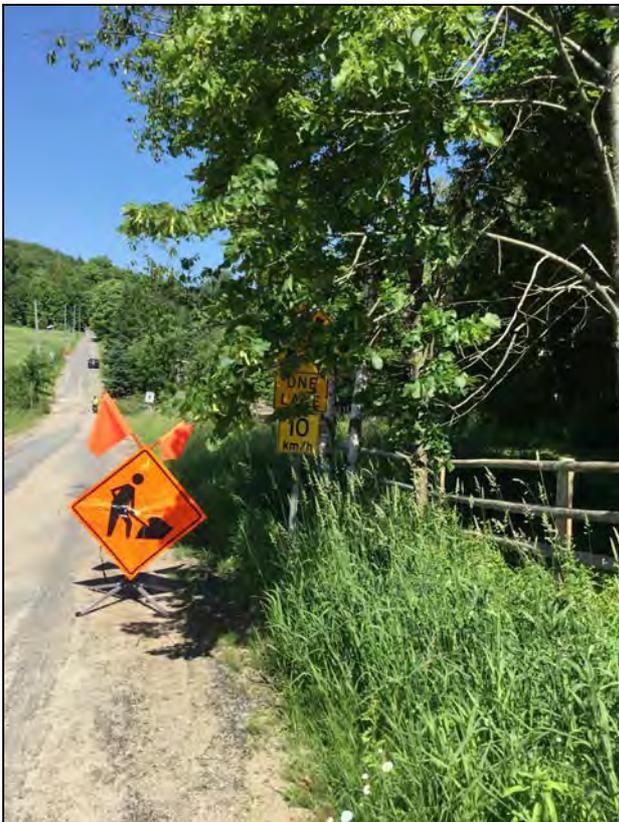
**Description: Vegetation covering view of W one lane sign**

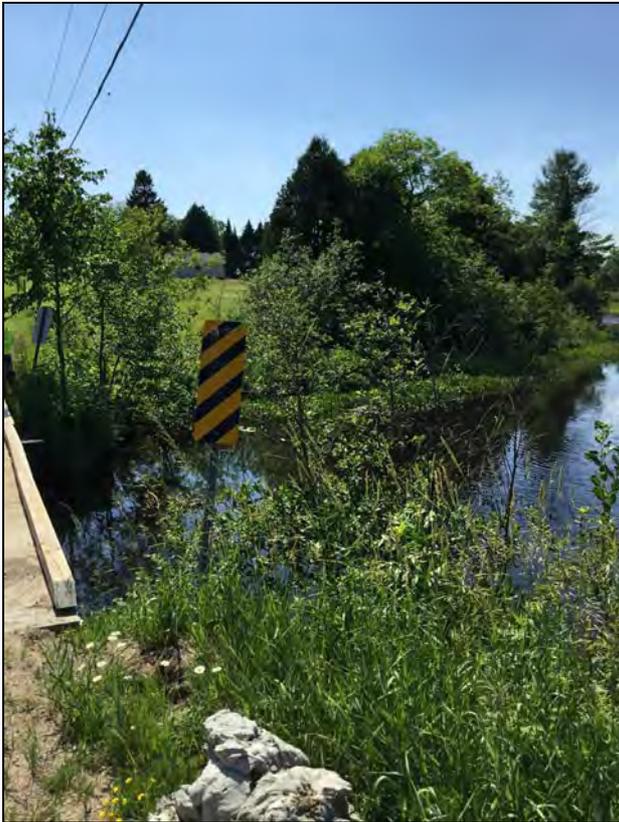
**Description: Bent NE hazard**

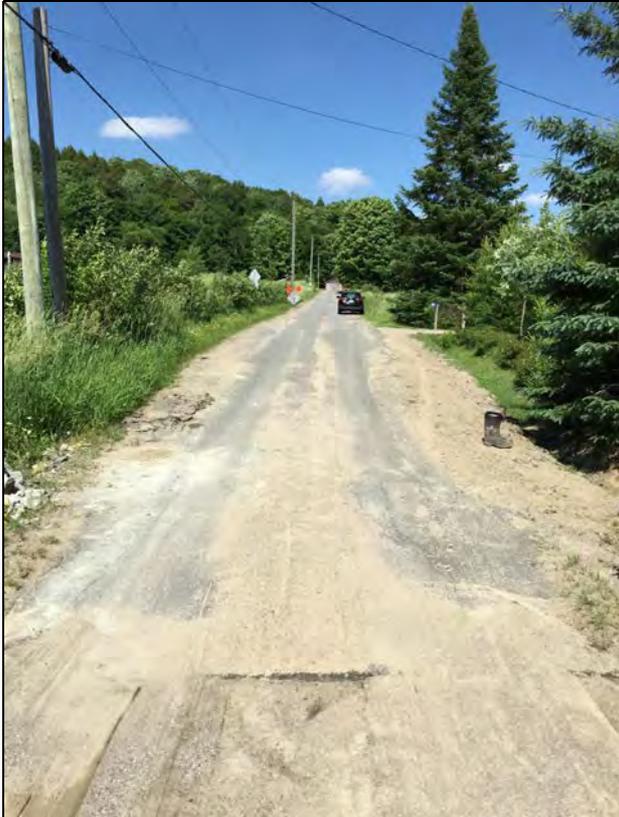
<b>Element Group:</b>	Approaches	<b>Length:</b>	6.0 (m)				
<b>Element Name:</b>	Wearing surface	<b>Width:</b>	4.6 (m)				
<b>Location:</b>	East and west of bridge	<b>Height:</b>					
<b>Element Description:</b>		<b>Count:</b>	2				
<b>Material:</b>	Asphalt	<b>Total Quantity:</b>	55.2 (sq.m)				
<b>Element Type:</b>		<b>Not Inspected:</b>	<input type="checkbox"/>				
<b>Environment:</b>	<input type="checkbox"/> Benign, <input type="checkbox"/> Moderate, <input checked="" type="checkbox"/> Severe	<b>Limited Inspection:</b>	<input type="checkbox"/>				
<b>Protection System:</b>		<b>Perform. Deficiencies</b>					
<b>Condition Data:</b>	<b>Units</b>	<b>Exc.</b>	<b>Good</b>	<b>Fair</b>	<b>Poor*</b>	03. Continuing settlement	
	sq.m	0.00	5.0	34.2	10.0	<b>BCI TEV:</b> 331.2	<b>BCI CEV:</b> 104.58
<b>Comments:</b>	Wheel rutting, settlement behind abutments, and various narrow longitudinal cracks on both approaches. Damaged asphalt on north east approach.

**Description: E approach**

<b>Recommended work:</b>					<b>Maintenance Needs:</b>		
<b>Comments</b>  Repave approaches.  <b>Type</b> <input type="checkbox"/> Rehab, <input type="checkbox"/> Repair, <input checked="" type="checkbox"/> Replace					<b>Timing</b> <input checked="" type="checkbox"/> 1 - 5 years, <input type="checkbox"/> Now < 1 year, <input type="checkbox"/> 6 - 10 years, <input type="checkbox"/> Urgent		
					<input type="checkbox"/> 1 year, <input type="checkbox"/> 2 years, <input type="checkbox"/> Urgent

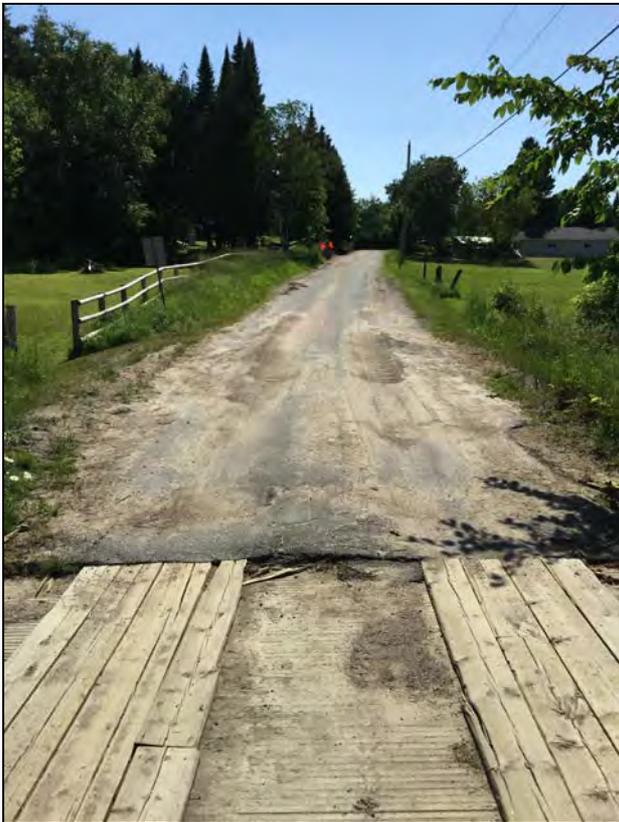
**Description: W approach**
